Characterisation of APS TBC system during isothermal oxidation at 1100°C

L. Swadźba ^a, G. Moskal ^{a,*}, B. Mendala ^a, T. Gancarczyk ^b

^a Silesian University of Technology, ul. Krasińskiego 8, 40-019 Katowice, Poland

^b WSK "PZL Rzeszów", ul. Hetmańska 120, 35-078 Rzeszów, Poland

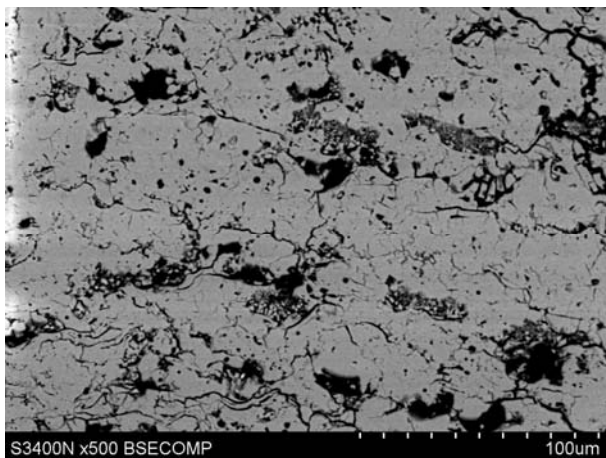
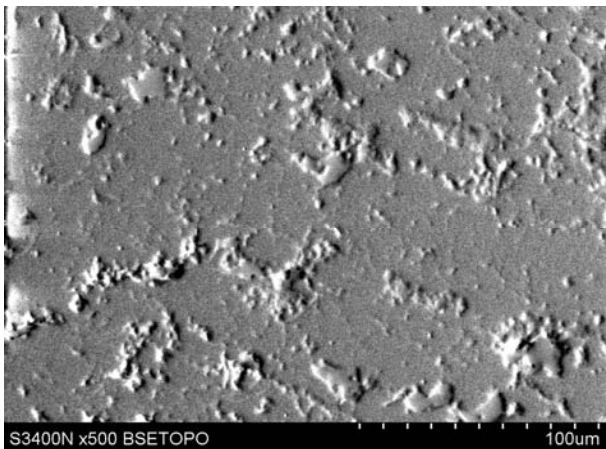
In initial condition of TBC's total porosity was ca. 0,9%. The details of ceramic top coat showed pores and probably vertical segmentation crack are present on Fig. 8.

Fig. 8. Details of microstructure if TBCs in initial conditions – porosity and micro cracks

The use of BSETOPO method permitted on clear distinction porosity as well as cracks. Comparing both pictures, some of cracks seem to be inequivalence.

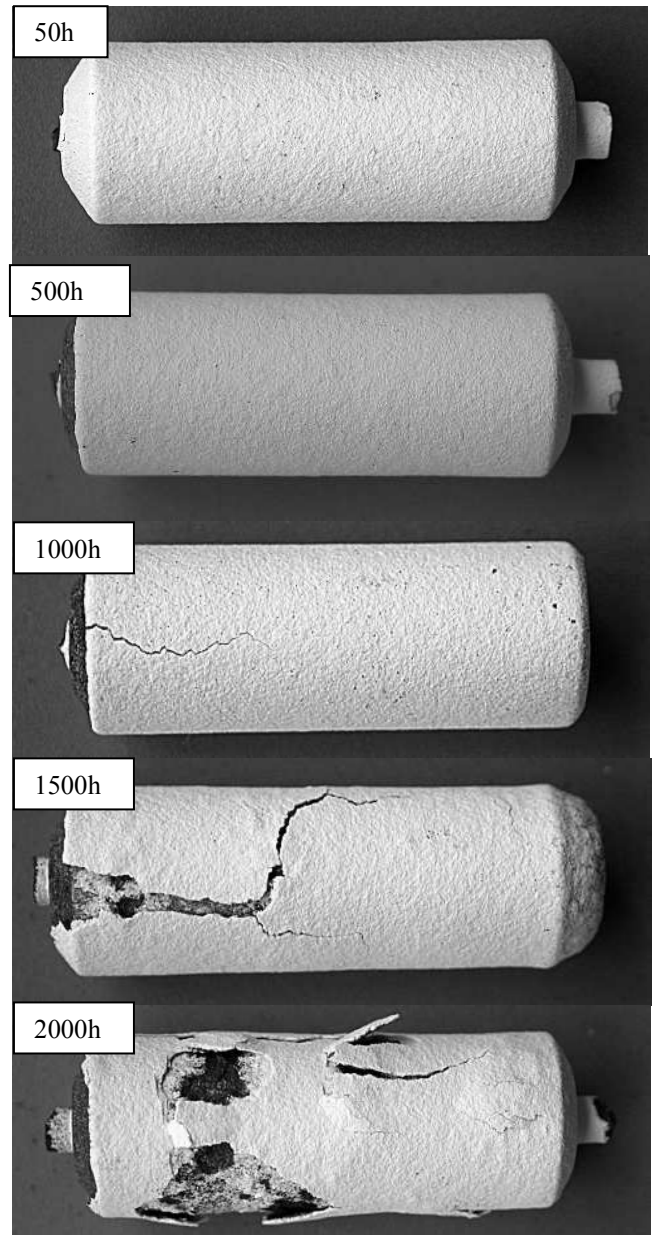
Fig. 9. General view of specimens with TBCs after each stage of isothermal oxidation at 1100°C

Figure 9 shows the failure progress of TBC's during isothermal conditions. The failure nature is different in different time of test. There is not observed macro-degradation effect after first 500h of exposure.

The most remarkable differences is observed from 1000 to 2000h of oxidation test. After 1000h the final failure appears by macro- cracking starting from edge of the ceramic top coat but

still larger areas of the TBC system are adherent. This type of crack formation is more typical for cyclic oxidation test than oxidation in isothermal conditions. After longer time of exposure during in this conditions the failure occurred is related to partially (1500h) and nearing totally delamination and in consequence spallation of the top-coat.

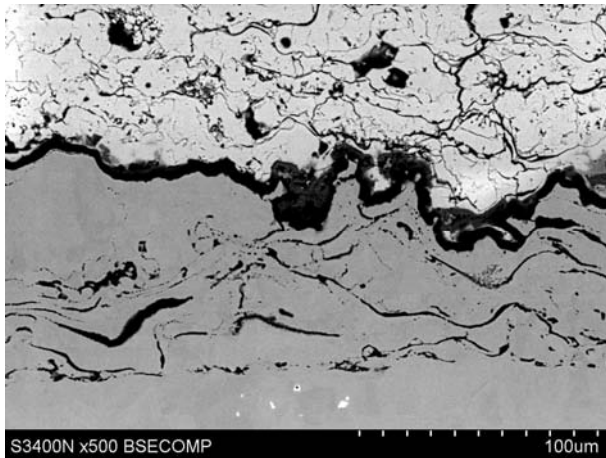
Fig. 10. Cross section of sample oxidized at 1100°C for 50h

Cross-sectional metallurgical investigations after 50h of oxidation (Fig.10) showed any important effect of cracks nucleation and delamination processes. The dark layer of TGO between ceramic layer and bond coat is dense with small amount of gray areas of oxides attached to the YSZ. After 50h of exposition the thickness of oxides in TGO is ca. 6µm.

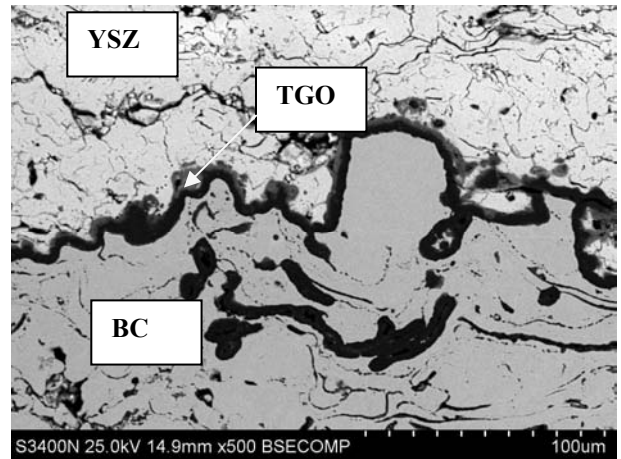
Fig. 11. Cross section of sample oxidized at 1100°C for 120h

After 120h of exposition dark layer of oxides in TGO became bigger then after 50h (Fig.11). The microanalysis of chemical composition of oxides areas in TGO showed that dense dark areas are rich in Al (the main component is Al_2O_3 , but in the gray oxides EDS showed presents of Al, Cr, Co and Ni. In this area exist probably mixed oxides such as Al_2O_3 , Cr_2O_3 and probably spinel $(Ni,Co)(Cr,Al)_2O_4$. Results of EDS analysis of oxide layer are presented in Tab.2.

Prior the final failure, damages in the form of micro-cracks were observed in the area of TGO. All this cracks are oriented parallel to the interfaces BC-TGO-YSZ. The presents of micro-cracks and cracks in TGO led to oxygen penetration through the TGO and in consequence internal oxidation of in the bond coat were some areas of oxides were detected (Fig.11).

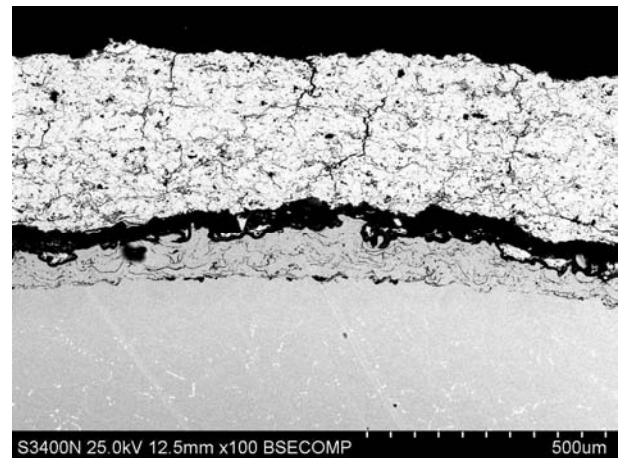
Fig. 12. Cross section of sample oxidized at 1100°C for 500h

The investigations of TBC system after 500h of oxidations in air showed initial stages of partially delamination effects in area of TGO and YSZ (Fig.12). In additions, the horizontal cracks are observed from top surface of ceramic to bond coat.

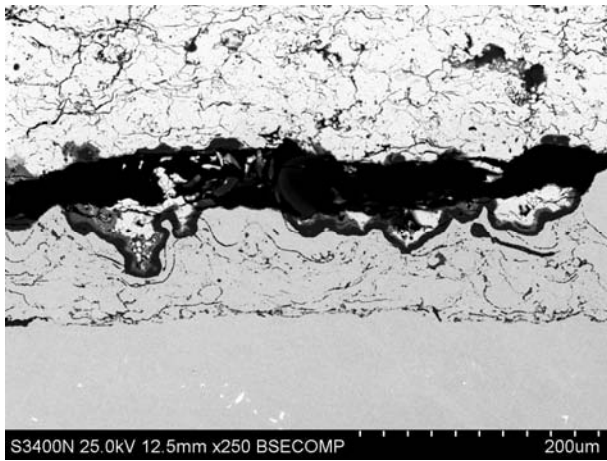
Fig. 13. Cross section of sample oxidized at 1100°C for 500h

The micro-cracks were either located within TGO or start in the TGO and subsequently penetrate into the zirconia top-coat (Fig.13). The main crack is formed in the TGO in the area of porous gray mixed oxides. This type of oxides dominated after 500h of exposition.

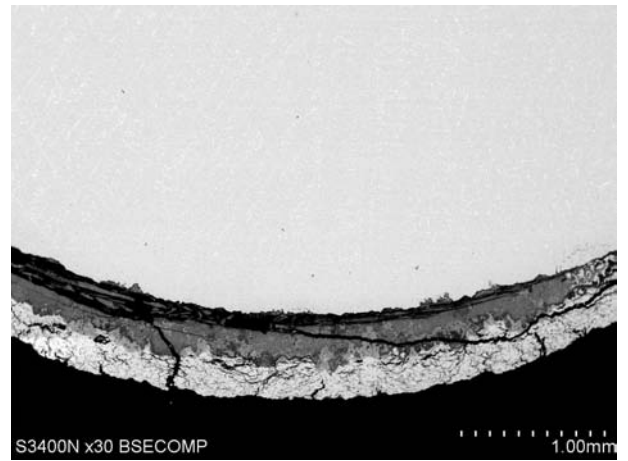
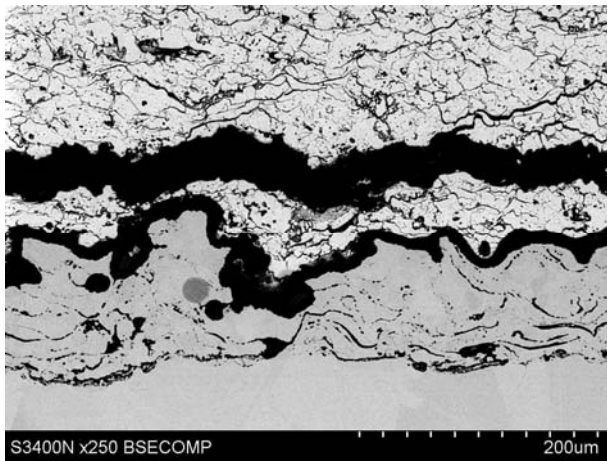
Fig. 16. Cross section of sample oxidized at 1100°C for 2000h

For longer exposure time of $t > 1000h$ the longer cracks in TGO area were observed. Cracks were parallel to the BC-TGO interface and analogical for earlier observations, their penetrate into zirconia top-coat (Fig.14 - 16). Metallographic examinations of cross section showed presents not only horizontal cracks but also long vertical macro-cracks especially in area of ceramic top-coat. Process of delamination was located generally in zirconia near TGO interfaces (Fig.17-19).

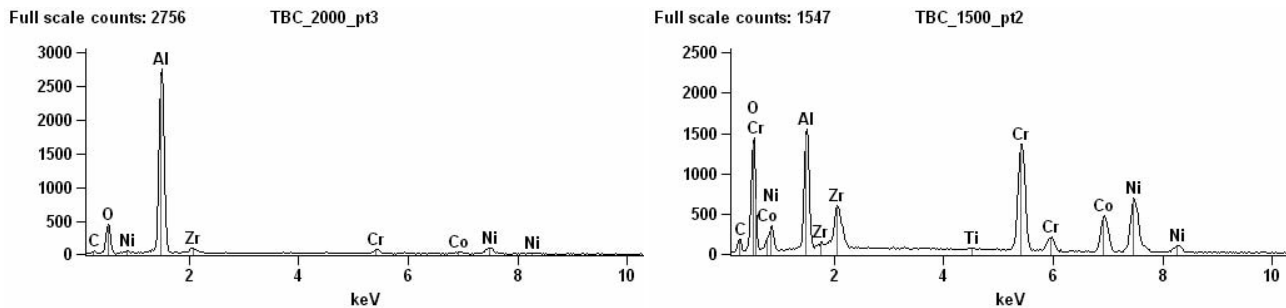
EDS analysis of oxides in TGO after 2000h and others times of oxidations showed that in this area dominated two types of oxides: dark on the base of Al_2O_3 and gray probably on the base spinel $(Ni,Co)(Cr,Al)_2O_4$ (Fig.20).

Fig. 20. EDS results from gray and dark oxides in TGO after 2000h of exposition at 1100°C

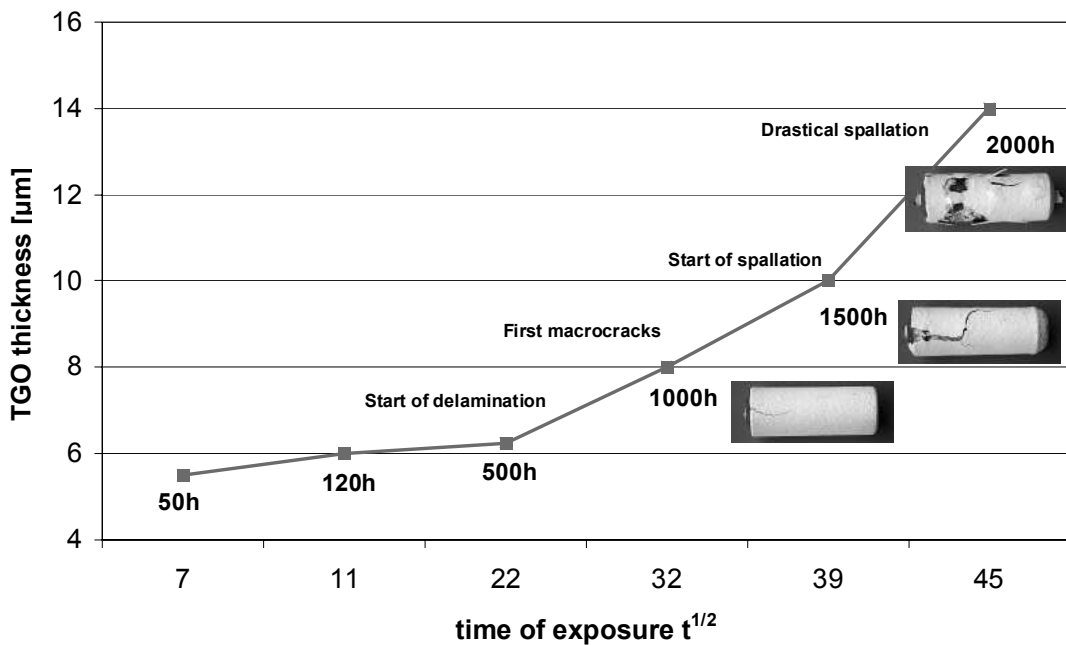
The oxidation kinetics of TBC was determined by measuring the thickness of the TGO as a function of square root of oxidation time (Fig.21). The oxidation rate followed the parabolic law for up to 500h. This stable state of oxidation is due to protective influence of TGO, because its growth rate was quite low. At longer time of exposure oxidation led to a substantial increase in the TGO growth rate and in consequence in thickness, but it appeared that the oxidation rate still followed the parabolic law with high oxidation rate constant.

Fig. 21. Scale thickness vs. oxidation time for TBC system oxidized in air at 1100°C
