The impact of repair welded joint on the life of Cr-Mo-V steel steam pipeline after service under creep conditions

Purpose: The purpose of this paper was to examine the impact of repair welded joints on the life time of primary steam pipelines after more than 200 000 h service under creep conditions.

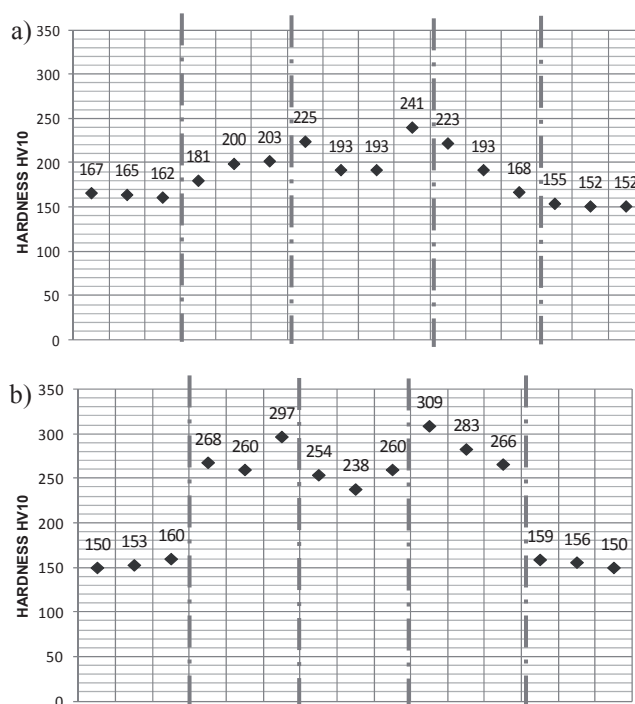
Fig. 1. Hardness measurement results for: a) circumferential welded joint from 13HMF steel after service; b) new repair circumferential welded joint from 13HMF steel

For the elements of circumferential welded joint after 218 h service the hardness measurements revealed no sudden changes during the transition through individual joint zones in contrast with the elements of repair circumferential welded joint from materials after 218 000 h service. Hardness for the circumferential joint after long-term service, from parent material through HAZ, weld, HAZ up to parent material, differs by approx. 90 units at the most and does not exceed 260 HV10, while for the new repair welded joint from materials after long-term service it is lower than the maximum admissible hardness of 350 HV10, ranging between approx. 150 and approx. 309 HV10 for the 13HMF steel primary steam pipeline.

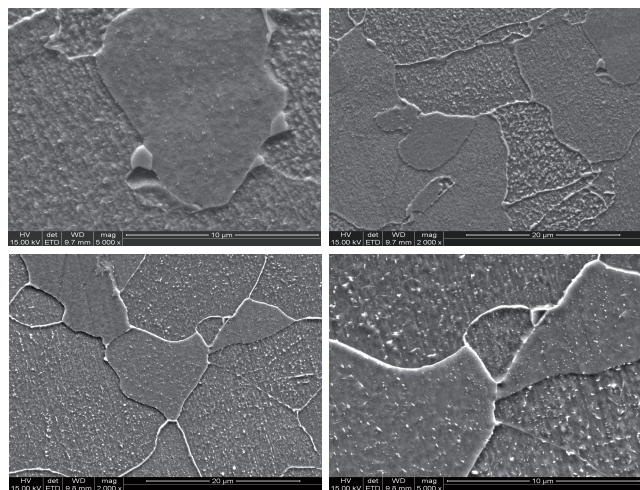
Fig. 2. Images of structure elements of the material of jacket of the 13HMF steel primary steam pipeline specimen after 218 000 h service (SEM), transverse microsection

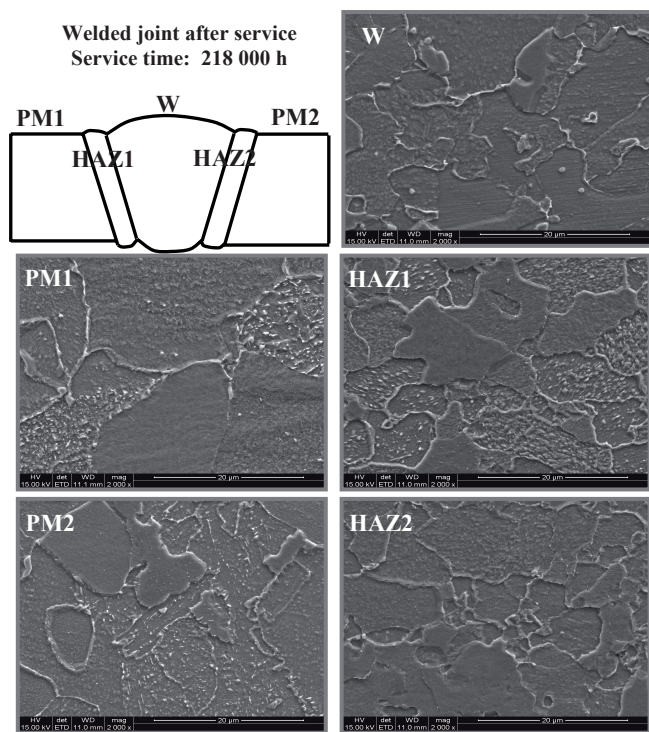
Fig. 3. Structure of the material of elements of tested 13HMF steel welded joint after 218 000 h service under creep conditions, microstructure testing area: parent material marked MR1, MR2; weld marked SP; heat-affected zone marked SWC1, SWC2

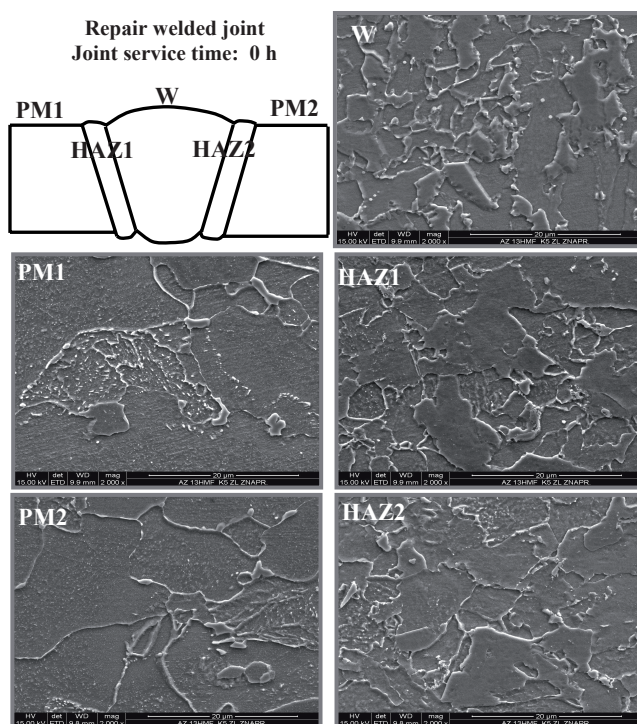
Fig. 4. Structure of the material of elements of tested repair welded joint, microstructure testing area: parent material marked MR1, MR2; weld marked SP; heat-affected zone marked SWC1, SWC2

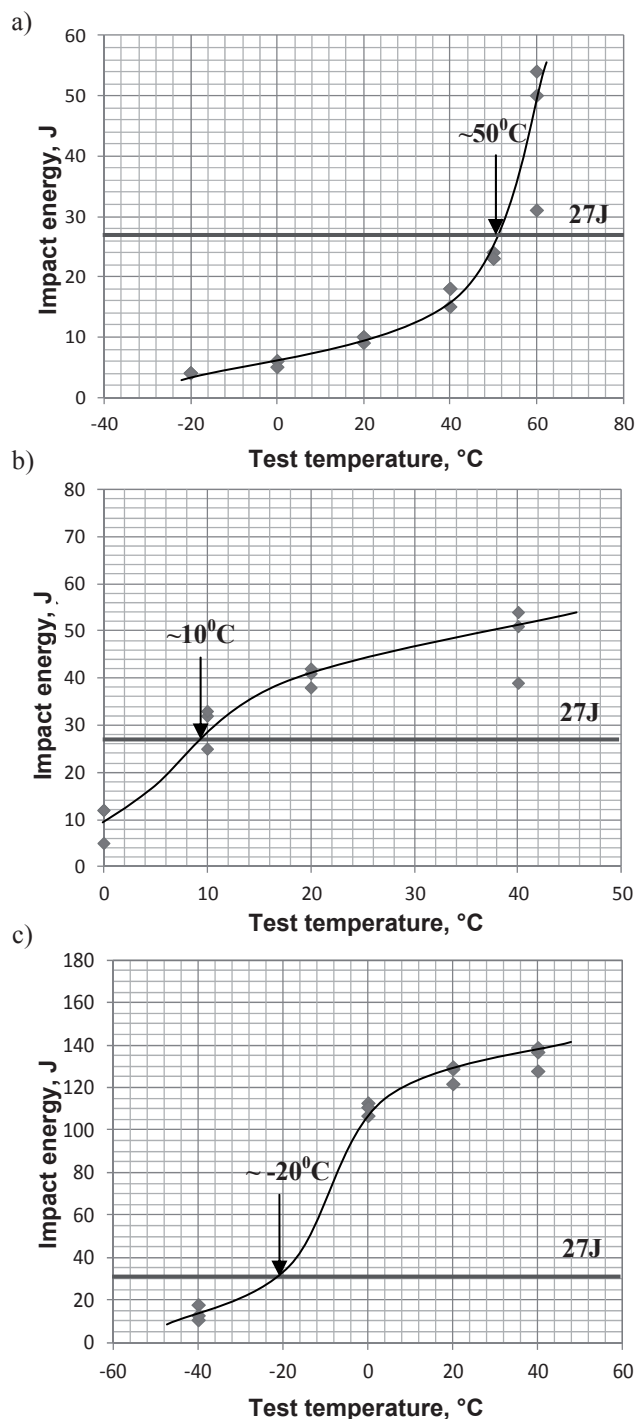
For tested materials the brittle fracture appearance transition temperature level was determined, and it differs according to the state of microstructure and corresponding exhaustion extent (Fig. 5). With increase in the exhaustion extent, the brittle fracture appearance transition temperature moves towards higher values [5]. As the brittle fracture appearance transition temperature of the parent material and circumferential welded joint after service is positive, the required boiler start-up and shutdown conditions should be followed absolutely [5].

Fig. 5. Relationship between impact energy KV and test temperature T_b , and brittle fracture appearance transition temperature determined for tested: a) parent material of primary steam pipeline after service; b) circumferential welded joint after service; c) repair circumferential welded joint

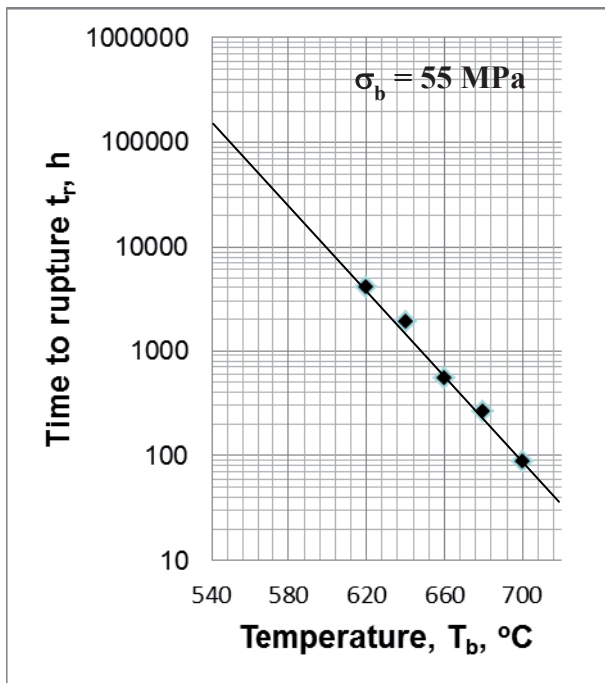
Fig. 6. Characteristics of creep-rupture strength for the parent material of primary steam pipeline after 218 000 h service

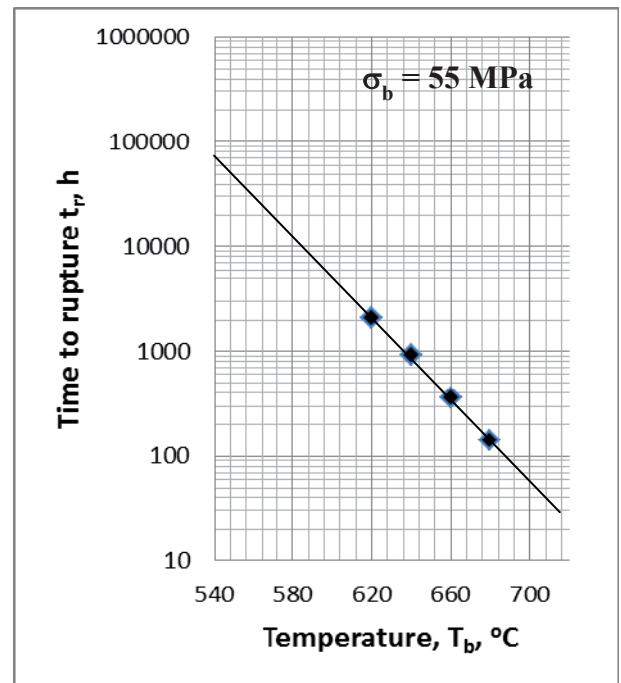
Fig. 8. Characteristics of creep-rupture strength for repair material of primary steam pipeline welded joint

4. The creep resistance tests of the 13HMF material, circumferential welded joint after 218 000 h service and repair welded joint revealed that the highest disposable residual life marked the parent material (120 000 h), whereas life time of the repair welded joint (55 000 h) was by 15% lower than the disposable residual life of the joint after service (66 000 h).

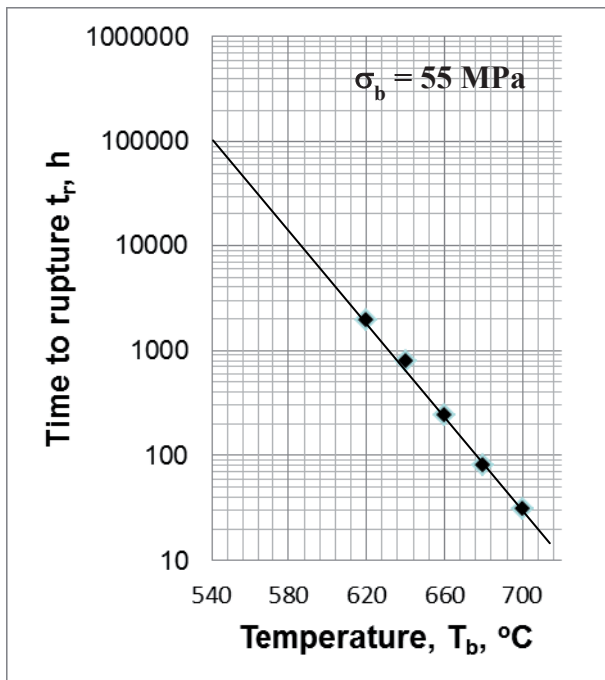
Fig. 7. Characteristics of creep-rupture strength for the material of primary steam pipeline welded joint of after 218 000 h service
