Josef ALDORF
Arnošt GRMELA
Eva HRUBEŠOVÁ
VŠB – Technical University Ostrava, Czech Republik

THE LARGEST BREAKDOWN OF THE SHAFT IN THE HISTORY OF CZECH MINING INDUSTRY

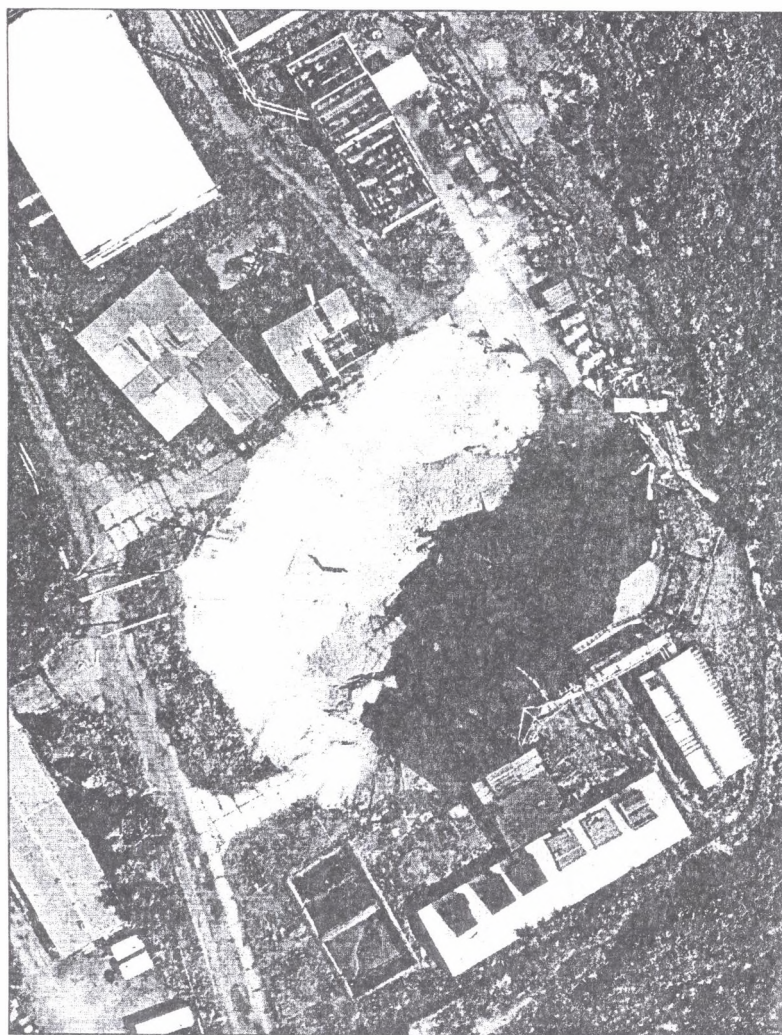
reinforcement. The upper part of the shaft, shaft building and the mining tower subsequently crashed into the created crater with dimensions approx. 63 x 53 m and with the depth approx. 36 m from the surface (see Fig. 1, 2). The volume of the created crater was approx. 65.000 m³. The lower part of the shaft was fully filled by surrounding damaged rocks and warped constructions of the overground and underground structures in the range of created crater.

Rys. 1. Lej powstały po zniszczeniu szybu Doubrava IV- lipiec 1998
Fig.1. Crater after breakdown of the shaft Doubrava IV- July 1998

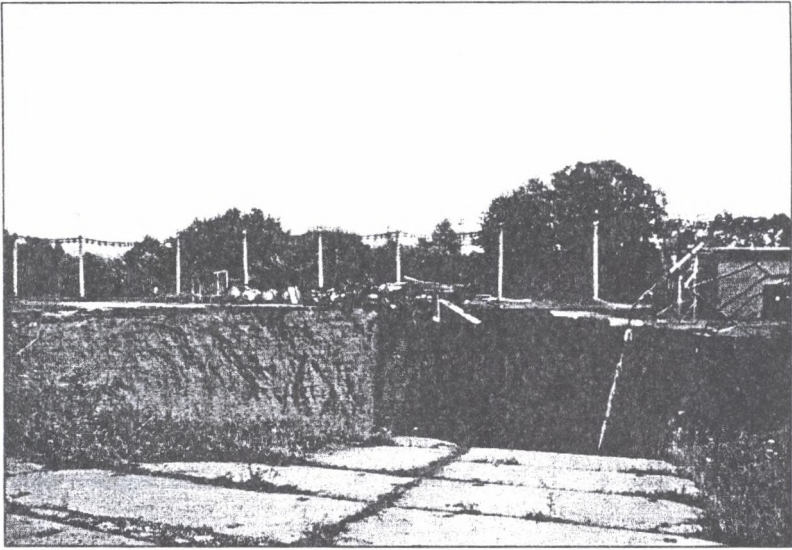
Rys. 2. Lej powstały po zniszczeniu szybu Doubrava IV- lipiec 1998
 Fig.2. Crater after breakdown of the shaft Doubrava-IV - July 1998

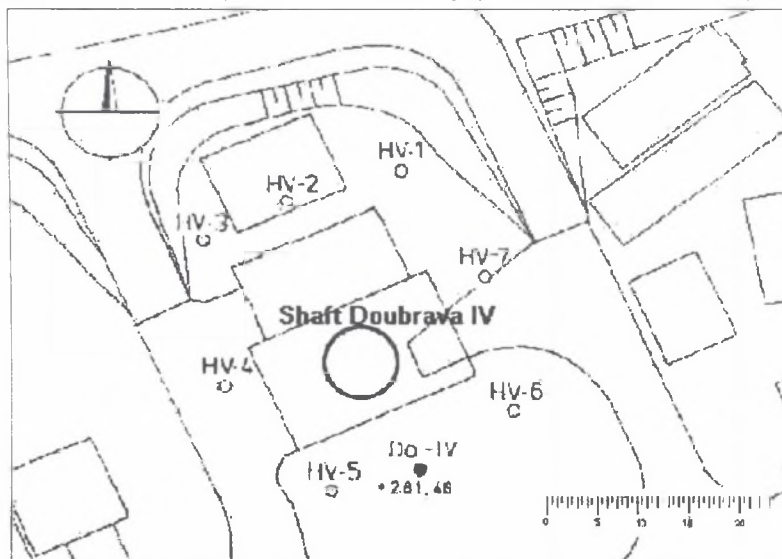
After the breakdown 20th January 1986, when concrete reinforcement failure and “... *the withdrawal of muddy rocks from the south-east side of the shaft ...*” (citation of the time record) took place in the level of 61,7 m under the surface, the bore Do-IV was realized in the south or south-east direction from the shaft Do-IV. This bore was situated between later realized dewatering bores HV-5 and HV-6 (in the area of a former concrete manufacture and near the created fall) - see Fig. 3.

After the breakdown in the excavation (20th January 1986) the shaft was filled up to the level approx. 47 m and as first, three dewatering bores (HV-1, HV-2, HV-3) on the periphery and as following four more bores (HV-4 till HV-7) were realized. The bores with the diameter 273 mm were accomplished up to the depth 100 m. The geological profiles of the bores are not available and their **liquidation protocol was not retained.**

Rys. 3. Położenie studni badawczej Do-IV i studni odwadniającej HV-1 - HV-7 w okolicy szybu Doubrava IV

Fig.3. Situation of exploration well Do-IV and dewatering wells HV-1 to HV-7 in the area of shaft Doubrava IV
