Design Elements for Snow-Load Resistant Membrane Roofs

Summary: The paper presents discussion on the issues related to design and use of tensioned fabric roofing and occurring in the winter. In case such structures are used as permanent, all-season ones, the issues of snow load and the methods of snow removal arise. The importance of the issue is emphasized by the fact that errors were not avoided even in major projects, such as the modernization of Dresden Central Railway Station or the Gelsenkirchen stadium.

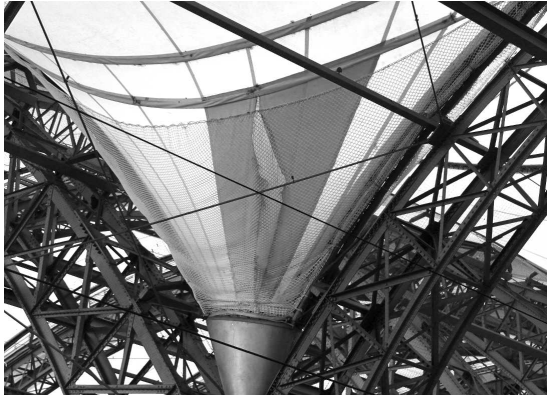
Fig. 4. One of the damages in the Dresden railway station roofing (author)

The holes made in this way relieved the membrane, which stopped any further damages. Each of over eight pockets has one fissure. To protect the people staying on the platforms, it was necessary to make an instant protection of the roofing. Protective mesh supporting the membrane from the bottom was introduced. This was applied in the points of damage and wherever some distinct deflections appeared caused by the snow lying on top. Most of the holes were covered by another layer of membrane, which clearly reduces the material's translucence and visually underlines the damages. The facility owner, i.e. German Rail demands post-warranty repair of the damages, due to failure to provide appropriate durability of the structure. Unfortunately, the replacement of the entire roofing covering the area of 30 000 m² is necessary. Panels cut with utmost precision cross the entire width of the station. This was done in order to minimize the number of seams. The serious issue at present is how to replace part of the damaged roof without dismantling the whole, particularly with the membrane being permanently stressed. The railway company does not permit to apply any further layers. Moreover, the contractor cannot do it, due to financial difficulties. The case has not been settled by date.

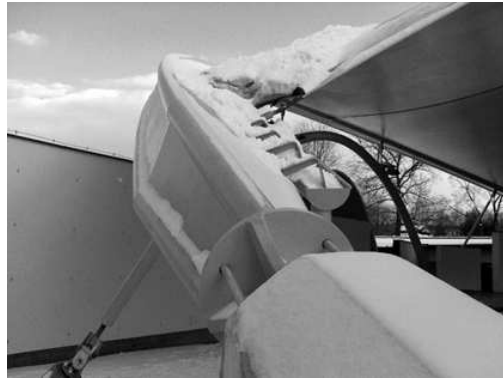
Fig. 10. Metal rainwater drainpipe in Wisła (author)

In spite of the free access to the area offered by the open-air theater roofing, its maintenance causes no issues. The high inclination of the pitches enables proper drainage of the water to special drainpipes, mounted in the bottom part of the roofing. The spacing of the supports and entrances produces such a configuration that there is no snow slide hazard. The open-air theater in Wisła is perhaps the only to hold events in spite of winter weather. During the Winter Olympic Games in Vancouver, the theater presented live transmissions of ski jumping by the famous inhabitant of Wisła – Adam Małysz. With the temperature below zero Celsius, snow and torches – a sample of the Olympics was created.

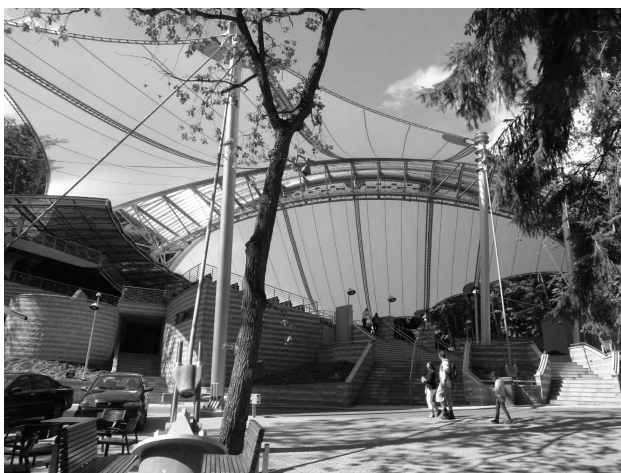
Fig. 15. The roofing of the Forest Opera in Sopot (author)

The interviews with designers and facility owners suggest that the newest example of roofing with monitoring erected in Poland is the Forest Opera in Sopot. The open-air theatre is the largest and the most famous structure in Poland, due to its history. The open-air theatre used to have roofing as early as in the 1960's. It used to be temporary roofing, dismantled every year before the winter. After the modernization in 2010-2012 the facility has permanent roofing. The structure is supported by two arches inclining towards each other, their span is 102 and 93 m. Two symmetrical patches of membrane, 1800 m² each, reinforced with anti-snow ropes, are tied to the main support structure. According to the design inspiration, the form of roofing was to suggest the form of a leaf laid among the trees.

The facility has a top class structure monitoring system. Such system monitors 28 measuring points simultaneously. Some of the points observed are situated on the support structure (resting points of the main

steel arches), which represent the points of reference for the measurements. What's even more interesting for this facility is the fact that some of the measuring points are directly on the membrane. The major element of the measuring module is the automatic tachymeter measuring the prism reflector's locations. The measurement of the relocations enables the evaluation of the technical condition of the facility and the creep processes resulting from long-term loads, snow-loads, for example. The system also measures vibrations and temperature of the structure in four points and measures the basic weather data, such as air temperature, humidity, wind velocity and direction.

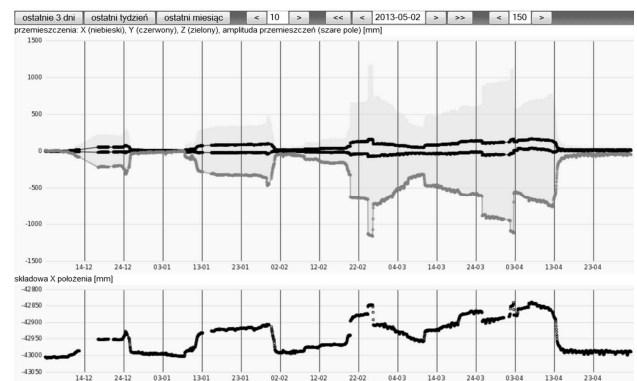
Below a sample diagram of a measuring point's relocations is presented. This is point No 10, located on the lowest level, along the longest panel. It is situated on the west patch, from the direction of the adjacent tall forest. The diagram presents the results of measurements held throughout 150 days (from December, 2012 to May, 2013). The following is presented in the diagram:

- periods when the roofing was loaded with snow,
- the way the load changed due to subsequent snowfalls (the growth of loads without dramatic leaps),
- rapid changes of snow load caused by the snow sliding off the top parts of the roofing and loading the lower parts,
- reduction of snow load caused by spontaneous sliding of the snow from the roof or as a result of snow removal carried out by teams of specialists.

The extreme deflection of the roofing for measuring point No 10 was 120 cm. The measuring results inform on the roof loads, which results in the necessity for the snow removal.

Fig. 18. Diagram of measuring point No 10 relocations throughout 150 days [5]
