FACADES OF MODERNIZED BUILDINGS – DIFFERENT STRATEGIES, DIFFERENT EFFECTS – CASE STUDIES OF SELECTED PUBLIC UTILITY BUILDINGS

Joanna TYMKIEWICZ *

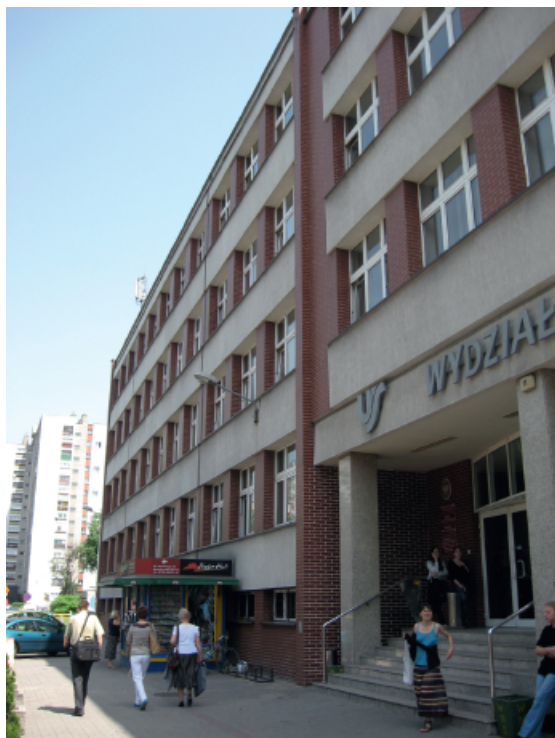
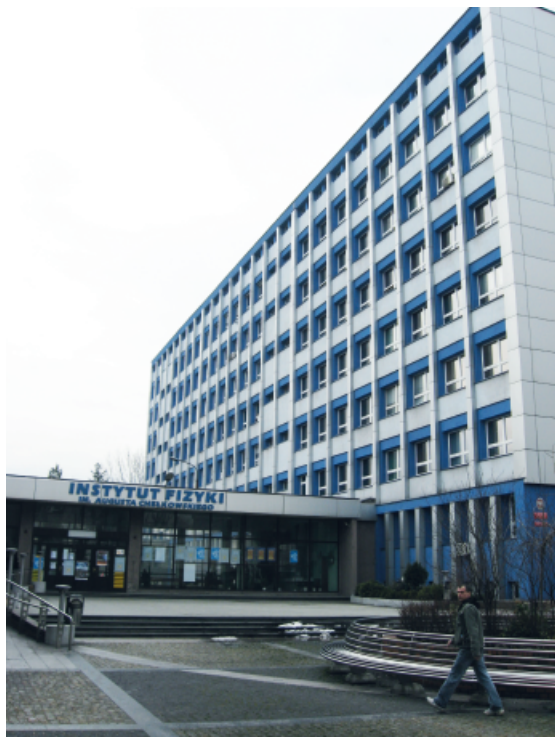
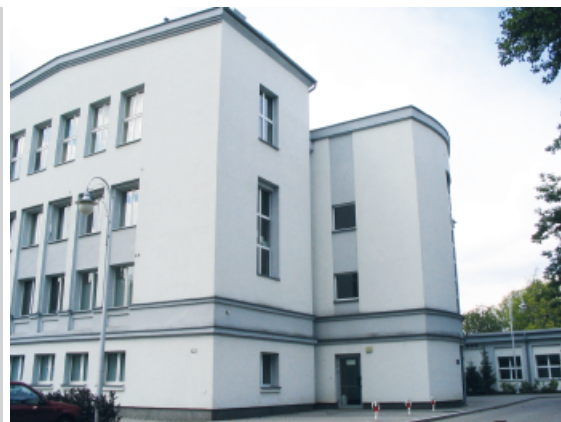
Figure 1.
Faculty of Social Sciences building, University of Silesia in Katowice (photo J. Tymkiewicz)

Figure 2.
Department of Physics building, University of Silesia in Katowice (photo J. Tymkiewicz)

Figure 3.
Management and Social Sciences College building in Tychy (photo J. Tymkiewicz)

ment of windows and doors. There are many examples of such procedures in Poland, in old university buildings (Fig. 1-3). Under such circumstances, the interiors of office buildings often receive new equipment including mechanical ventilation or air conditioning.

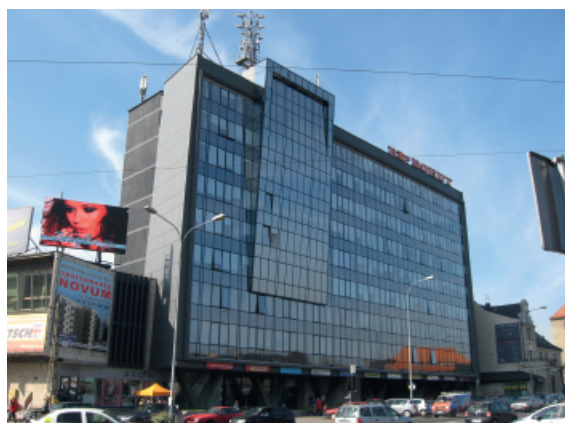
Figure 4.
Replacement of glass facades – “Biprohut” building in Gliwice (photo J. Tymkiewicz)

In 2007-2009 the building was subjected to modernization works (design architect *C. Knebloch*) and received a new “skin” in the form of glazed facades, aluminium structure, with two types of glazing – transparent and opaque. In the strip below the windows spandrels were used, thanks to which the facade seems completely glazed (Fig. 4-6). The renewal of the facade was intended to improve the micro-climate of the interiors (air conditioning was planned to be installed), energy-efficiency and aesthetics of the building, as well as to endow it and its owners with a new, modern look.

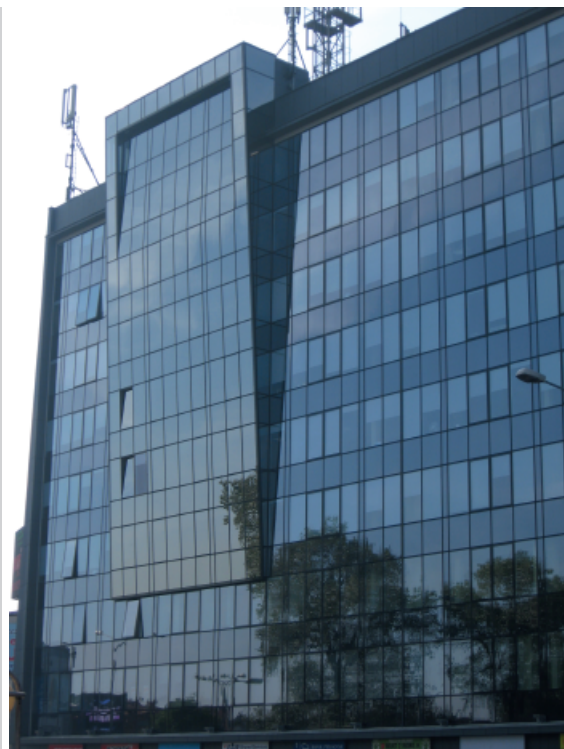
Figure 5.
The front facade after renovation – “Biprohut” building in Gliwice (photo J. Tymkiewicz)

The new window bay highlights the flat facade and makes it look more dynamic; moreover, it serves some specific function – it enlarges the floor area (total: 70 m²). In addition, a recreation zone was created at the top floor of the building.

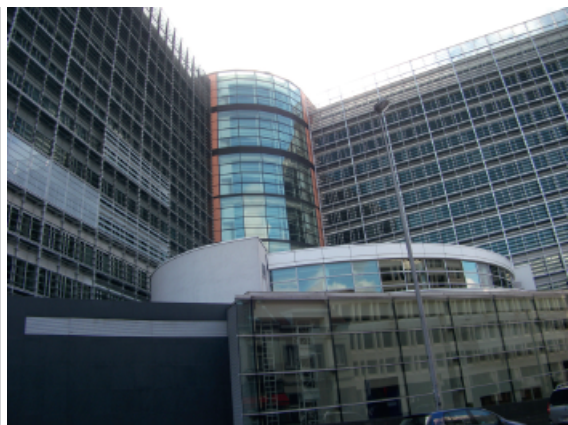
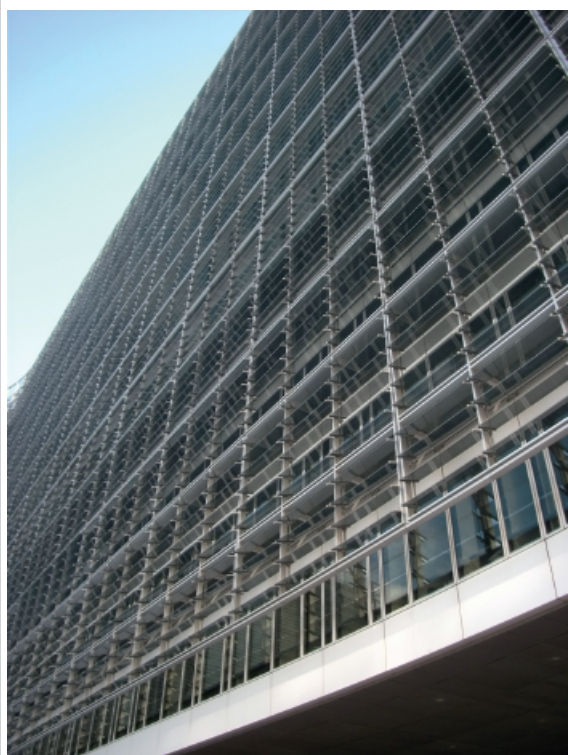
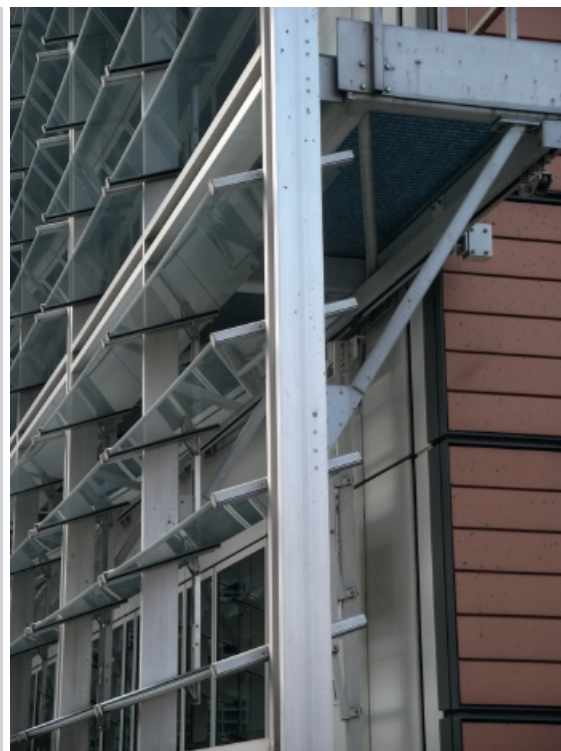
Figure 7.
The headquarters of the European Commission in Brussels after modernization (photo K. Mastej)

Figure 8.
Facade of Berlaymont building in Brussels (photo K. Mastej)

Figure 9.
Details in the facade of Berlaymont building, Brussels (photo K. Mastej)

The building, erected in 1960-69 (the design architects: *L. De Vestel, J. Gilson, and J. and A. Polak*), was given the form of a cruciform with four wings and fourteen above-ground floors. The renovation and modernization architectural design (authors: *P. Lallemand, S. Beckers and W. Van Campenhout* 1995-2004) assumed shielding the building facade with a double-glazed wall. The external shell consists of movable laminated screen printed glass panels. The panels are divided into autonomous units and are automatically controlled by the BMS, which, thanks to the coupling with the meteorological station, determines their position, depending on the prevailing weather conditions. Moreover, an integrated system of managing the lighting of the building was installed with sensors placed in the rooms, coupled with the system of adjusting the position of the panels in the external building facade to achieve the required lighting intensity on the surface of the workstations – 500lx [10] (Fig. 7-9).

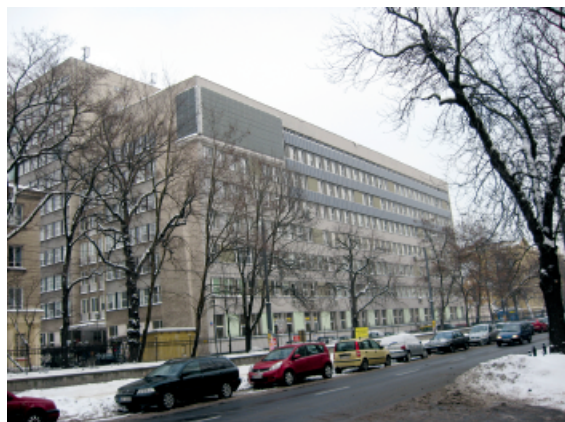
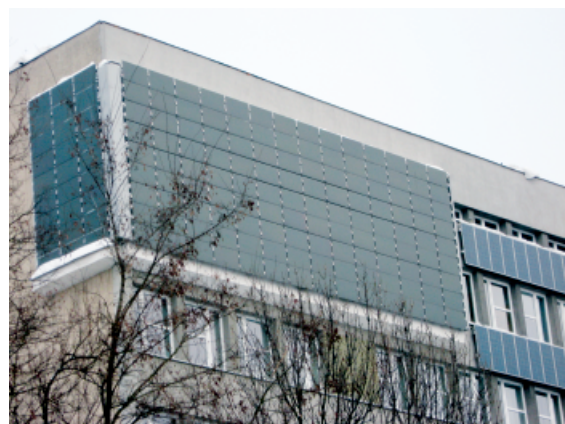
Figure 10.
The facade of the Environmental Engineering Faculty building, Warsaw University of Technology (photo J. Tymkiewicz)

Figure 11.
PV modules installed on facade – Environmental Engineering Faculty building in Warsaw (photo J. Tymkiewicz)

The already mentioned European Parliament and Council of Europe's Directive also assumes that, starting with 2018, the demand for energy will have to be substantially covered by renewable sources that generate energy at site or in the nearest vicinity [16]. One of the possible solutions are photovoltaic modules that may be applied in renovated facades. For example, the USA Embassy building in Genève, which is 20 years old, had its facade and roof transformed in 2005 into a specific solar power plant [12]. A Polish example of modernized facades with the use of PV modules is the building of the Faculty of Environmental Engineering, Warsaw University of Technology, which has the photovoltaic modules installed on its facade and on the roof [12] (Fig. 10, 11).

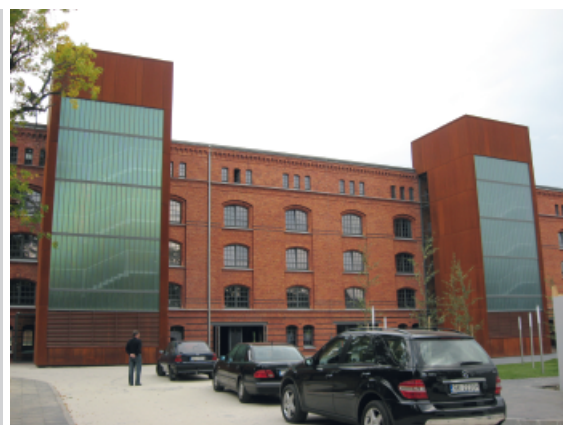
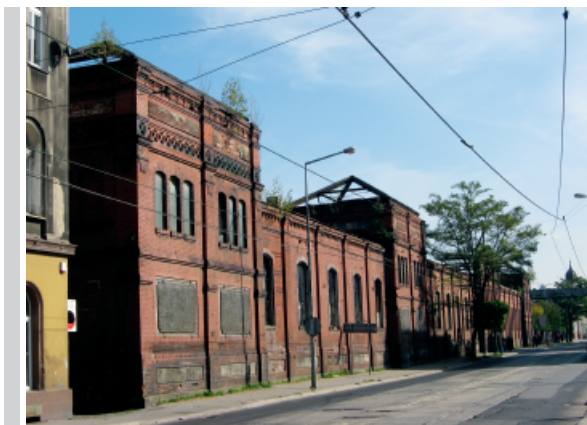
Figure 12.
The revitalised building of the old granary house in Gliwice – presently housing the lofts designed by Medusa Group (photo J. Tymkiewicz)

Figure 13.
Preparation works for further revitalization – empty “shells” of Gliwice Steel-Works facilities (photo J. Tymkiewicz)

Likewise, in Poland, in the course of the revitalization of post-industrial sites and facilities, numerous projects have been implemented involving the use of old building facades endowed with new functions (Fig. 12, 13).

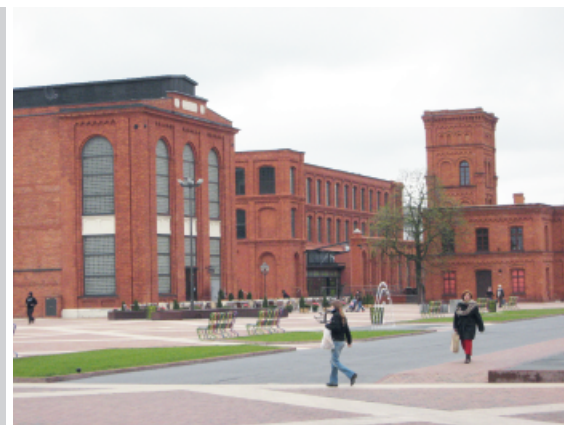
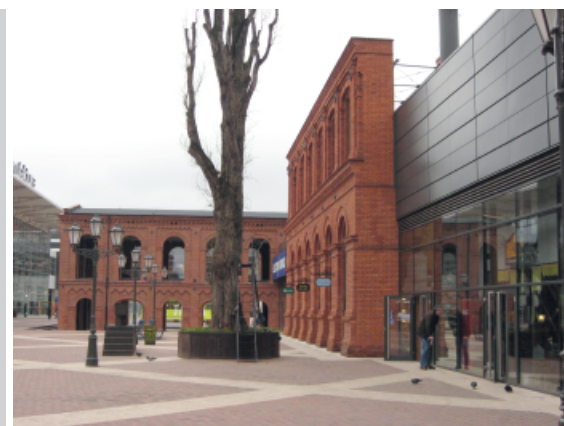
Figure 14.
Post-industrial facilities in Łódź, designed by H. Majewski in the late 19th century (photo J. Tymkiewicz)

Figure 15.
“Manufaktura” shopping mall, leisure and business centre (the modernization design – 2003, implementation – 2006 – Sud Architectes and arch. A. Mrowiec – conceptual design), (photo J. Tymkiewicz)

Such manner of altering the functions of buildings poses some serious problems, which for instance came up in the case of I. Poznański’s factory facilities in Łódź, transformed into “Manufacture” Centre. Originally, the facilities served industrial functions, with fairly constant internal air parameters during the 24 hours. In the early 1990s the facilities were not heated and started to deteriorate year by year [4]. The unprotected elements of the buildings were exposed to the destructive impact of the external environment, including rainwater. The technical condition of the facade “made of dark red brick with highlighted lesenes joined with the frieze and brick cornices” was seriously threatened [3]. The new functions embedded in the old structures evoked changes in the internal and external “environmental context” of the renovated complex. As far as the external space is concerned, the intervention in the urban system led to changes in the local climate, involving the natural lighting, shade, and air flow around the buildings [4]. To secure the durability of the historical factory walls and to prevent their destruction caused by the internal and external environments, simulation analyses were conducted focused on the assessment of the impact of various modernization methods on the condition of the external walls. One of such methods is discussed in detail in D. Heim and S. Krawczyński’s paper, where the authors presented the analysis of the physical and construction problems occurring in post-industrial facilities on the basis of the case study of “Manufaktura” in Łódź, which was the biggest European brown-fields revitalization project and a specific “study field” (Fig. 14-15) [4].

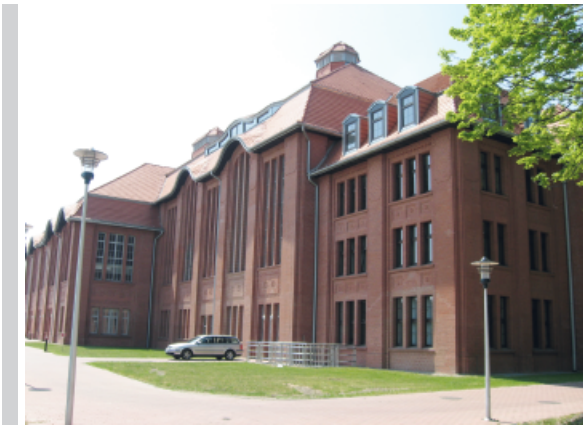
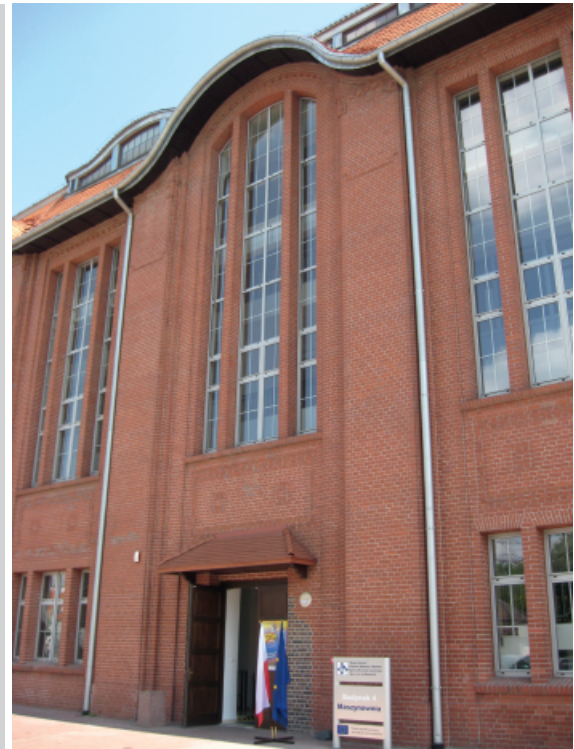
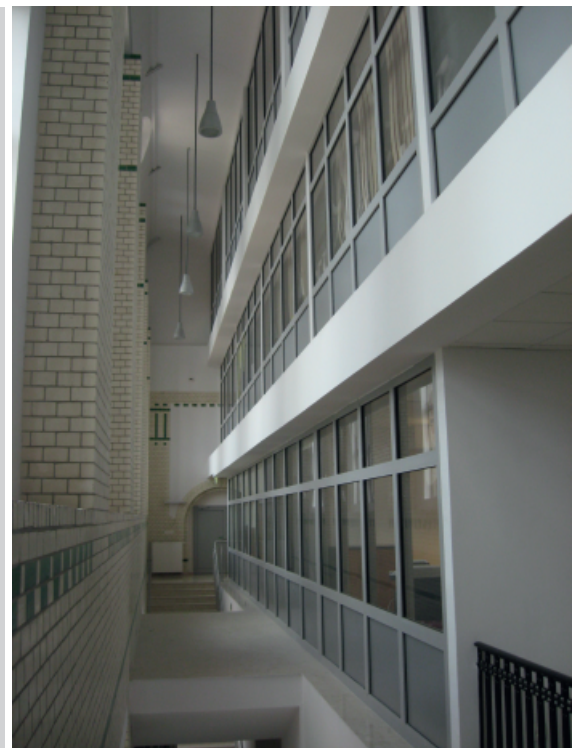
Figure 16.
The old Machine House at the site of the previous coal mine in Gliwice – the back facade (photo J. Tymkiewicz)

Figure 17.
The entrance facade of Machine House building, Gliwice (photo J. Tymkiewicz)

Figure 18.
Interior of Machine House, currently functioning as an office building (photo J. Tymkiewicz)

visiting the post-mining complex in Gliwice. The visit included the round and local inspection of the buildings, interview with the administrator and surveys of the users. From the aesthetic point of view, the buildings are on a very high level. The revitalization project has brought the site of the liquidated coal mine back to life. The problems involved in the old walls were effectively solved and new functions really well-planned [2], [14]. However, one of the problems that has not been properly addressed is the micro-climate of the office facilities arranged in the old Machine House (designed by *G. and E. Zillmann* in the early 20th century) (Photographs 16, 18). The implemented concept of “a building inside the building” (Photograph 17), i.e. an independently glazed structure inserted into the single-space interiors of the old facility (foredesigns for the adjustment of the post-mining buildings to serve new functions: ArKuS design and consultation office, the construction project: Mexem, 2004/2005). The combination of various issues – starting with the assumed ventilation concept, through the ensuing decision about the modules of the glazed internal partition that cannot be opened, up to the so called “human factor”, have all resulted in the users’ complaints about excess heat in the building and their total incomprehension of the fact that the simplest solution, involving opening the windows and airing the overheated interiors, is impossible.
