## Hydrogen degradation of high-strength steels

**J. Ćwiek\***

J. Ćwiek, Hydrogen degradation of high-strength steels, Journal of Achievements in Materials and Manufacturing Engineering 37/2 (2009) 193-212.

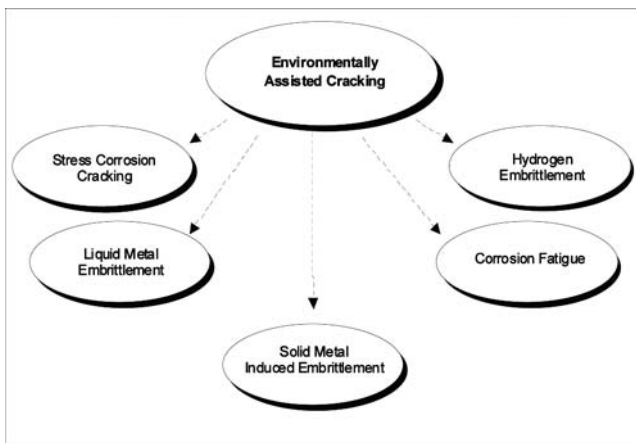
Fig. 1. Forms of environmentally assisted cracking

Synergic action of stress and environment may result in various types of degradation of metallic materials (Fig. 1). Environmentally assisted cracking (EAC) is a general term encompassing more specific terms such as: stress corrosion cracking (SCC), hydrogen embrittlement (HE) or hydrogen assisted/induced cracking (HAC/HIC), corrosion fatigue (CF), liquid metal embrittlement (LME), and solid metal induced embrittlement (SMIE). In all these cases, cracks initiate and grow at lower stresses in the presence of specific environments than in inert environments. Hydrogen has influence on three forms of EAC, i.e. hydrogen embrittlement, stress corrosion cracking, and corrosion fatigue [1].

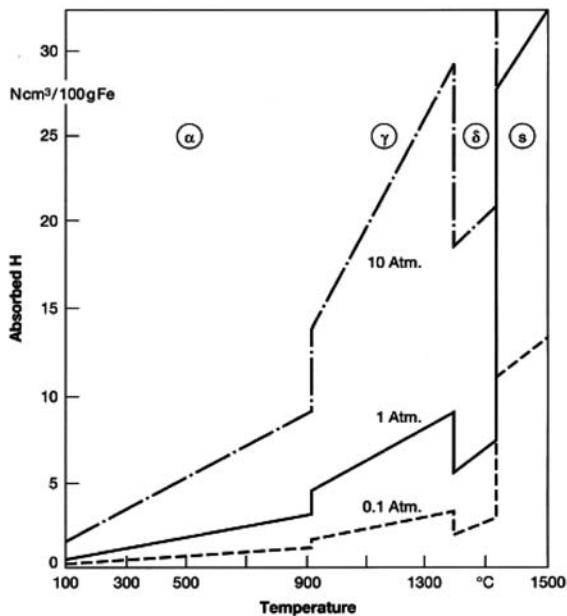
Fig. 2. Solubility of hydrogen in iron as a function of temperature and pressure [2, 13]

A component or structure can be contaminated by hydrogen in various stages of its life. This begins in the metallurgical process, because the hydrogen solubility in the molten metal is much higher than in the solid condition (Fig. 2). This hydrogen loading is reversible to a great extent, because it is caused mainly by the storage of the hydrogen in the interstitial positions of the lattice. Irreversible hydrogen degradation only occurs if the hydrogen can effuse or if it can accumulate as gas in the hollow spaces. This type of hydrogen damage is of importance in welding practice in the form of cold cracks. This type of damage is also produced during casting as fish eyes (or fakes) [2, 13].

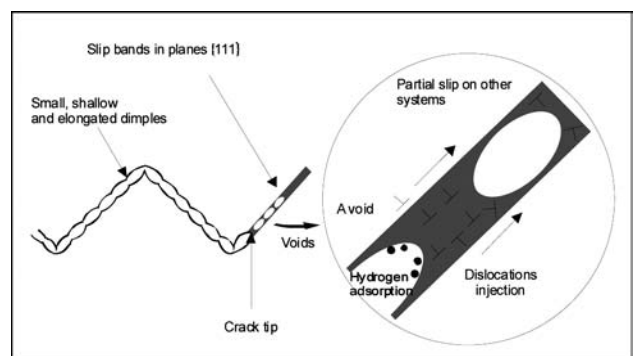
Fig. 3. Diagram illustrating the adsorption-induced localized slip process occurring along alternate shear planes [19]

Adsorption of environmental hydrogen atoms at crack tip results in weakening of interatomic bonds facilitating dislocation injection from a crack tip and then crack growth by slip and formation of microvoids (Fig. 3). Mechanism proposed by Lynch.

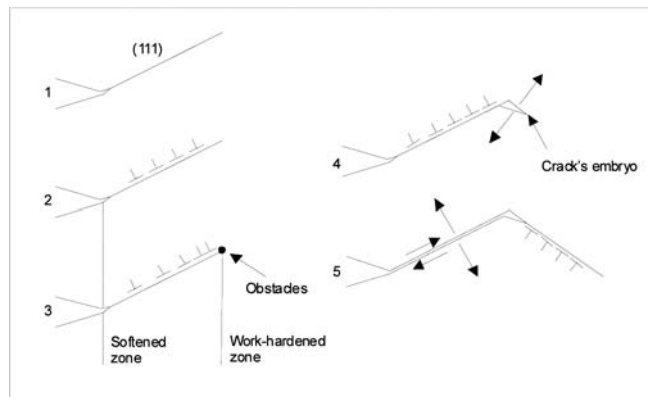
Fig. 4. Steps of the Corrosion Enhanced Plasticity Model [21]

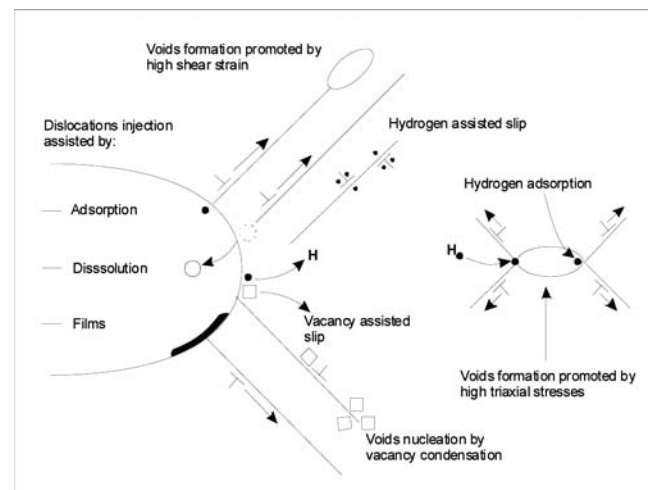
Fig. 5. Processes that could result in hydrogen assisted cracking by localized slip and microvoids coalescence [19]

Summary of possible corrosion-deformation interactions that could produce hydrogen assisted cracking is shown in Fig. 5 [19].

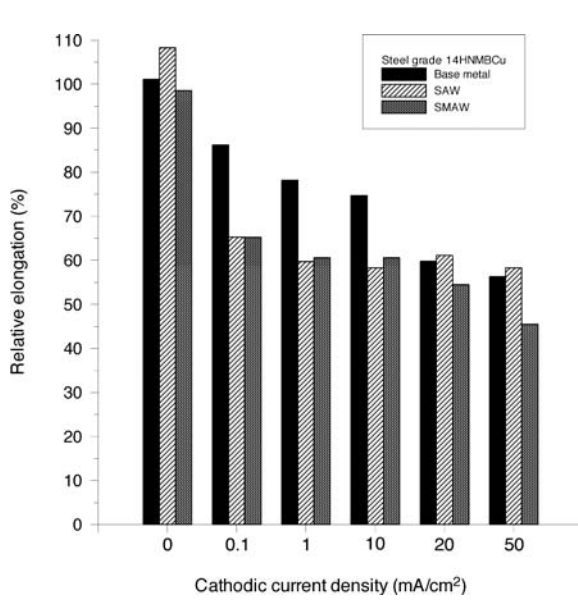
Fig. 6. Relative elongation versus cathodic current density for 14HNMCu steel and its welded joints

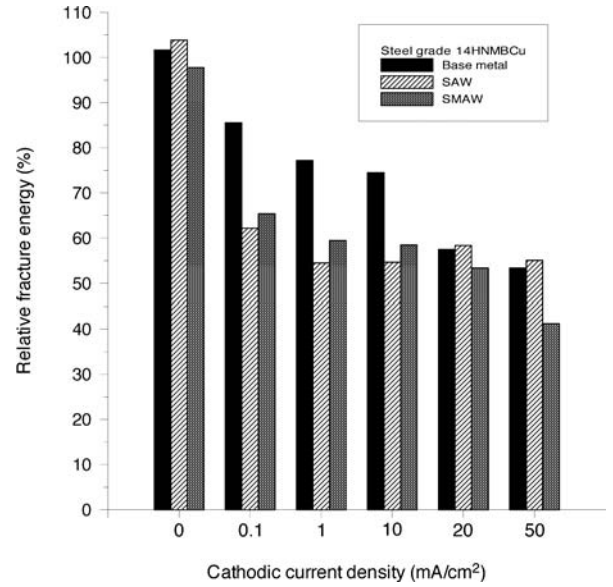
Fig. 8. Relative fracture energy versus cathodic current density for 14HNMCu steel and its welded joints

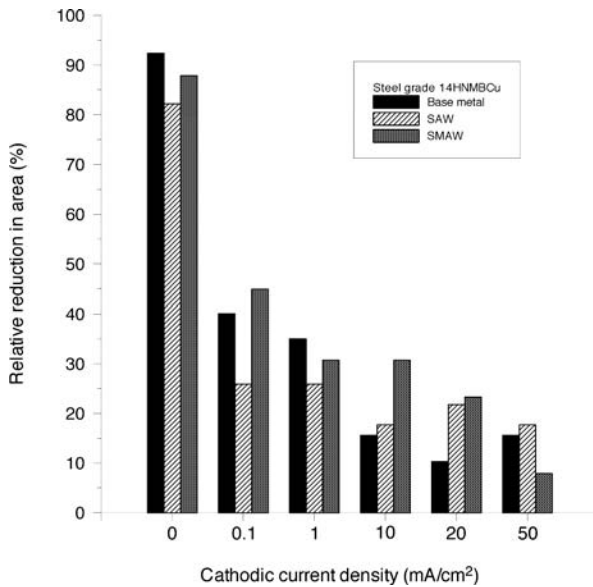
Fig. 7. Relative reduction in area versus cathodic current density for 14HNMCu steel and its welded joints

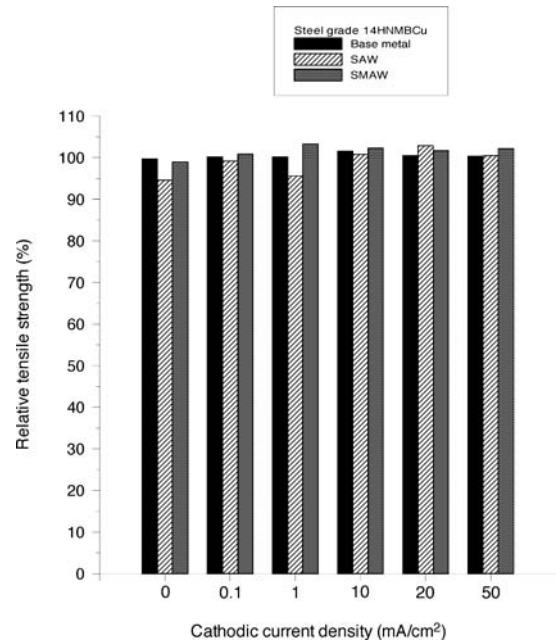
Fig. 9. Relative tensile strength versus cathodic current density for 14HNMCu steel and its welded joints

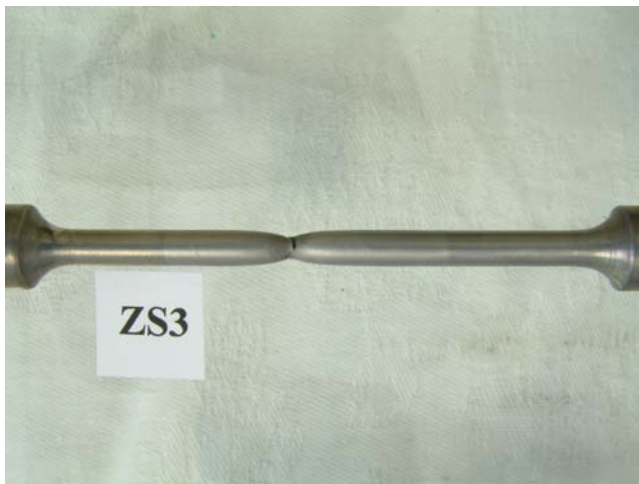
Fig. 10. View of the sample with SAW welded joint after SSRT in the air. Fracture localized in weld metal

Failure of samples with welded joints occurred always in weld metal (Figs. 10-11), where strength was lower comparing to base metal. The reduction of ductility by hydrogen was accompanied by a change in fracture mode. For samples tested in the air, crack growth occurred in a ductile mode. Base metal samples tested in the air had mixed-quasi-cleavage and micro void coalescence (MVC) fracture (Fig. 12). Under cathodic polarisation base metal changed fracture mode, i.e. portion of quasi-cleavage fracture increased (Fig. 13), and cleavage fracture also appeared at higher current densities. Samples with welded joints tested in the air revealed ductile – MVC fracture mode (Fig. 14). When cathodic polarization was applied, mixed – MVC and quasi-cleavage fracture was observed (Fig. 15). At higher cathodic current densities, the presence of hydrogen induced microcracks and flakes in weld metal (Fig. 16).

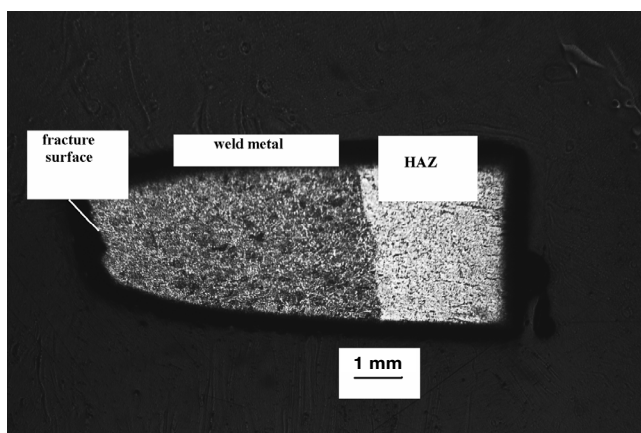
Fig. 11. Longitudinal cross section of the sample with SAW welded joint after SSRT in the air. Fracture localized in weld metal. Etched with 4%  $\text{HNO}_3$

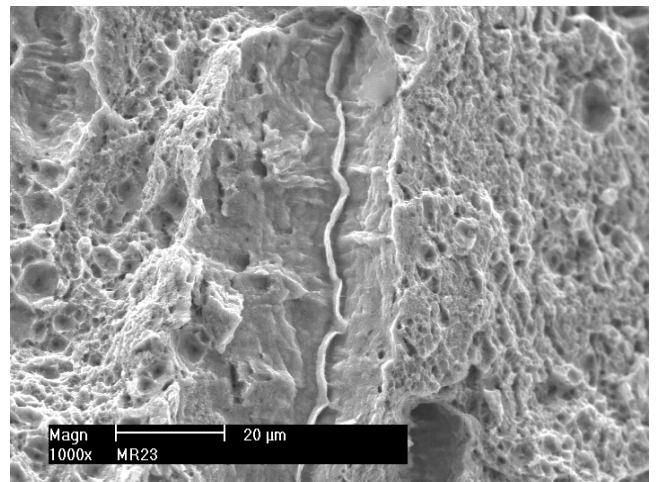
Fig. 12. SEM image of fracture surface of base metal sample after SSRT test the air

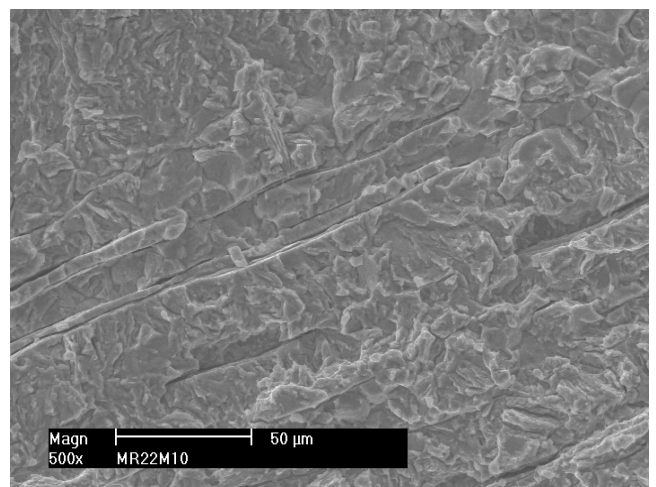
Fig. 13. SEM image of fracture surface of base metal sample after SSRT test in seawater,  $i = 10 \text{ mA/cm}^2$

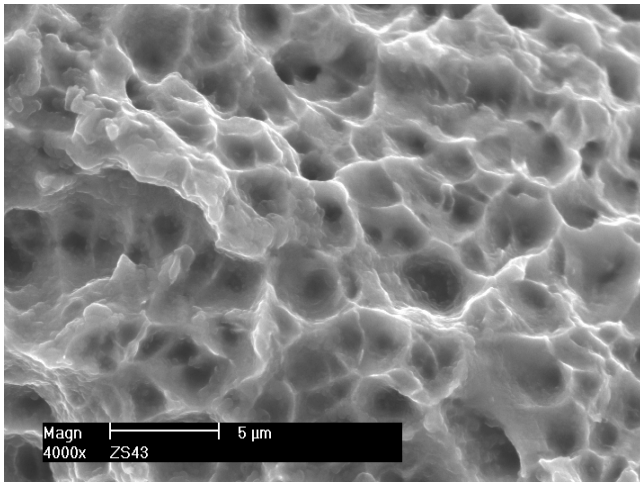
Fig. 14. SEM image of fracture surface of sample with SMAW welded joint after SSRT test in the air. Fracture localized in weld metal

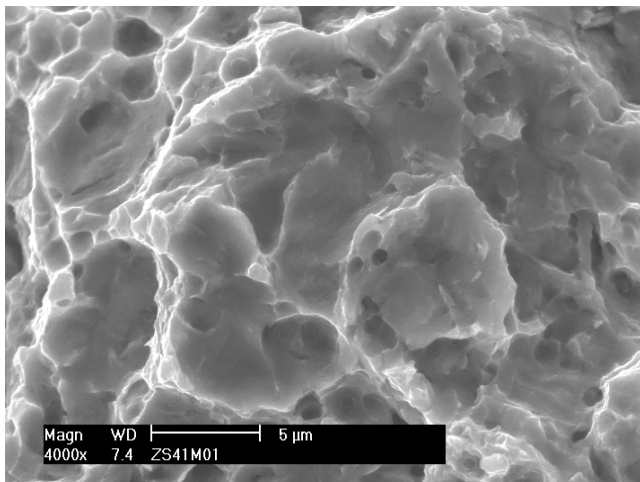
Fig. 15. SEM image of fracture surface of sample with SMAW welded joint after SSRT test in seawater,  $i = 0.1 \text{ mA/cm}^2$ . Fracture localized in weld metal

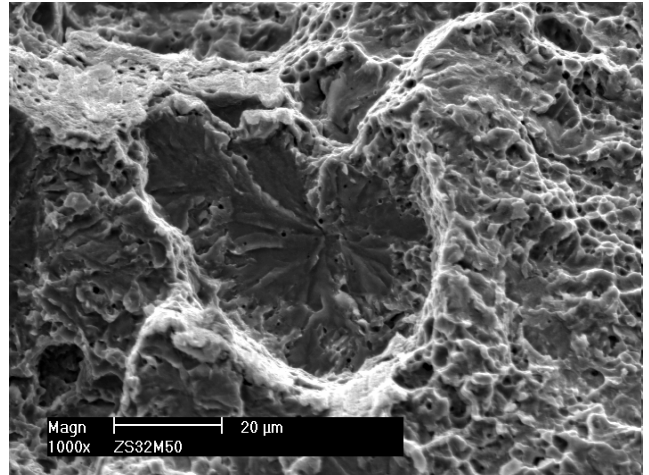
Fig. 16. SEM image of fracture surface of sample with SAW welded joint after SSRT test in seawater,  $i = 50 \text{ mA/cm}^2$ . Fracture localized in weld metal

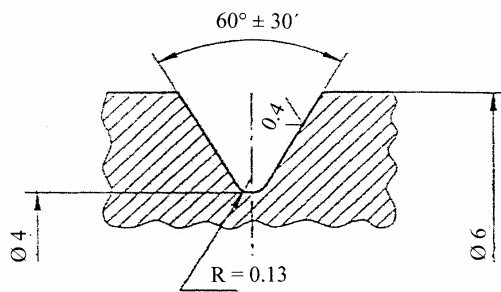
Fig. 17. The notch geometry of a specimen

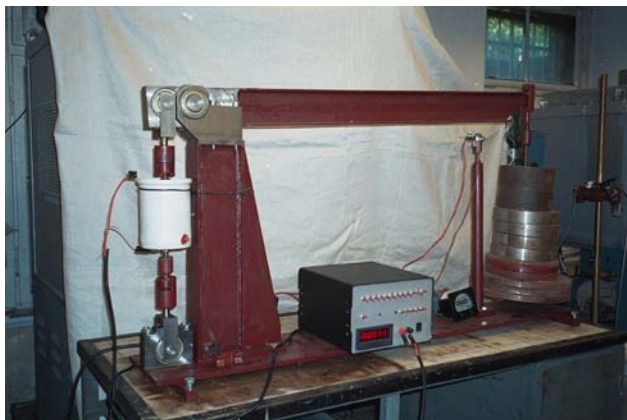
Fig. 18. View of the lever machine with the environmental cell

The constant load test was carried out with the use of a lever machine with leverage 25:1 and maximum load capacity of 20 kN. The machine was equipped with the environmental cell with platinum polarisation electrode (Fig. 18).

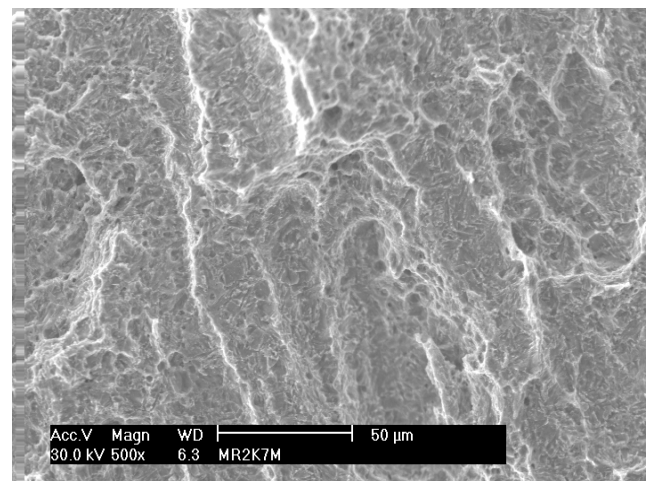
Fig. 19. SEM image of a fracture surfaces of S690Q steel. Sample after a constant load test in seawater. Relative load  $F/F_m = 0.96$ , open circuit potential

Fracture surfaces of failed samples were investigated with the use of the scanning electron microscope (SEM) PHILIPS XL30 to determine mode of fracture. Examples of fractographic observations are shown in Figs. 19-22.

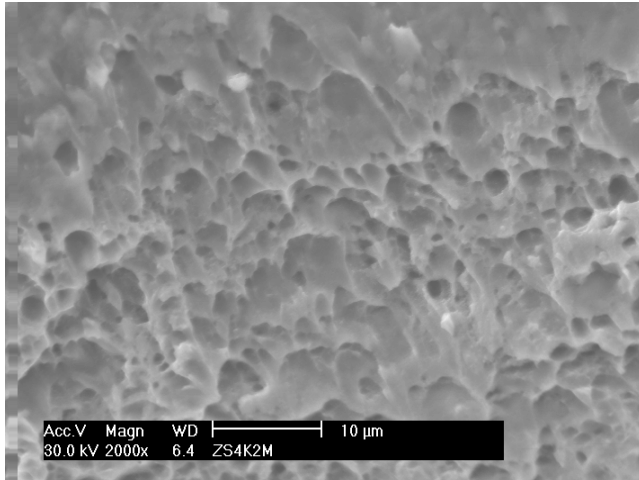
Fig. 20. SEM image of a fracture surfaces of weld metal (SMAW) of S690Q steel. Sample after a constant load test in seawater. Relative load  $F/F_m = 0.96$ , open circuit potential

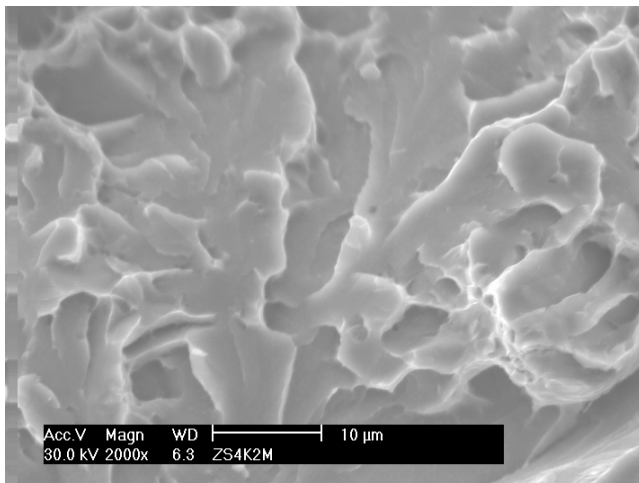
Fig. 21. SEM image of a fracture surfaces of HAZ (SMAW) of S690Q steel. Sample after a constant load test in seawater. Relative load  $F/F_m = 0.96$ , open circuit potential

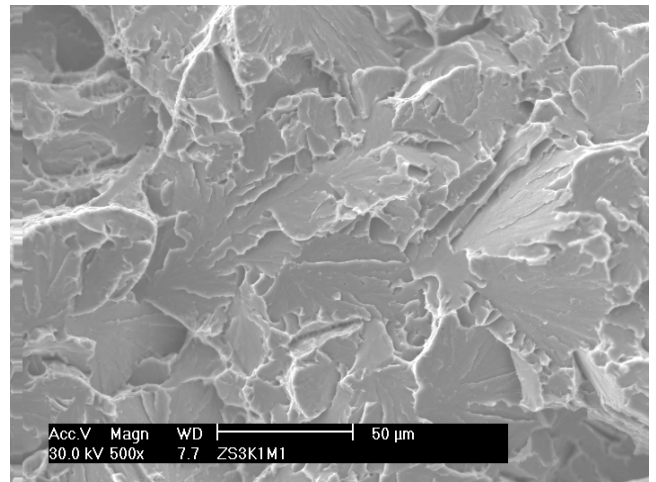
Fig. 22. SEM image of a fracture surfaces of HAZ (SAW) of S690Q steel. Sample after a constant load test in seawater. Relative load  $F/F_m = 0.92$ , cathodic current density  $1 \text{ mA/cm}^2$

Fractographic observations of failed samples revealed various fracture modes according to material and hydrogenation conditions. Base metal samples of S690Q steel revealed quasi-cleavage fracture for test performed at open circuit potential, and under cathodic polarisations (Fig. 19). Samples with SMAW welded joints, tested at open circuit potential, had micro void coalescence (MVC) fracture in the weld metal (Fig. 20), which turned into transgranular cleavage in the heat affected zone (Fig. 21). This observation is consistent with constant load test results where SMAW welded joints had the lower resistance to hydrogen delayed cracking (c.f. Table 5). Welded joints samples tested under cathodic polarisations showed brittle transgranular cleavage and intergranular fracture (Fig. 22).

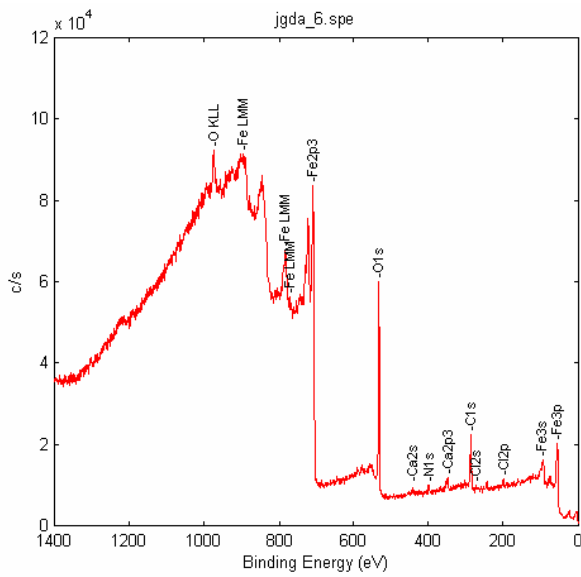
Fig. 23. The whole XPS spectrum for diffusion zone of nitrated layer on sample 34A2

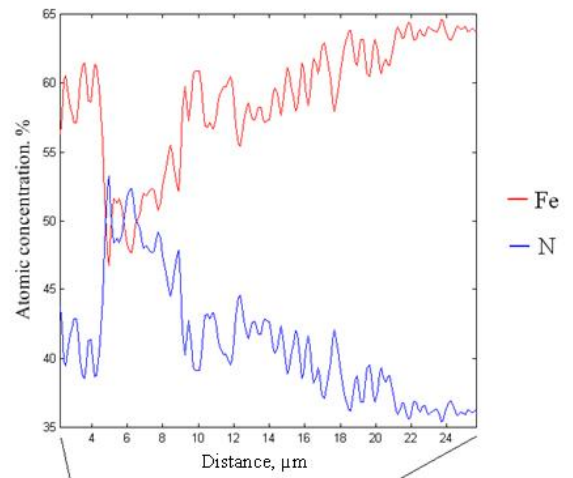
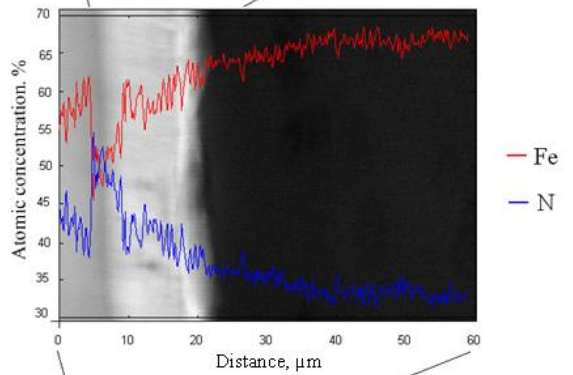
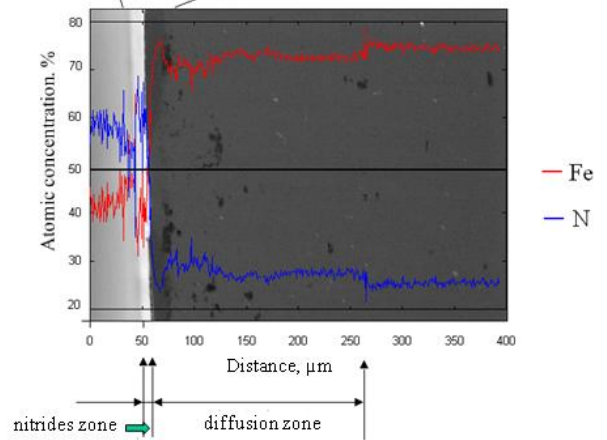
Fig. 25. AES line profiles of chemical composition (nitrogen and iron) with SEM view of nitrated layer on sample 34A2

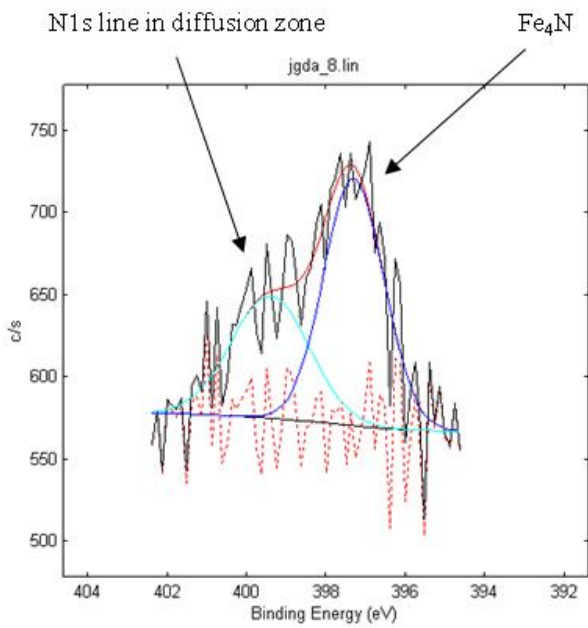
Fig. 24. The shape of nitrogen N1s line (XPS) in diffusion zone of nitrated layer on sample 34A2

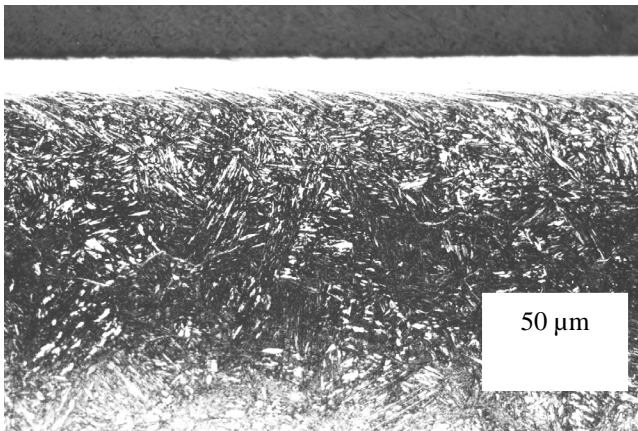
Fig. 26. Microstructure of plasma nitrided layer. Sample 34A1. Compact nitride and diffusion zones. Nital etching

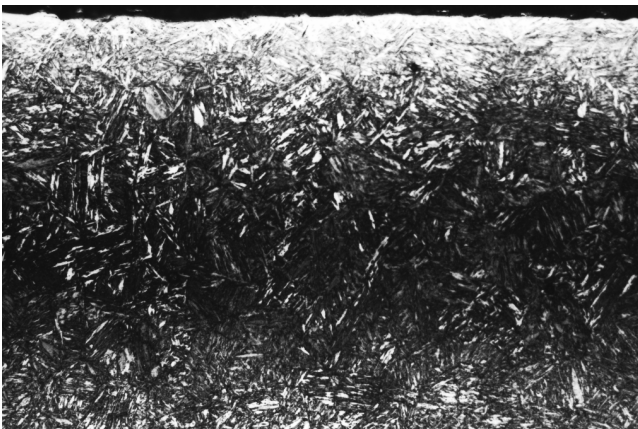
Fig. 27. Microstructure of plasma nitrided layer. Sample 34A2. Compact nitride and diffusion zones. Nital etching

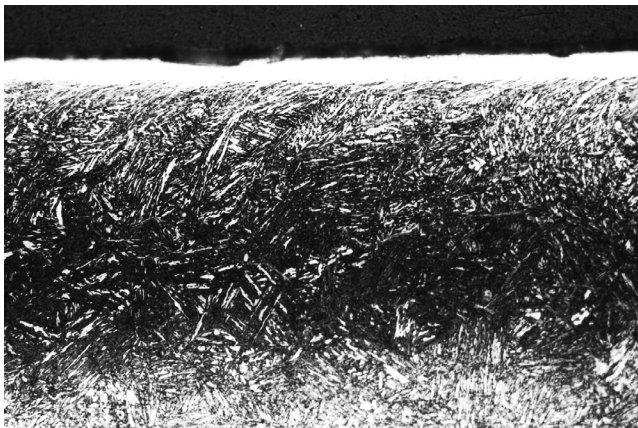
Fig. 28. Microstructure of plasma nitrided layer. Sample 34A3. Compact nitride and diffusion zones. Nital etching

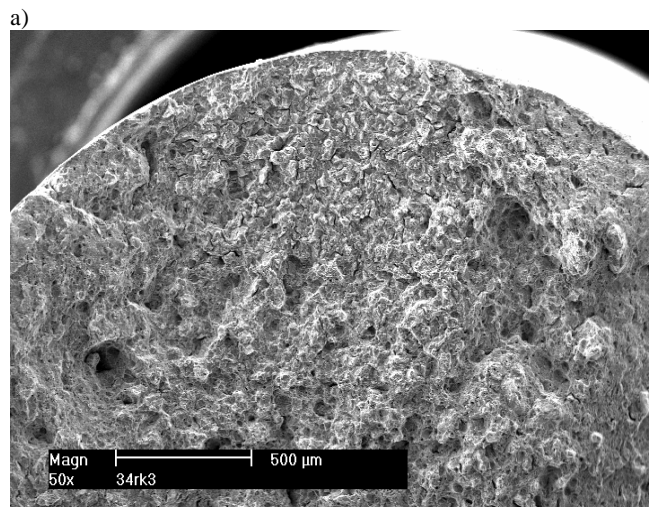
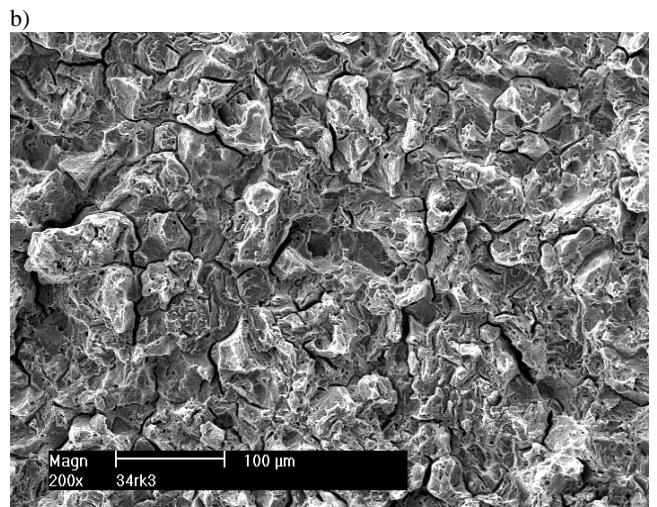
Fig. 29. SEM images of fracture surface of 34R sample after SSRT tested in acid solution under cathodic polarisation. Magnification: a) 50x, b) 200x

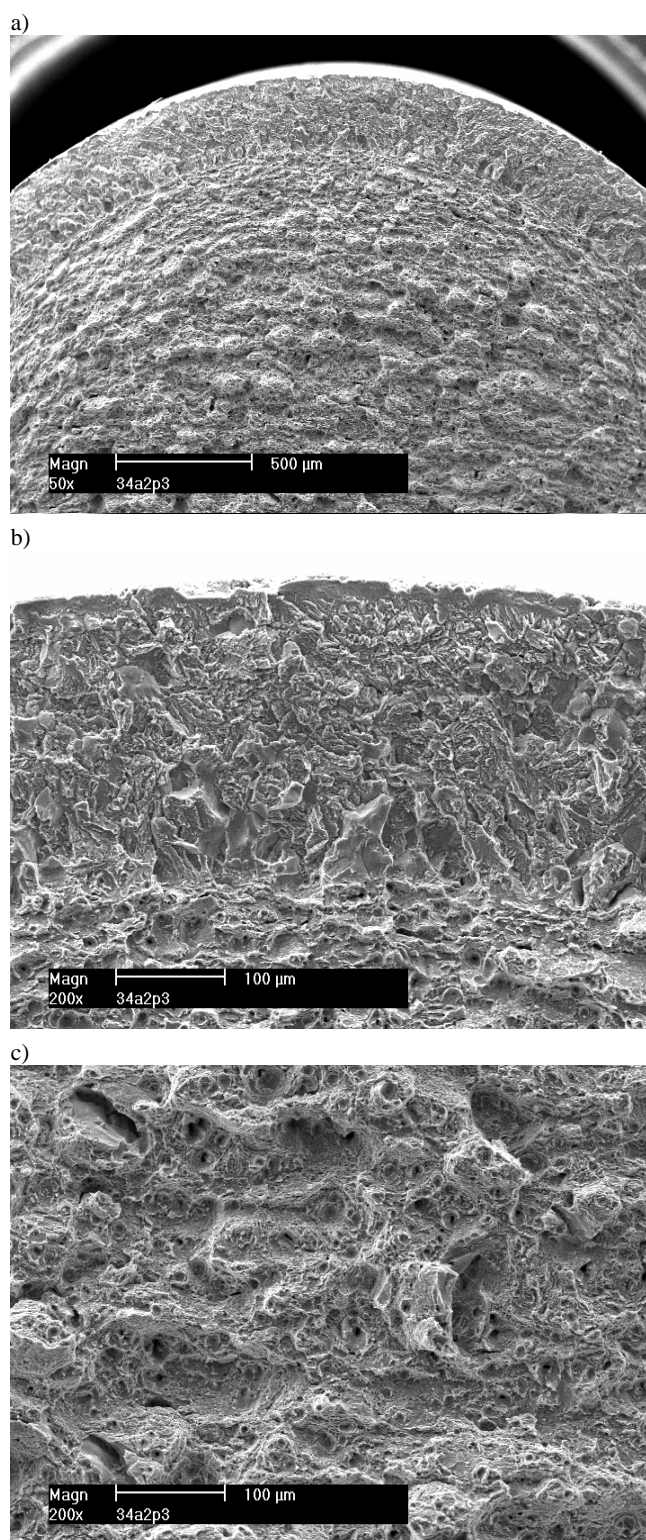
Fig. 30. SEM images of fracture surface of 34A2 sample after SSRT tested in the air. a) macroscopic view, b) modified layer, c) core of base metal

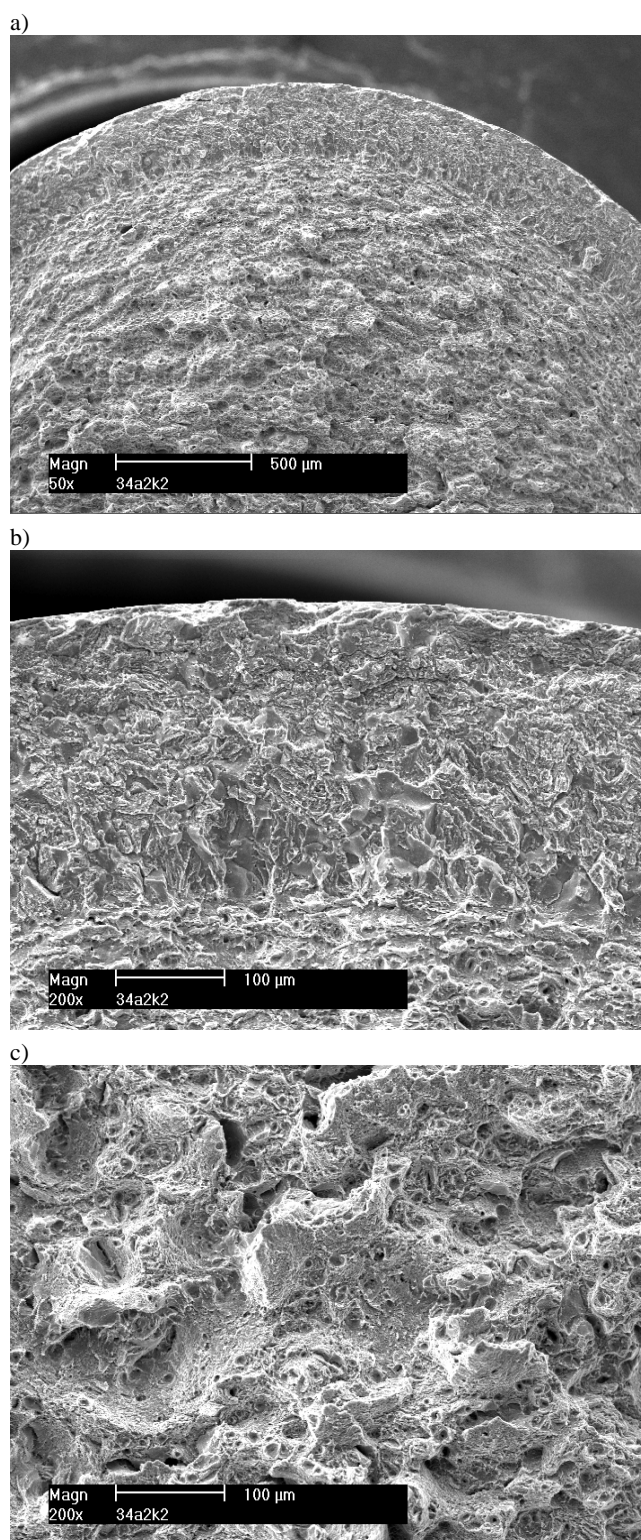
Fig. 31. SEM images of fracture surface of 34A2 sample after SSRT tested in acid solution under cathodic polarisation. a) macroscopic view, b) modified layer, c) core of base metal
