Characterisation of properties and microstructural changes of 12% Cr-W steels after long-term service

Purpose: Characterization of the influence of long-term exposition on microstructural stability and properties of new modified ferritic steels containing 12% Cr with W addition.

Design/methodology/approach: The examinations were made on samples from superheater tubes (HCM12 and HCM12A type of steel) after long term exposition (20 and 30 thousand hours). The major technique used to investigations are: microstructural analysis with the use of LM, SEM and TEM and measurement of hardness and strength at an ambient temperature and at 600°C.

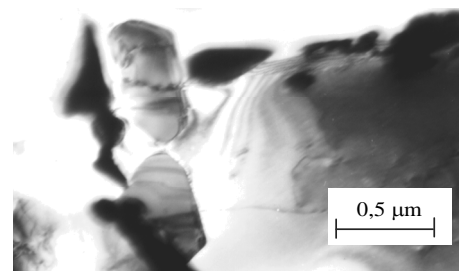
Fig. 11. Elongated precipitations of Laves phases in HCM12A steel (dark field)

Fig. 12. $M_{23}C_6$ carbide precipitations in the HCM12A steel (bright field)

of the coagulated $M_{23}C_6$ carbide precipitations, elongated particles of Laves phases were observed (Figs. 11 and 12). The image of such phases, however, was rare and the elongated precipitations were frequently particles of the $M_{23}C_6$ carbides. Precipitations of MX type occurred inside the subgrain.
