Agnieszka LISOWSKA-LIS¹, Franciszek WITOS²

10. THE USE OF THERMOGRAPHY TO IMPROVE THE SAFETY OF ELECTRICAL DEVICES IN THE POWER INDUSTRY

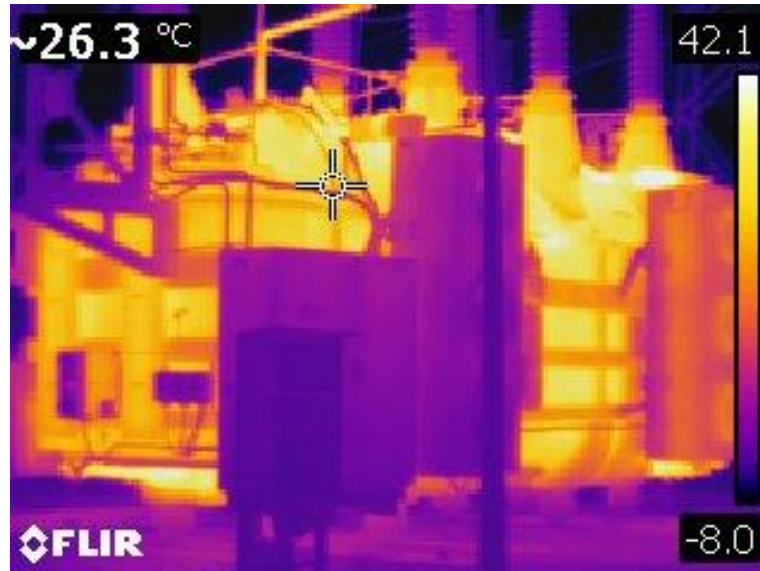
Fig. 2. The thermogram presents transformer with ineffective cooling. The surface temperature is almost even, despite the working fans and cooling circulation (autotransformer: 220/110/15 kV, 160 MVA). The thermogram was made with a FLIR E50 camera

Disruptions or failures in a power system affect the transformer work parameters. For a transformer in good condition, the lower areas on the surface should be cooler. It was observed that for transformers with deteriorated electrical insulation (Fig. 2) the maximum temperature areas ("hot-spots") could be observed on any surface [8, 11].

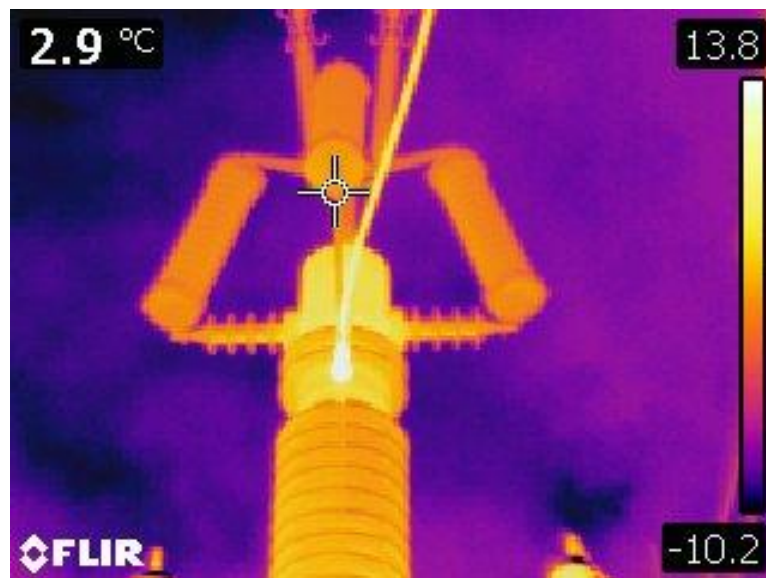
Fig. 4. The thermogram shows the slightly higher temperature for the wire and isolation at the 110 kV voltage side of power transformer (autotransformer: 220/110/15 kV, 160 MVA). The thermogram was made with a FLIR E50 camera

The higher temperature on the entire upper surface of the transformer tank is justified by all possible processes responsible for the generation of heat within the working transformer. On Figs. 3 and 4 local temperature increase due to **improper state of junction or improper wires connection** was observed. The thermogram in Fig. 3 shows uneven temperature distribution on the screw joint (a). Detailed analysis Fig. 3b demonstrates that the temperature difference between the screws reaches 10°C. This could be due to a loose screw and eddy currents.

The temperature increase is associated with an increase in the connection resistance. The reasons for this may be defects or damage to the structure, loose screws, corrosion, oxidation, improper connection and others [2, 5, 6, 8, 13]. In electrical power stations and substations, the

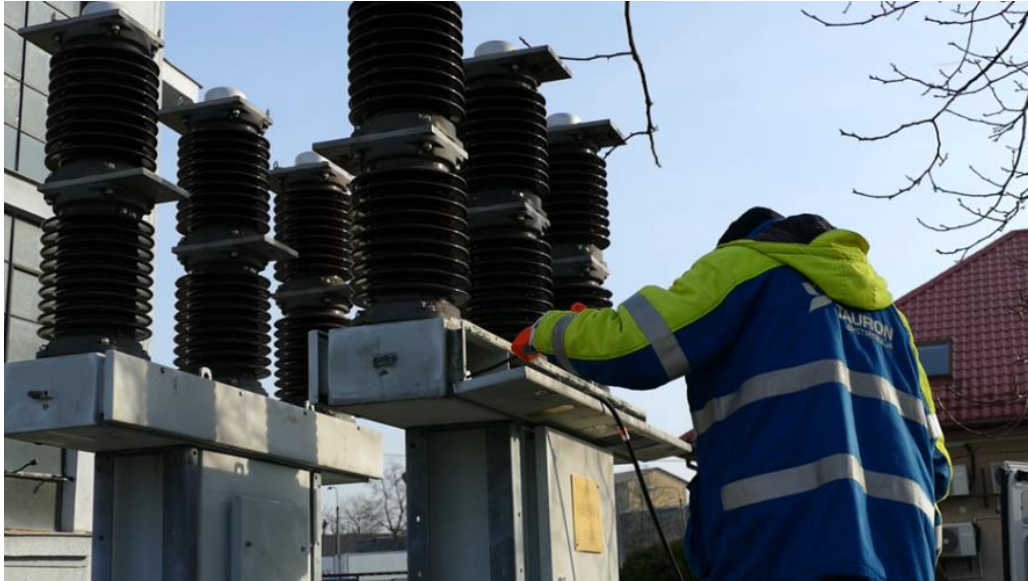
Fig. 7. Testing SF₆ gas leakage from an electric switch, using a chemical detector. (Switch type: ABB OHB 1539; $U_N=110$ kV), [photo: A. Lisowska-Lis]

Within the hermetically closed equipment gas pressure must be monitored. There are also detached switches in use, without constant gas pressure monitoring. All the equipment with SF₆ insulation must be tested (constantly or periodically) for gas leakage Fig. 7. Usually it is done with chemical gas detectors. Much more effective but more expensive is the application of thermal imaging camera dedicated to specific gas detection. Measurement with a FLIR GF306 thermal imaging camera gave much better results than the test with chemical detector [26, 27]. A FLIR GF306 thermal imaging camera can record: editable thermograms, editable thermogram sequences, and recordings in MP4 (video) format [27]. Using thermographic recording in the differential, highly sensitive mode it is possible to **compare image changes in real time** (i.e. temperature gradient analysis). Thermograms are analysed in the device's memory and the displayed graph shows the areas (pixels) indicating the intensity of temperature changes over time. For the black and white temperature scale, the thermal background was grey and the intensely cooled areas were black, while the intensely heated areas were white. This mode of operation is especially helpful for investigating small SF₆ gas leaks. In professional gas detection cameras (FLIR, FLUKE), such operations are performed by logic operations. The user obtains differential images in which the presence of gas or substance vapours is more clearly visible than on the single thermogram [27]. Image analysis in cameras allows for complex logical functions or the use of the Faster-RCNN method based on an advanced convolutional neural network, i.e. artificial intelligence [26].
