Silesian University of Technology
Faculty of Mechanical Engineering
Department of Fundamentals of Machinery Design

Doctoral Dissertation

**MANUFACTURING PROCESS
DIAGNOSTICS AND DAMAGE
ASSESSMENT OF HSLA STEEL
BUTT-WELDED PIPELINES**

Gliwice, 2022

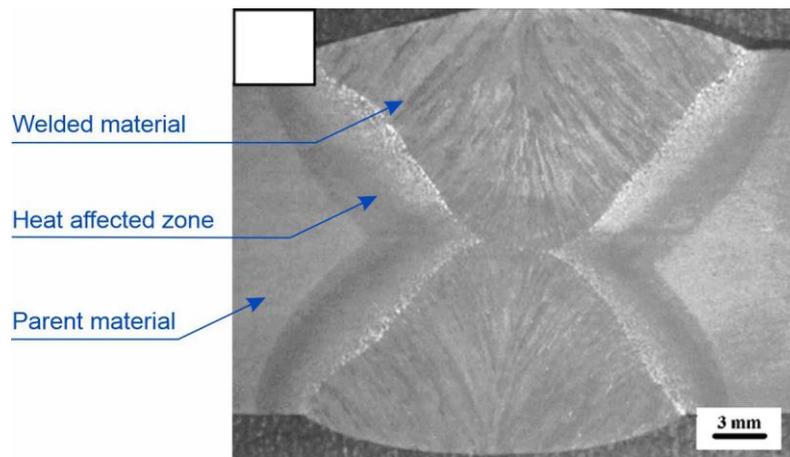
FIGURE 8: TRANSVERSAL SECTION OF A BUTT-WELDED JOINT [23]

In this research the attention was particularly put on the welded connections between two HSLA pipes. Although significant aspects of piping systems installations, e.g., layout, materials, joining solutions are discussed in a following specific paragraph it is necessary here to motivate the reason behind this choice. For complex piping systems there are several connections between the various elements e.g., pipes, elbows, fittings. These connections are sensitive parts that could trigger failure mechanisms in case of extreme loads. In fact, joints are discontinuities regarding material and/or geometry and therefore they can constitute a possible weakness to the integrity of the system. Regarding butt-welded joints, which were shown in Figure 5, the discontinuity is the results of the interactions between three different interfaces. The first one is represented by the parent material, which is the original metal constituting the pipe. The second one is the heat affected zone (HAZ), which is a region of the original material that is affected by the thermal input typical of the welding process. The last one is the welded metal, which is the external molten material that solidifying creates the bonding between the two pipes. A section of a butt-welded joint with the indication of the three areas just described is depicted in Figure 8.

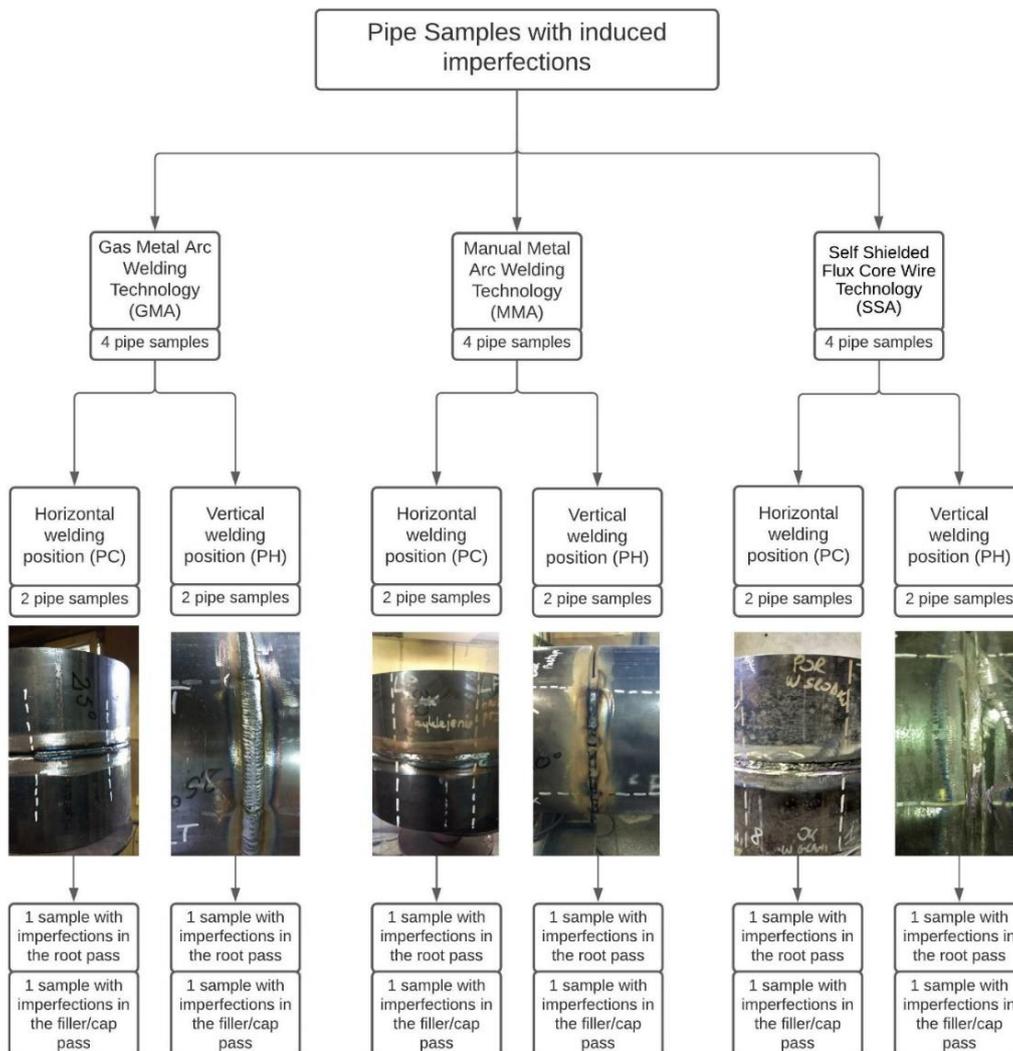
FIGURE 11: PIPE SAMPLES MANUFACTURED WITH DEFECTIVE WELDED JOINTS

In the fourth chapter the process regarding the manufacturing of butt-welded joint pipes is introduced. A part of the pipe samples was produced with induced imperfections in the welded joint, while the second set of pipe samples was manufactured with optimal acceptance quality level of the welded joints. The first group consisted of twelve pipes specimens: four of them were manufactured using GMA welding technology, four using MMA welding technology and the last four using SSA welding technology. For each welding technology two welding positions were adopted, horizontal and vertical, and imperfections were artificially introduced alternatively on the root layer and on the fill pass to simulate the possible adverse conditions occurring during welding process. A resume of all these samples manufactured is depicted in Figure 11. During this stage, the parameters of welding process were recorded: in particular, welding pool temperatures with a thermal camera as well as the electrical parameters, welding current and arc voltage.

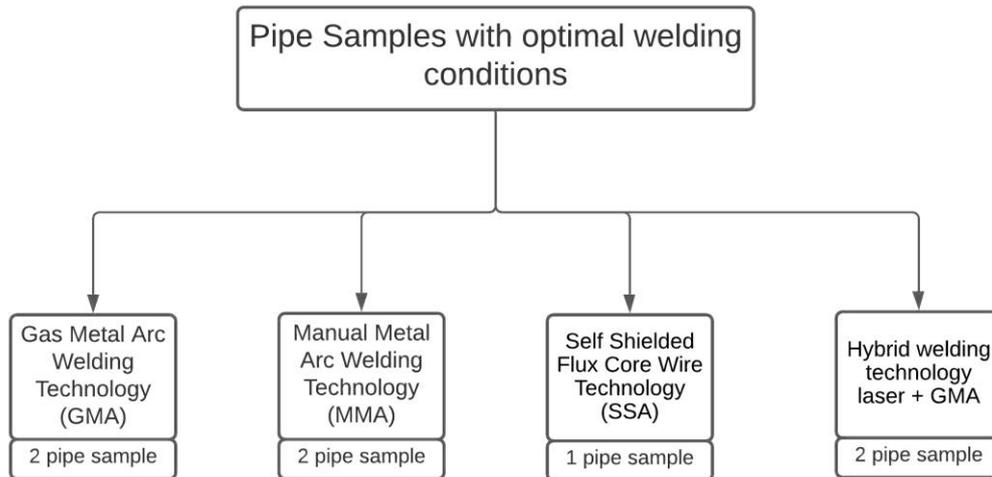
FIGURE 12: PIPE SAMPLES MANUFACTURED WITH OPTIMAL JOINTS

The second group of pipe specimens were manufactured to obtain optimal quality of the welded joints in accordance with accepted standards and regulations. It was produced using the same welding technologies (GMA, MMA and SSA) in addition with hybrid welding technology where the root pass is manufactured with the use of laser technology and the filler/cap pass with GMA technology. These pipe samples were later tested with impact load test. A total number of seven pipe specimens were manufactured at Mostostal Zabrze laboratories as reported in Figure 12

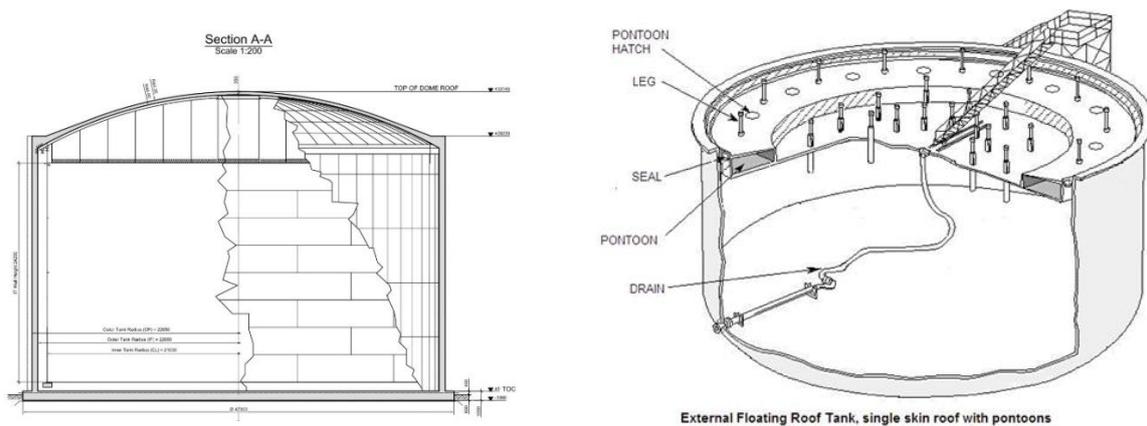
FIGURE 13: FIXED ROOF STORAGE TANK (LEFT) [26] AND FLOATING STORAGE TANK (RIGHT) [27]

Regarding the top, it can be made in a shallow cone, umbrella or dome shape. The roof can also be fixed or floating on the cylindrical structure below. In the first case the roof is completely connected with the vertical walls of the tank, while in the second solution it raises and lowers to automatically adjust to the level of the commodity in the tank [15]. The material is selected based upon its cost, ease of fabrication, resistance to corrosion, compatibility with stored fluid and its availability. Most common materials are carbon steel, stainless steel, used for storage of corrosive liquid tanks and concrete. In Figure 13 it is depicted the section of a fixed roof concrete storage tank (left) and a section of a floating roof steel storage tank (right).

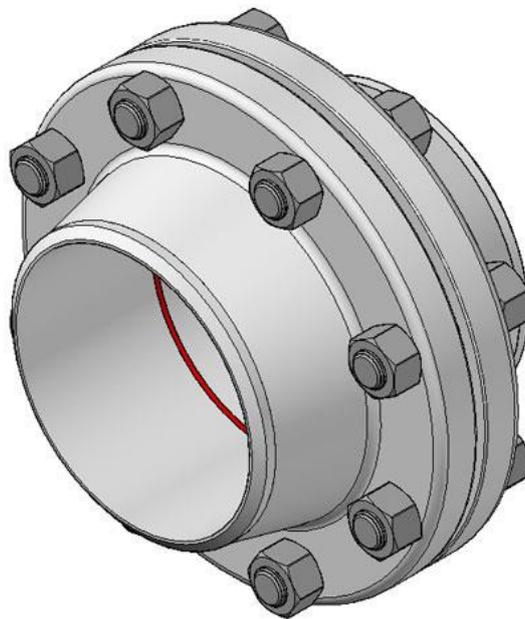
FIGURE 17: PIPE BOLTED FLANGE JOINT [31]

The flange blade is the circular area through which there is a standard bolting pattern, based on the outside diameter of the pipe and the design pressure rating. It has a seal face accurately machined to a predetermined finish, on which the gasket sits and a back face on which the nut sits. The hub is located on the back of the blade and it receives the pipe. An example of a typical bolted flange joint is depicted in Figure 17.

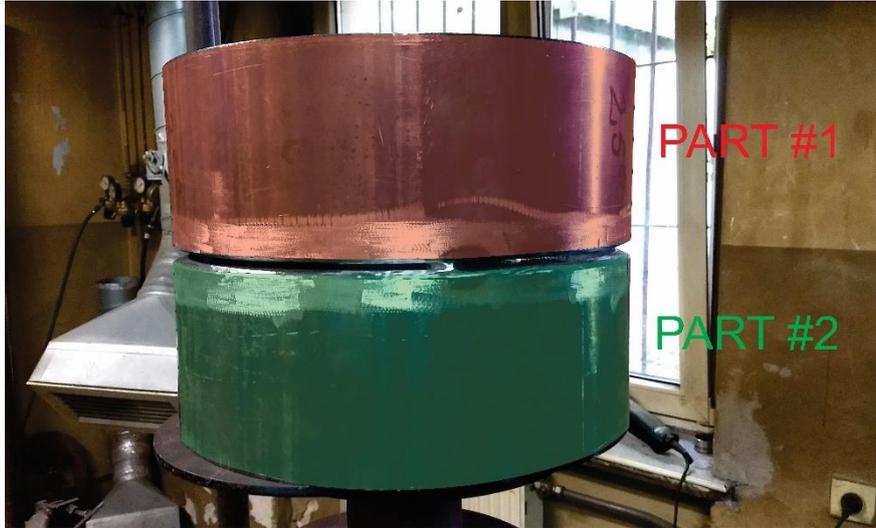
FIGURE 25: EXAMPLE OF TWO SEGMENTS OF THE 10 M PIPE BEFORE EXPERIMENTAL ACTIVITY

To perform the experiments the pipe was cut in segments of about 20-25 cm of length in order to prepare proper samples. As an example, two of these segments clamped are depicted in Figure 25 ready for the experimental activity. As described in Figure 11 twelve samples similar to the one depicted in Figure 25 were manufactured with induced imperfection in the welded joint, while seven samples were manufactured with optimal joint conditions as described in Figure 12.

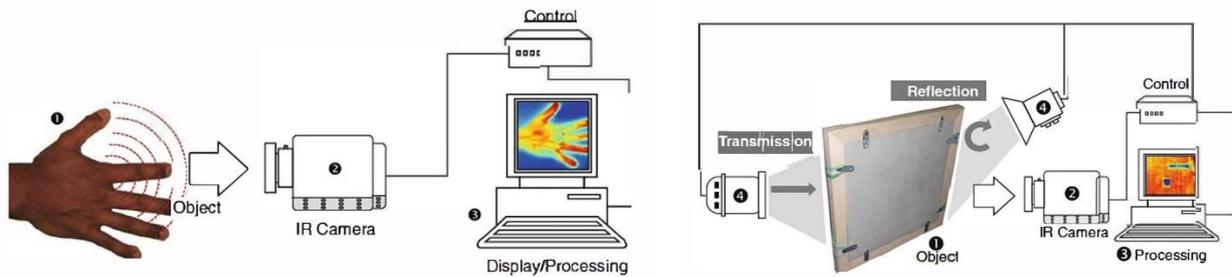
FIGURE 38: PASSIVE AND ACTIVE APPROACHES IN THERMOGRAPHY [55]

Two approaches are generally adopted in thermal non-destructive evaluation: passive, in which materials and structures emit electromagnetic radiation due to their temperature usually higher than room temperature, and active, in which an external energy source stimulates the material to be inspected. The first approach is typically implemented in the manufacturing of the materials, in the diagnosis of abnormalities or hot spots with respect to the surroundings. In the second case an external source of energy excites the object of the analysis. Defective and non-defective areas, due to different thermo-physical properties, produce thermal contrast that can be measured with the thermographic apparatus. The two approaches are depicted in Figure 38.

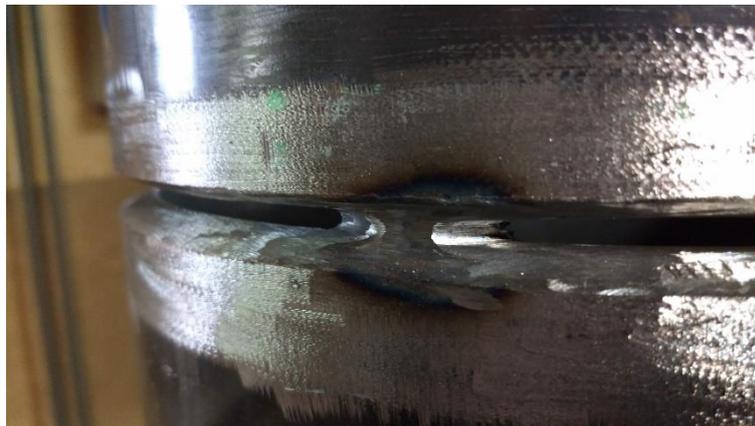
FIGURE 40: BEVELLING OF THE PIPES BEFORE WELDING PROCESS

All pipe segments were bevelled, in general with angles of 25 or 30 degrees, and then clamped together as depicted in Figure 40, ready for being welded together using different welding technologies: Gas Metal Arc Welding (GMA), Manual Metal Arc Welding (MMA) and Self Shielded Flux Cored Wire Welding (SSW).

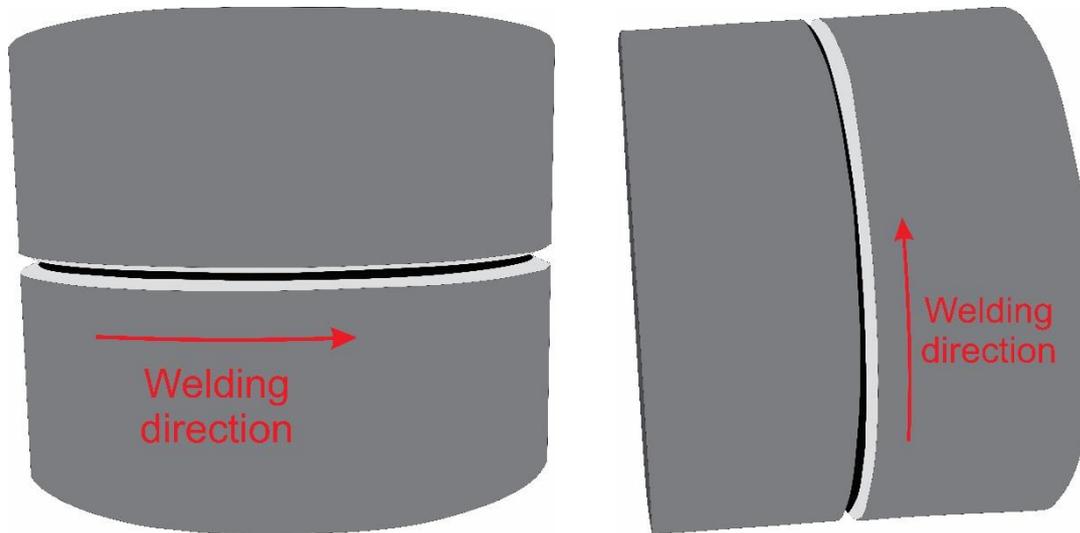
FIGURE 41: HORIZONTAL WELDING POSITION (PC) ON THE LEFT AND VERTICAL WELDING POSITION (PH) ON THE RIGHT

To perform the experiments twelve butt-welded joint pipes were manufactured during this stage, four samples for each welding technology abovementioned. The four specimens manufactured for each welding technology had different configurations to simulate as much as possible real conditions of the process: two of them were manufactured applying horizontal welding position (PC) while the other two applying vertical welding position (PH) as depicted in Figure 41.

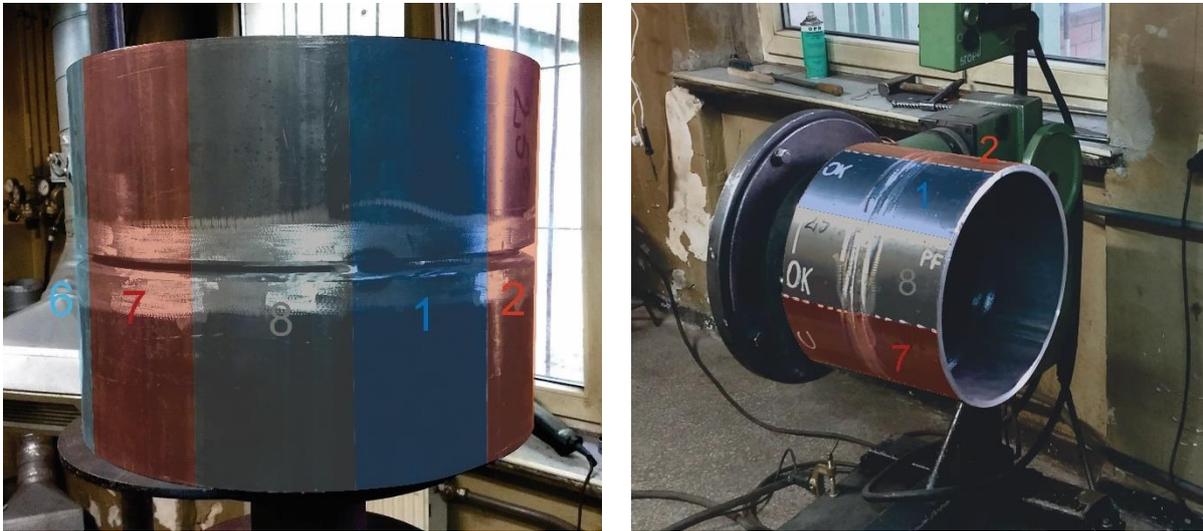
FIGURE 42: SEGMENTS ALONG THE PIPE CIRCUMFERENCE WITH DIFFERENT WELDING PARAMETERS APPLIED

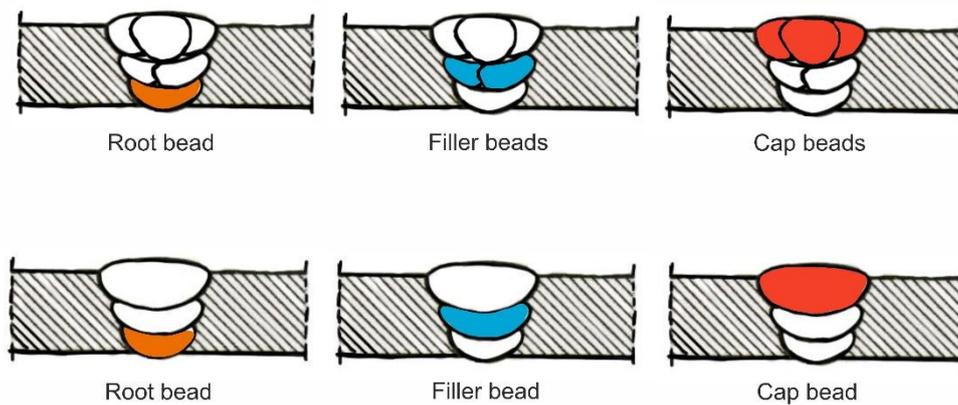
FIGURE 43: BEADS DEPOSITIONS

On pipe specimens manufactured using horizontal welding position (PC) the procedure consisted in the deposition of six weld beads (one root pass, two filler passes and three final cap passes). For the case of vertical welding position (PH) were instead deposited three weld beads (one root pass, one filler pass and one cap pass). The two conditions are displayed in Figure 43.

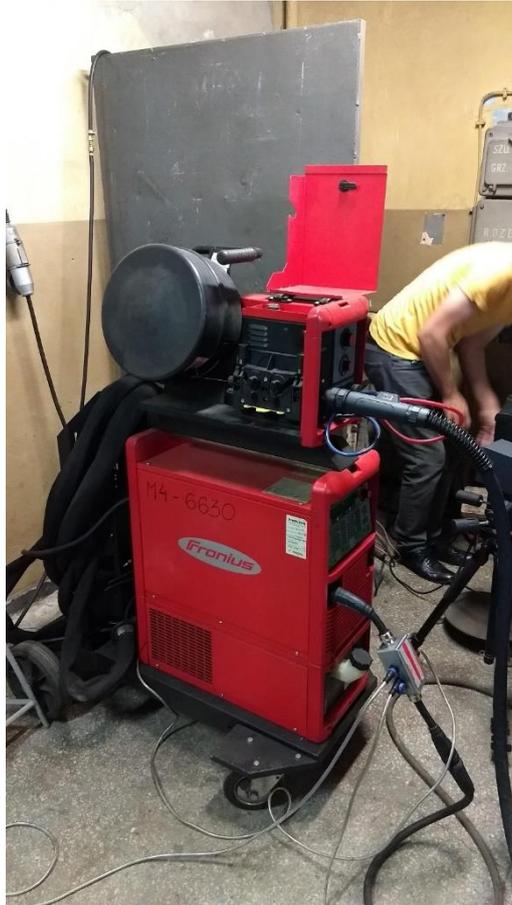
FIGURE 45: POWER SOURCE DEVICE FOR GMA APPLICATIONS

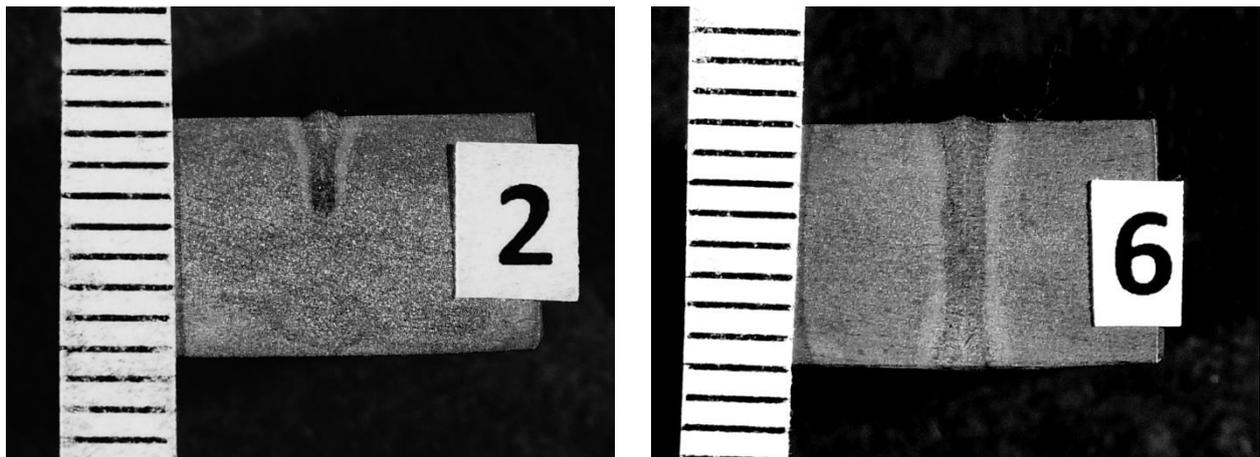
FIGURE 70: MACRO EXAMINATION OF SERIES #1

The next step was extraction of samples cross sections from all of twenty segments of melted material. All these sections were subjected to macro examination necessary to assess the quality of the fusion. The results of this procedure with the specimens obtained from the configuration number 2 and 6 for all four series are depicted in Figure 70 - Figure 73. It can be observed that different configurations produce different levels of penetration and therefore the possibility to achieve the complete fusion of the root section of the planned hybrid welded joints.

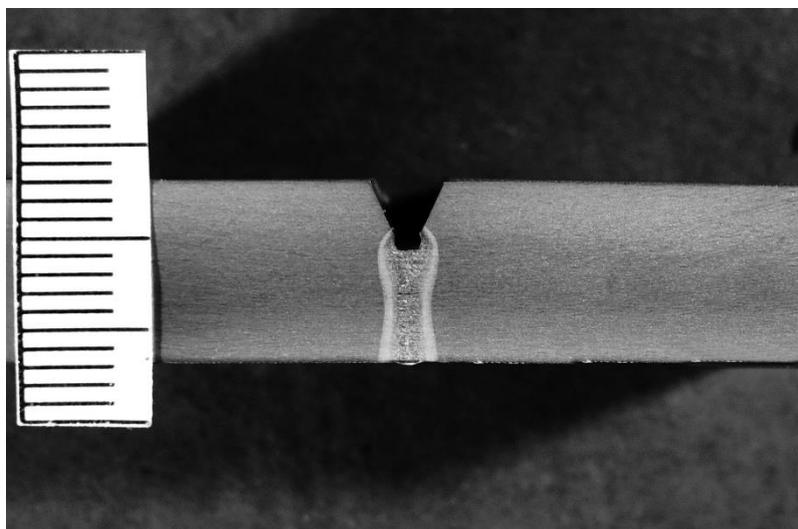
FIGURE 74: MACRO EXAMINATION OF X80 PIPE SECTION

The assessment of quality of all presented cases on the macro examinations led to the decision to adopt the parameters used for the combination number 25. The effects of this choice were analysed based on samples acquired from the pipe. In Figure 74 the cross section of the pipe sample showing macrostructural properties as well penetration depth of the root pass of the welded joint is presented.

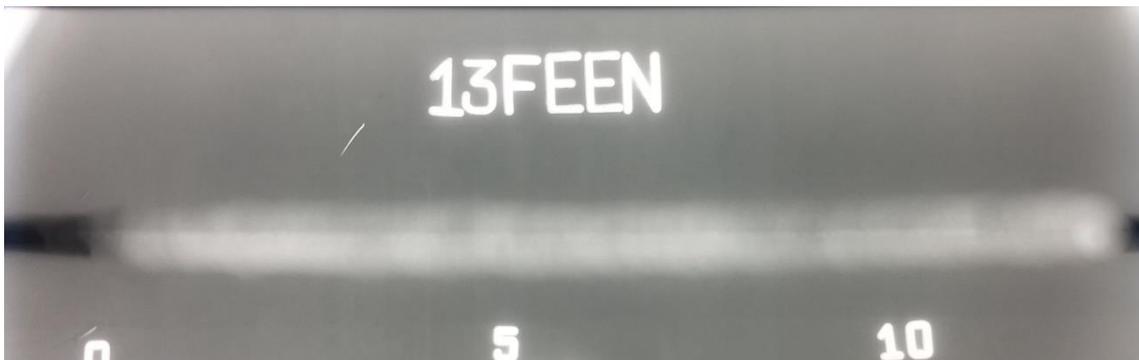
FIGURE 75: RADIOGRAPHIC TEST OF LASER ROOT PASS FOR COMBINATION 25

The pipes were moved to the laboratory of Mostostal Zabrze where the missing groove passes, manufactured according to the welding procedure specification for GMA welding technology, were added. Radiographic examinations were also carried out at the end of the gas metal arc welding process assessing the whole quality of the joint before the subsequent impact load tests.

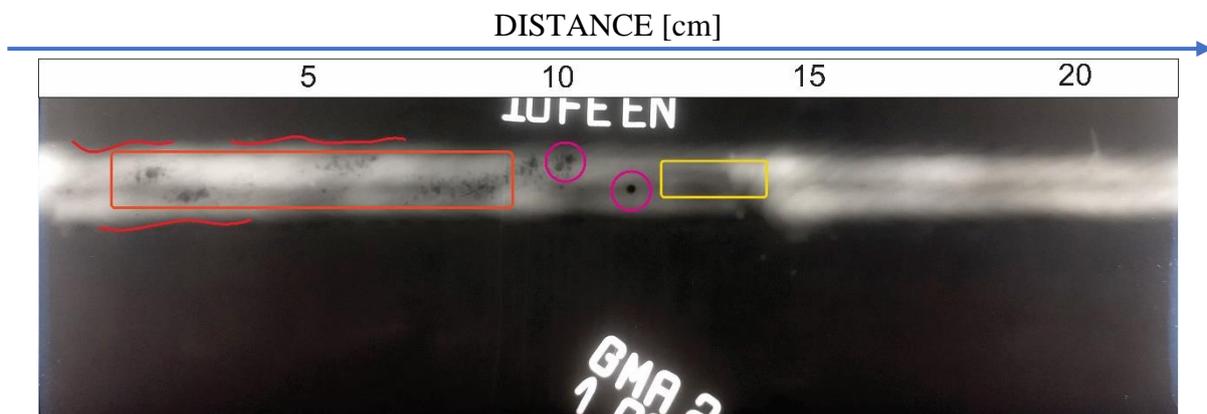
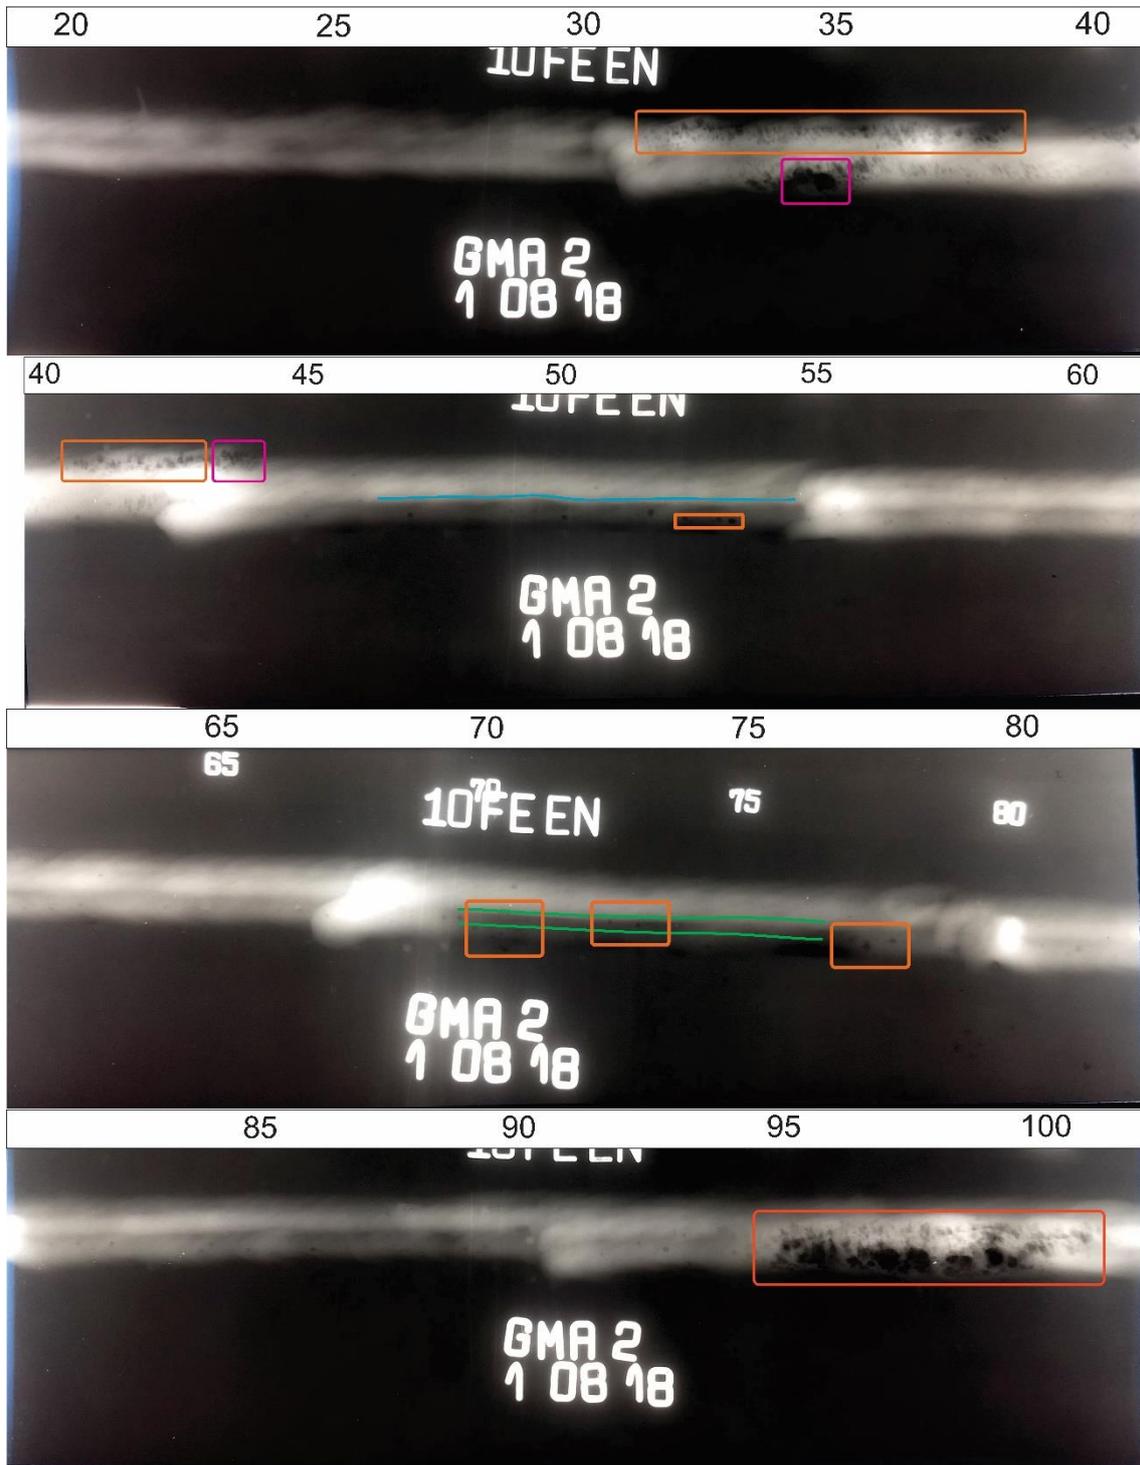
FIGURE 81: RADIOGRAPHIC INSPECTION OF GMA2 PIPE

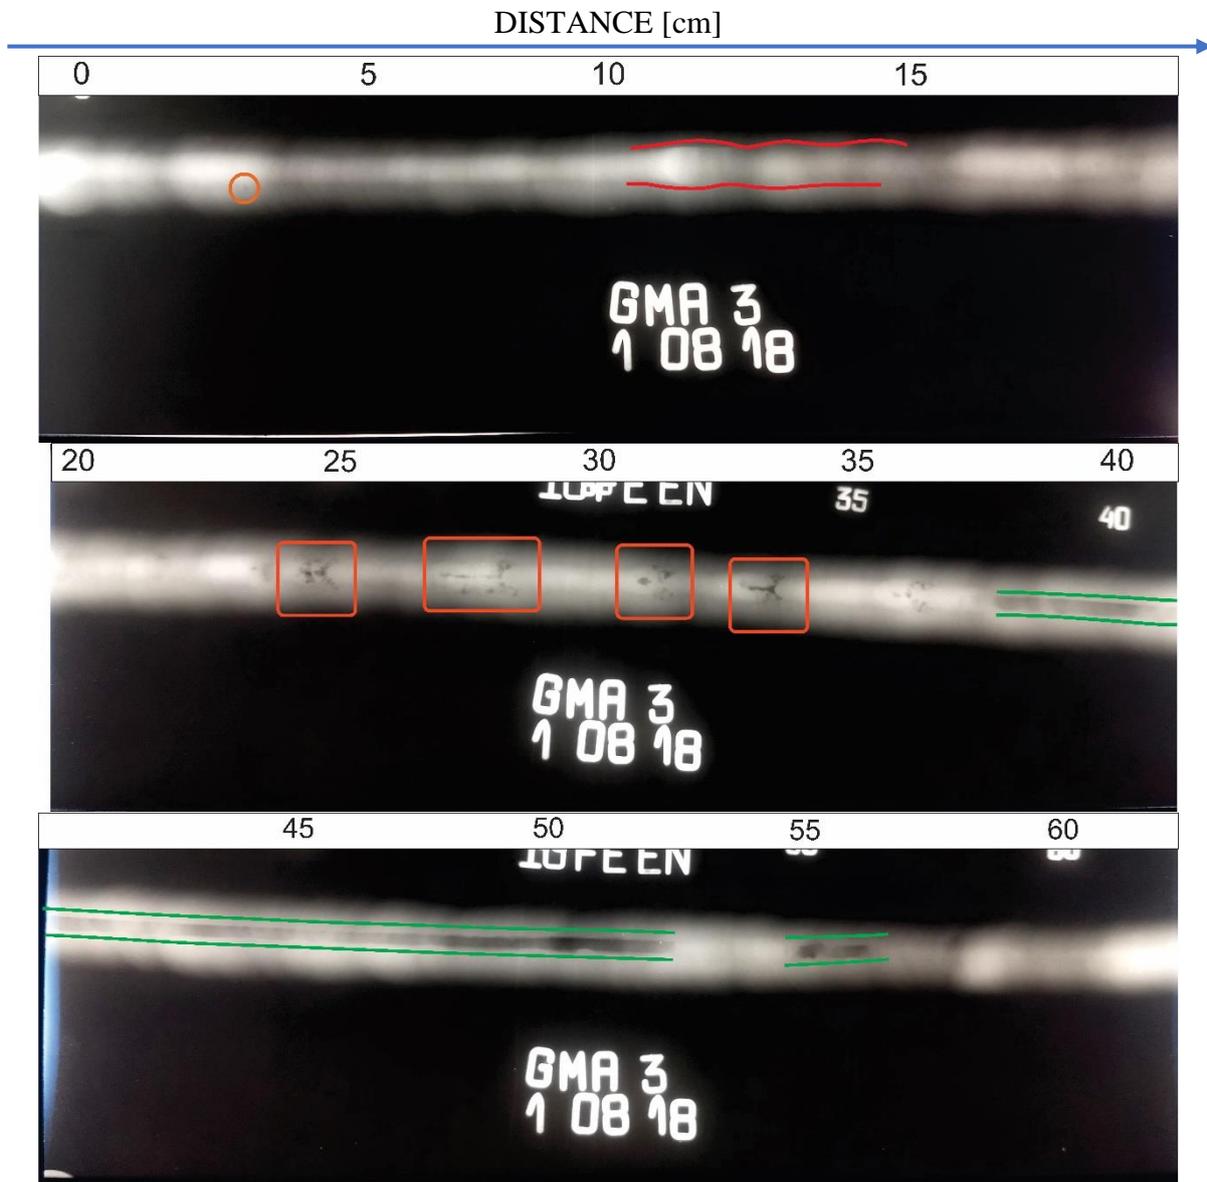
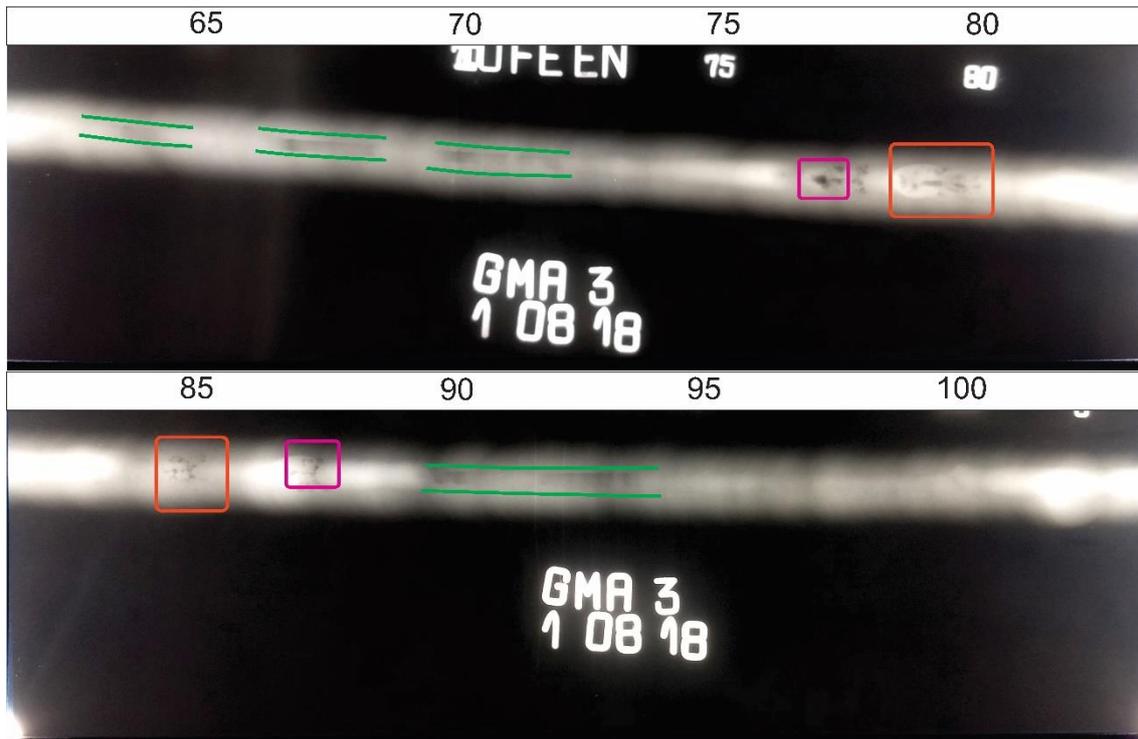
FIGURE 82: RADIOGRAPHIC INSPECTION OF GMA3 PIPE

The X-Ray films showing the results of the radiographic test performed on this pipe sample is presented in Figure 82.

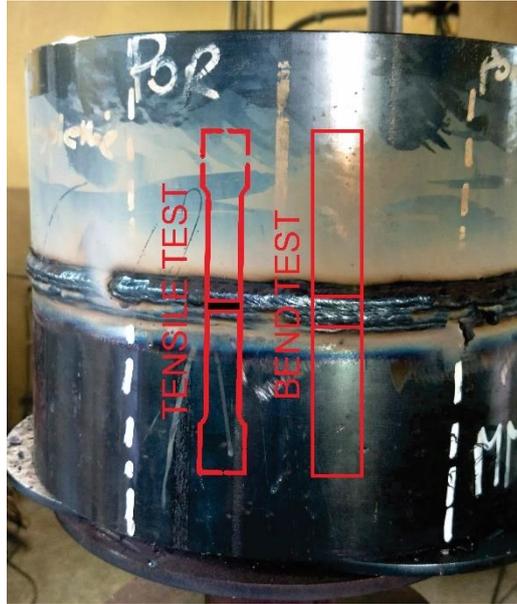
FIGURE 85: POSITION AND SHAPE OF THE SAMPLES FOR DESTRUCTIVE TESTS

In this paragraph are discussed the results of the mechanical tests performed on the defective pipe specimens. The sections of the pipe including defective spots were obtained cutting longitudinally (Figure 85) the twelve pipe specimens. These sections included single major defects listed in Chapter 5 specifically for the pipe specimens marked as GMA2, GMA3 and MMA1 and on Appendix A.3A.2 for all the other nine specimens. The shape and the dimensions of this parts are prescribed by [67] for tensile test and by [68] for bend test.

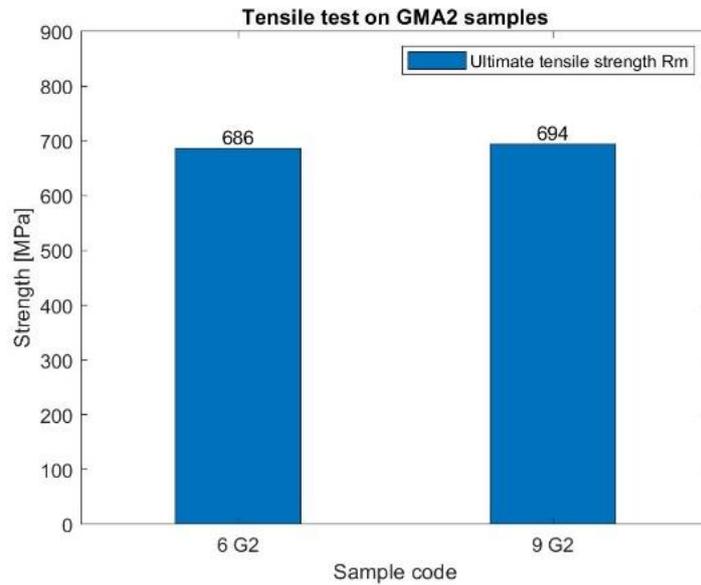
FIGURE 90: ULTIMATE TENSILE STRENGTH FOR G2 SAMPLES

samples were respectively 686 MPa and 694 MPa (Figure 90). It must be noted that the two values are higher than the value of 625 MPa required by [40] for the selected steel.

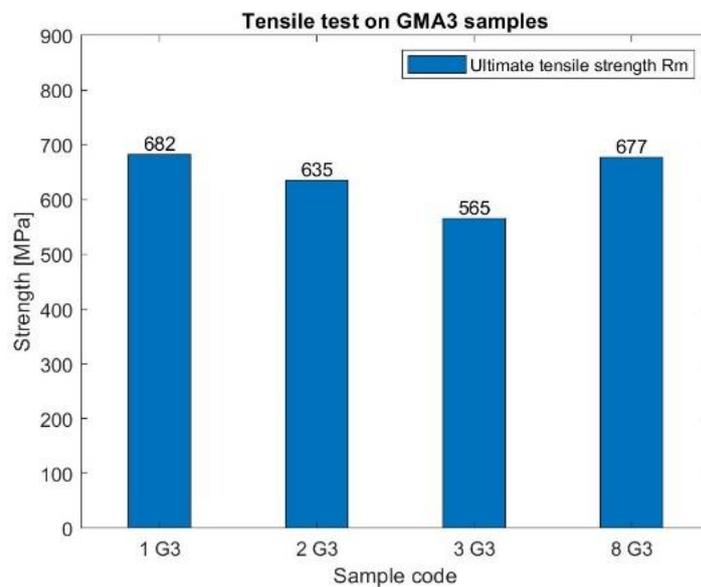
FIGURE 92: ULTIMATE TENSILE STRENGTH FOR G3 SAMPLES

Ultimate tensile strength values for the samples 1_G3, 2_G3, 3_G3 and 8_G3 are included in the graph presented in Figure 92. The failure on the samples 2_G3 and 3_G3, which were affected by heavy lack of penetration defect, occurred on the welded joint section as shown in Figure 93. The pieces subjected to bend test showed full compliance to optimal quality acceptance requirements.

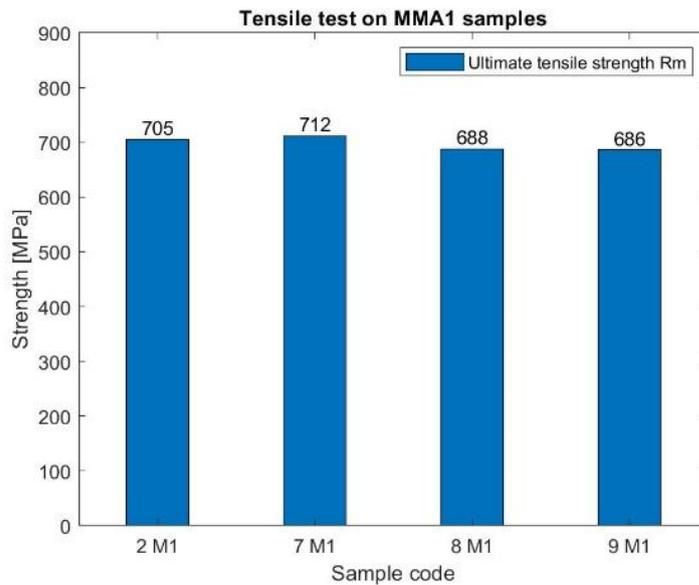
FIGURE 94: ULTIMATE TENSILE STRENGTH FOR M1 SAMPLES

Among these samples subjected to tensile tests, in the sample labelled 9_M1 the failure occurred in the welded joint section (Figure 95).

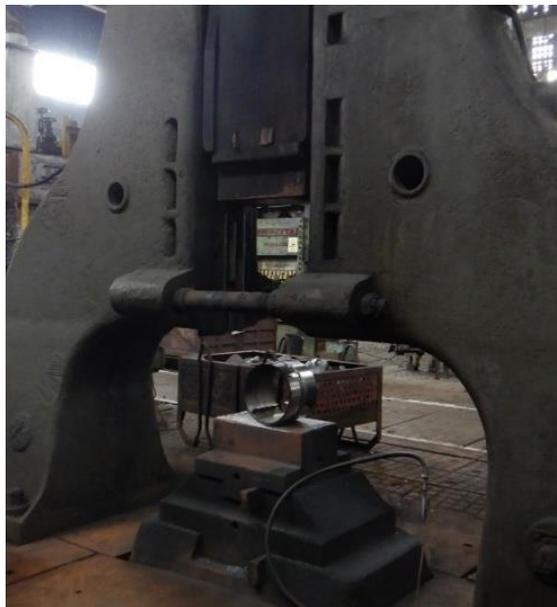
FIGURE 96: FORGING HAMMER SKM-3T

As described in Paragraph 4.2, the first steps of the experimental activity were dedicated to the manufacturing of both defective and optimal quality acceptance level butt-welded joint pipes. The performances of specific pipe sections including various defects submitted to tensile and bend test were discussed in the previous paragraphs. In this paragraph the application and observation of impact load test on full-size butt-welded joint pipes are described. The purpose of these experiments was to simulate the catastrophic impact of a nearby collapsing structure on a piping system. The goal was also to evaluate the ability to undergo plastic deformation by flattening without damages of the piping system. The tests on the GMA, MMA, SSA and laser+GMA butt welded joint pipes, which were described in Paragraph 4.2, were carried out at KUZNIA ŁABĘDY S.A. factory [69] using the die forging hammer SKM-3T machine (Figure 96) with freely dropping mass of 3000 kg.

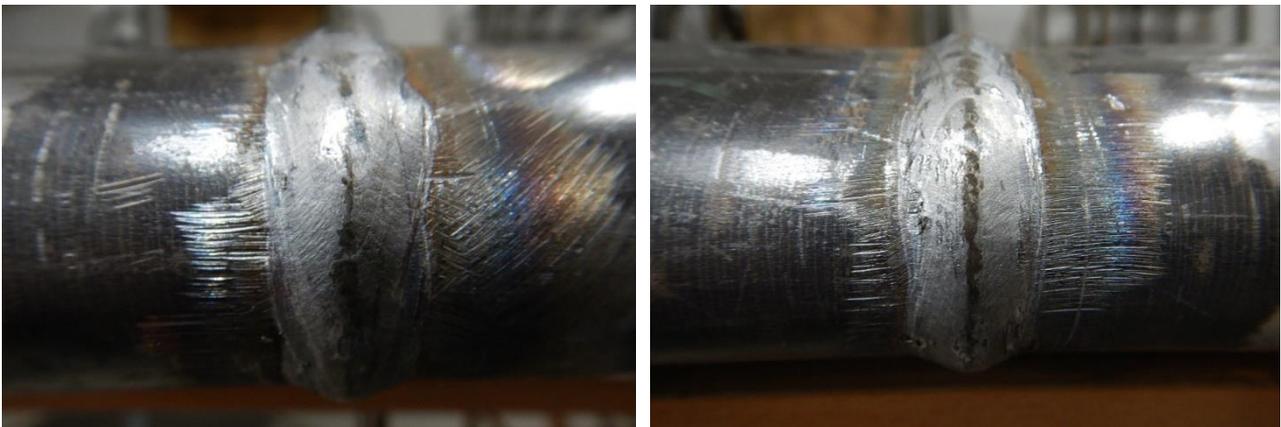
FIGURE 108: EFFECTS OF IMPACT LOAD TEST ON LASER + GMA PIPE SPECIMEN (1 M)

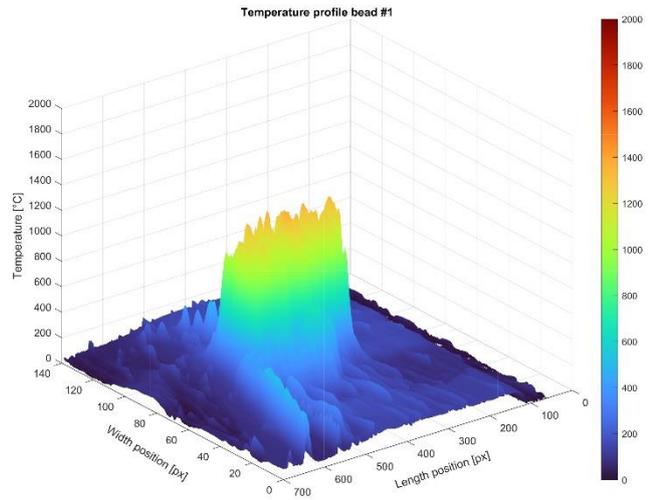
FIGURE 110: PROFILE TEMPERATURE BEAD #1

It was observed that the sample 4_G2, located inside segment number 3 (Paragraph 4.1.1.2), suffered the failure of the welded joint during the bend test. The defect detected was classified as porosity mixed with wormholes and it was located 35 cm along the circumference inside the three cap beads. The data from the infrared camera recorded during the deposition of these three beads were processed to obtain the temperature profiles of the portion of the pipe where the welding process took place. These profiles represent the maximal temperature reached by the welding pool melted material on each single point along the section of the joint monitored. The plain 2D and 3D representations of these three temperature profiles are depicted in Figure 110, Figure 111 and Figure 112.

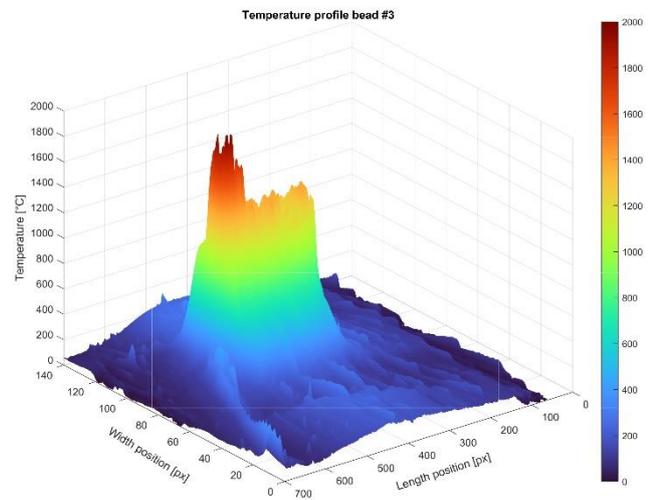
FIGURE 112: PROFILE TEMPERATURE BEAD #3

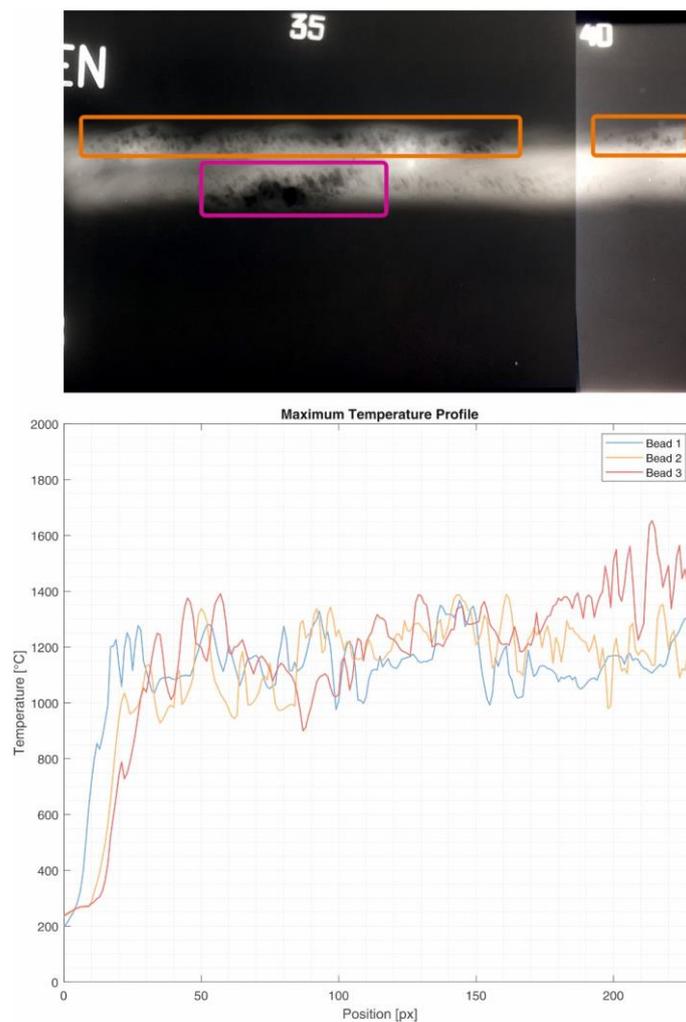
FIGURE 113: TEMPERATURE PROFILE SEGMENT #3

This temperature profile may be compared with the profile obtained from segment number 2 where any imperfections were detected. The result of the analysis for this set of data is depicted in Figure 114. In this case, due to technical issues of the infrared camera it was possible to record only two of three beads and the temperature values in the first part of the graph are low because the welding operator partially obstructed the view of the pipe sample to the camera. However, the temperature profile along segment number three, which was affected by porosity, appears to be more irregular and less constant in comparison to the one obtained from segment two. Moreover, on the temperature profile of segment number three, specifically for bead number 3, can be observed a sudden peak of the temperature profile in the last part of the graph.

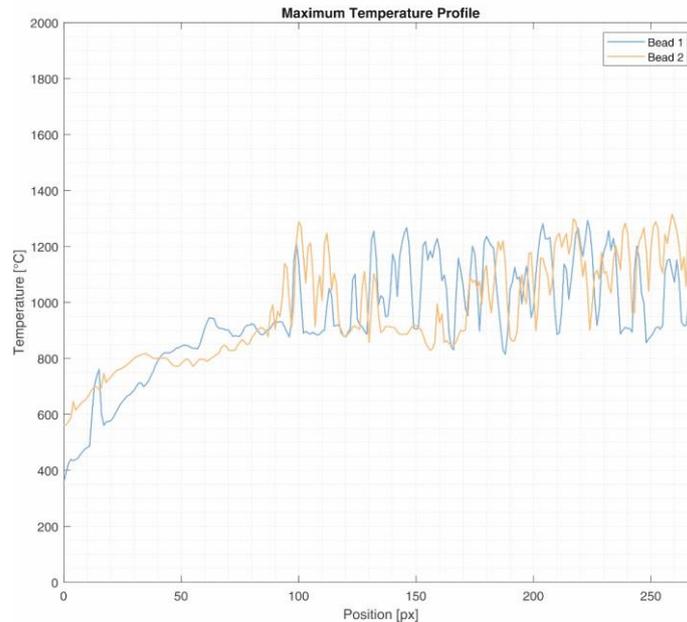
FIGURE 114: TEMPERATURE PROFILE SEGMENT #2

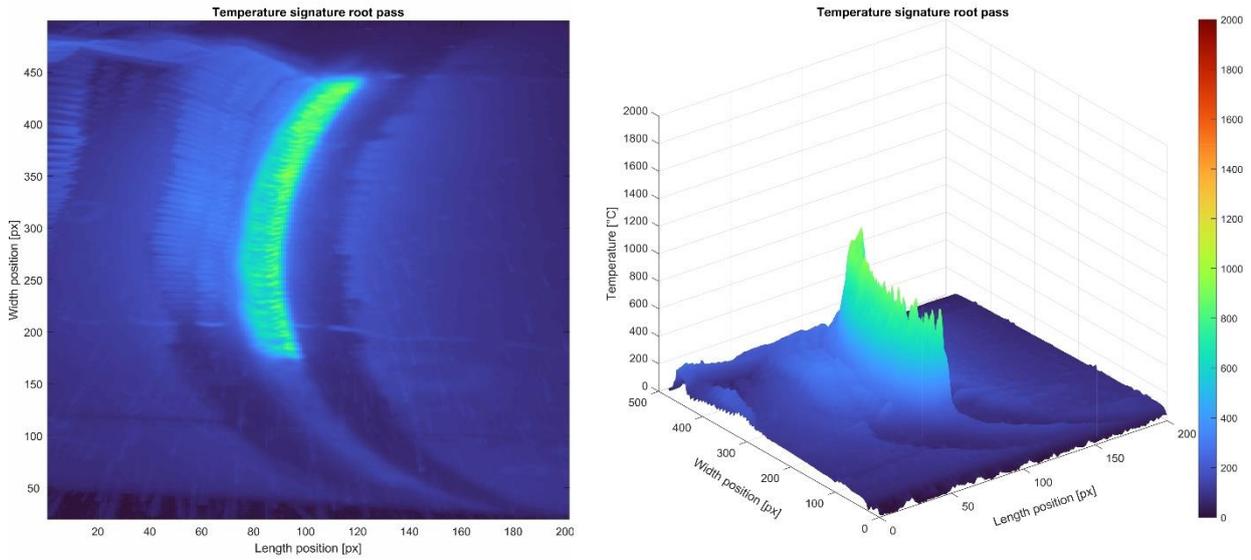
FIGURE 115: PROFILE TEMPERATURE ROOT BEAD SEGMENT 4

It was observed that the samples 2_G3 and 3_G3 suffered the failure of the welded joint during the tensile test: these samples were located 43 and 50 cm along the pipe circumference on segment number four. For both samples, the type of defect detected was characterized by a heavy lack of penetration in the root pass. The analysis of data collected with the use of infrared camera for this specific bead allowed to obtain the welding pool temperature profile depicted in Figure 115. The maximum temperature reached by the welding pool in the area that includes lack of penetration defect, is approximatively in the range between 600 and 800 °C as it can also be seen from the linear 2D profile temperature of Figure 116.

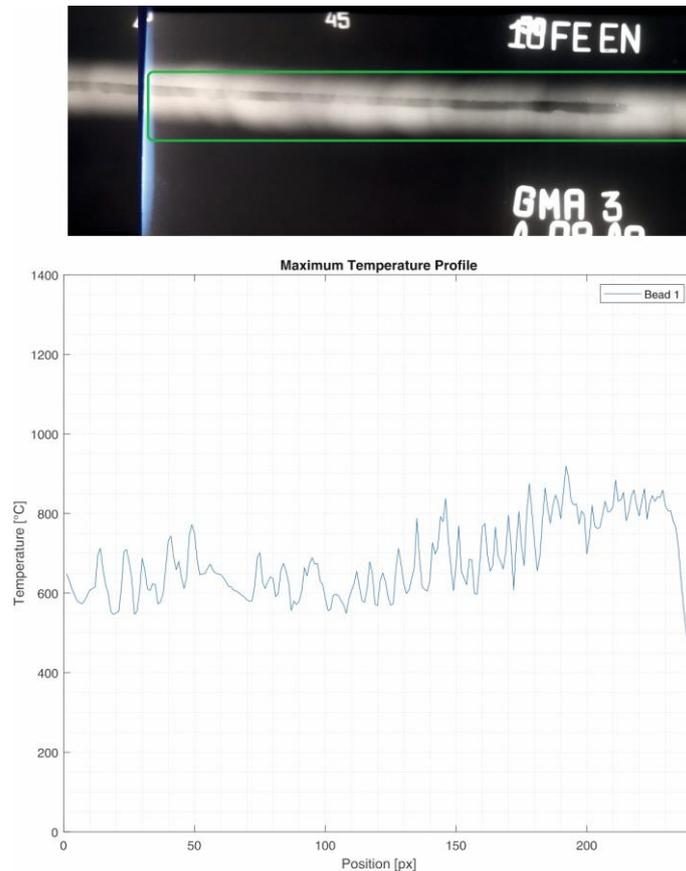
FIGURE 116: TEMPERATURE PROFILE OF SEGMENT 4

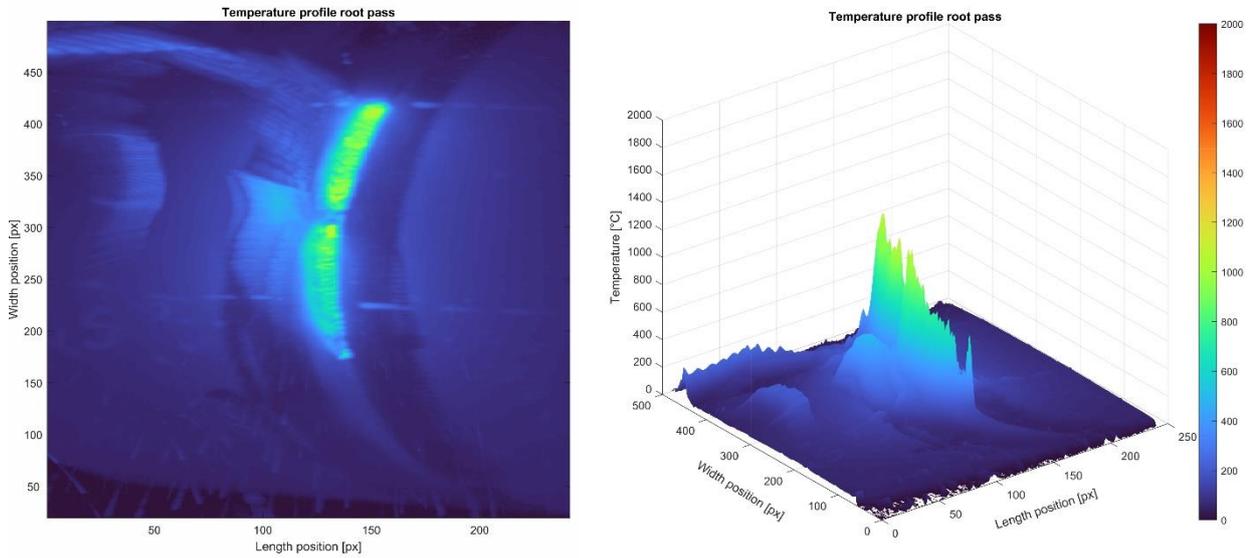
FIGURE 117: PROFILE TEMPERATURE ROOT BEAD SEGMENT 2

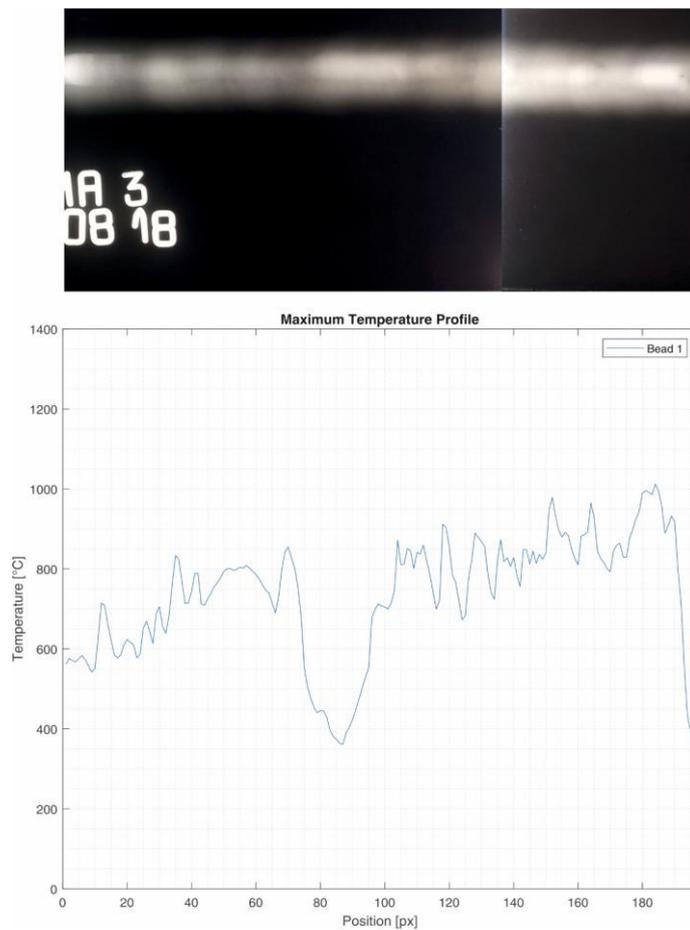
FIGURE 118: TEMPERATURE PROFILE OF SEGMENT 2
