Silesian University of Technology
Faculty of Mechanical Engineering
Department of Fundamentals of Machinery Design

Doctoral Dissertation

**MANUFACTURING PROCESS
DIAGNOSTICS AND DAMAGE
ASSESSMENT OF HSLA STEEL
BUTT-WELDED PIPELINES**

Gliwice, 2022

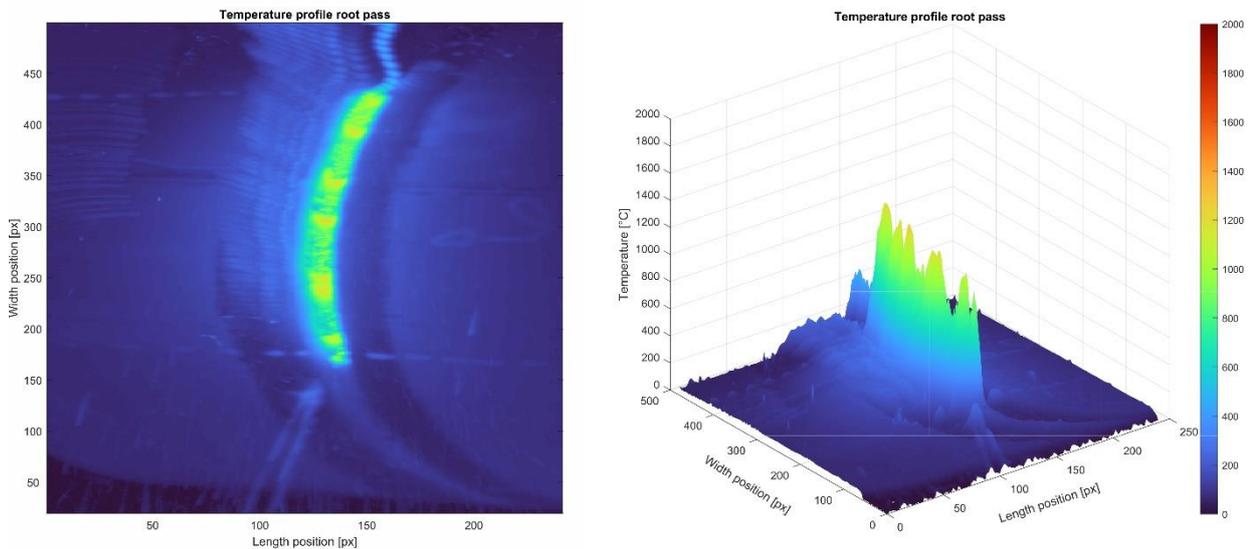
FIGURE 119: PROFILE TEMPERATURE ROOT BEAD SEGMENT 3

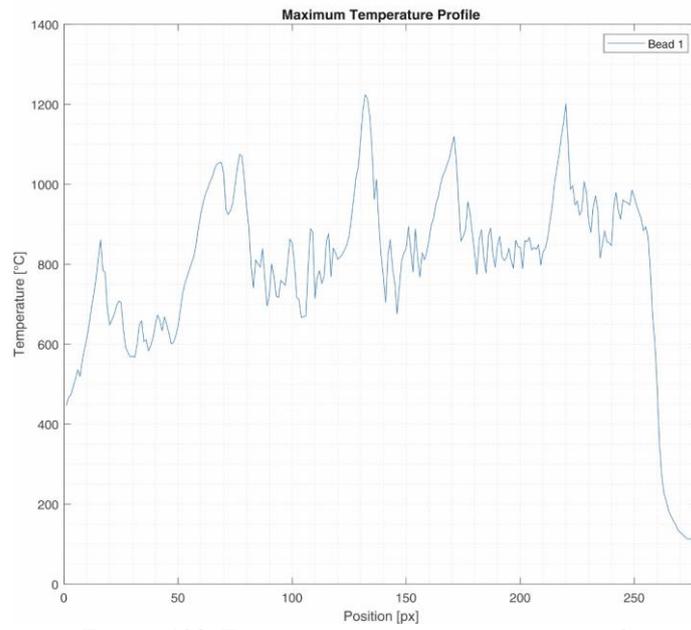
FIGURE 120: TEMPERATURE PROFILE OF SEGMENT 3

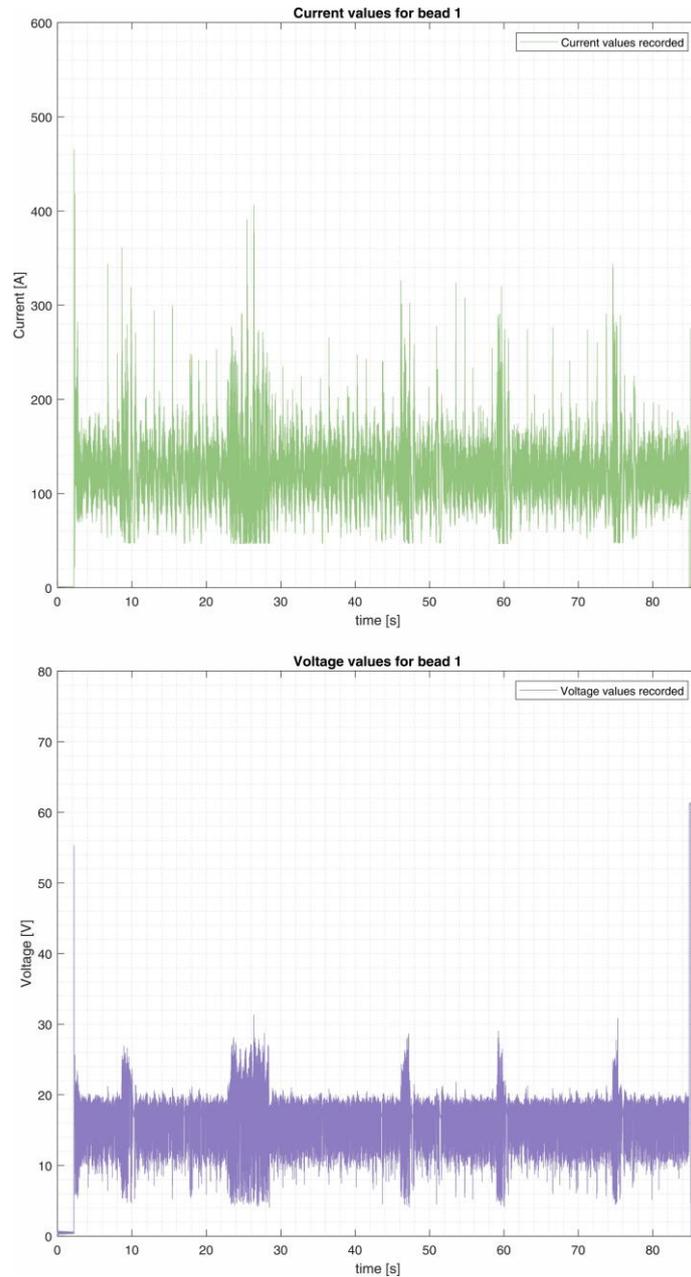
FIGURE 121: WELDING PARAMETERS OF SEGMENT 3

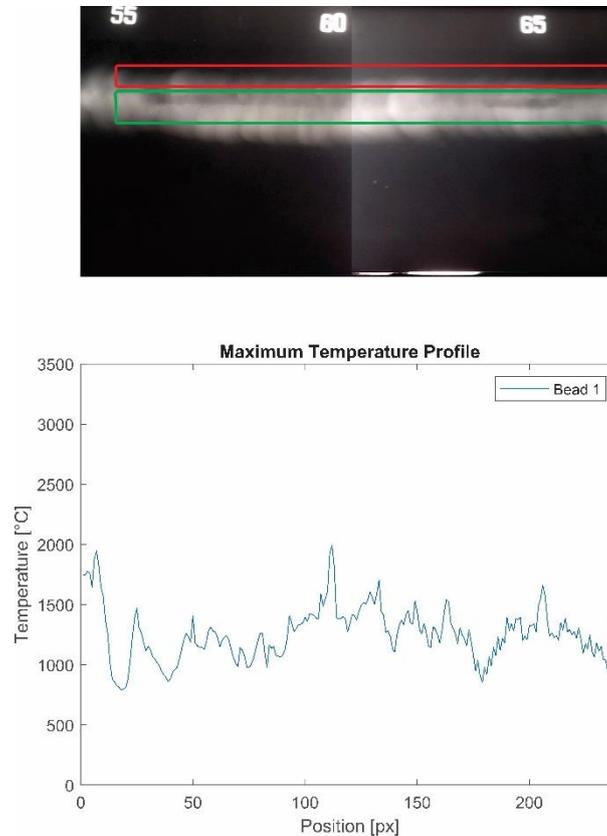
FIGURE 122: TEMPERATURE PROFILE OF SEGMENT 5

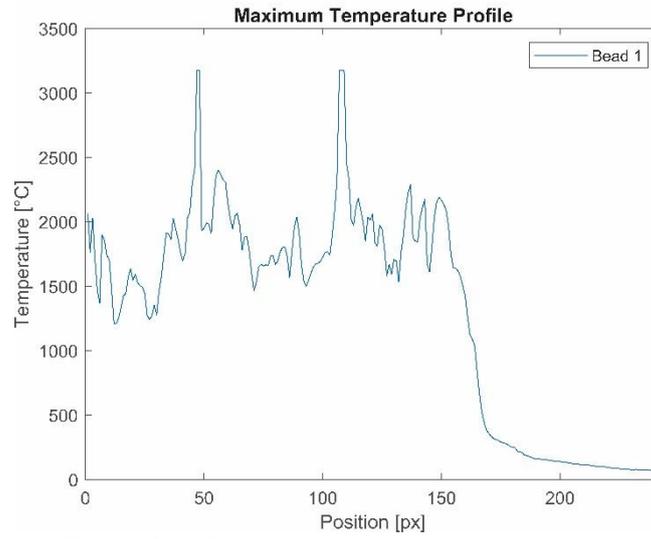
FIGURE 123: TEMPERATURE PROFILE OF SEGMENT 4

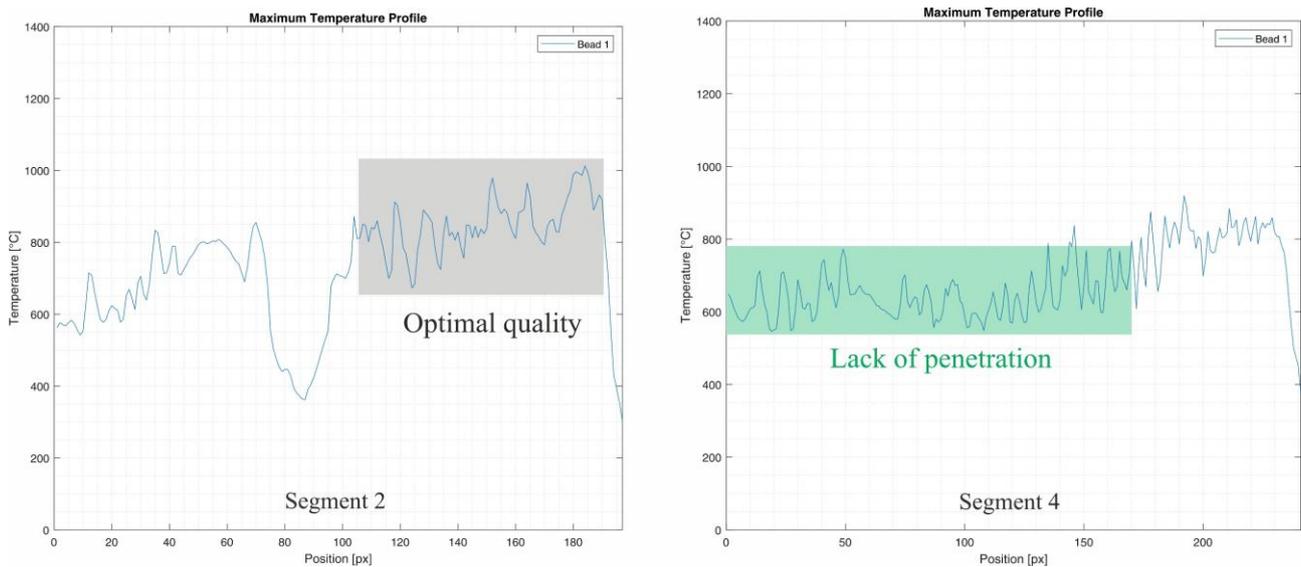
FIGURE 126: COMPARISON BETWEEN SEGMENTS IN GMA3 PIPE

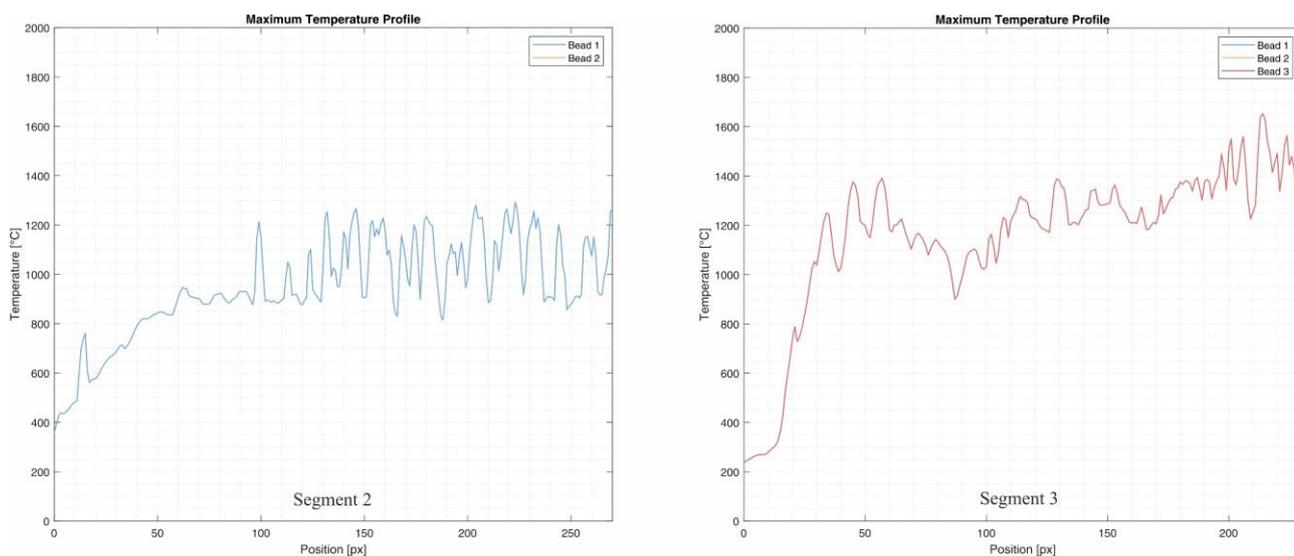
FIGURE 127: COMPARISON BETWEEN SEGMENTS IN GMA2 PIPE

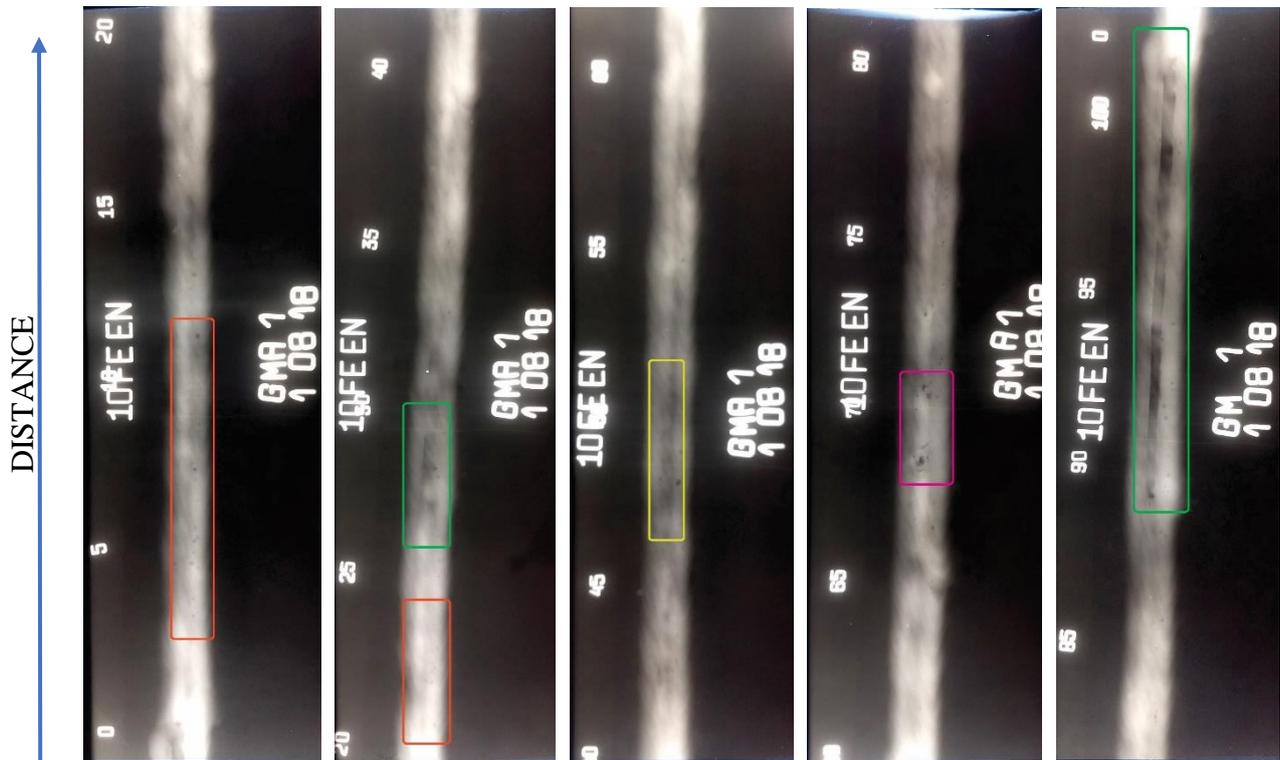
FIGURE A8: MAP OF THE DEFECTS IN GMA1 PIPE SAMPLE

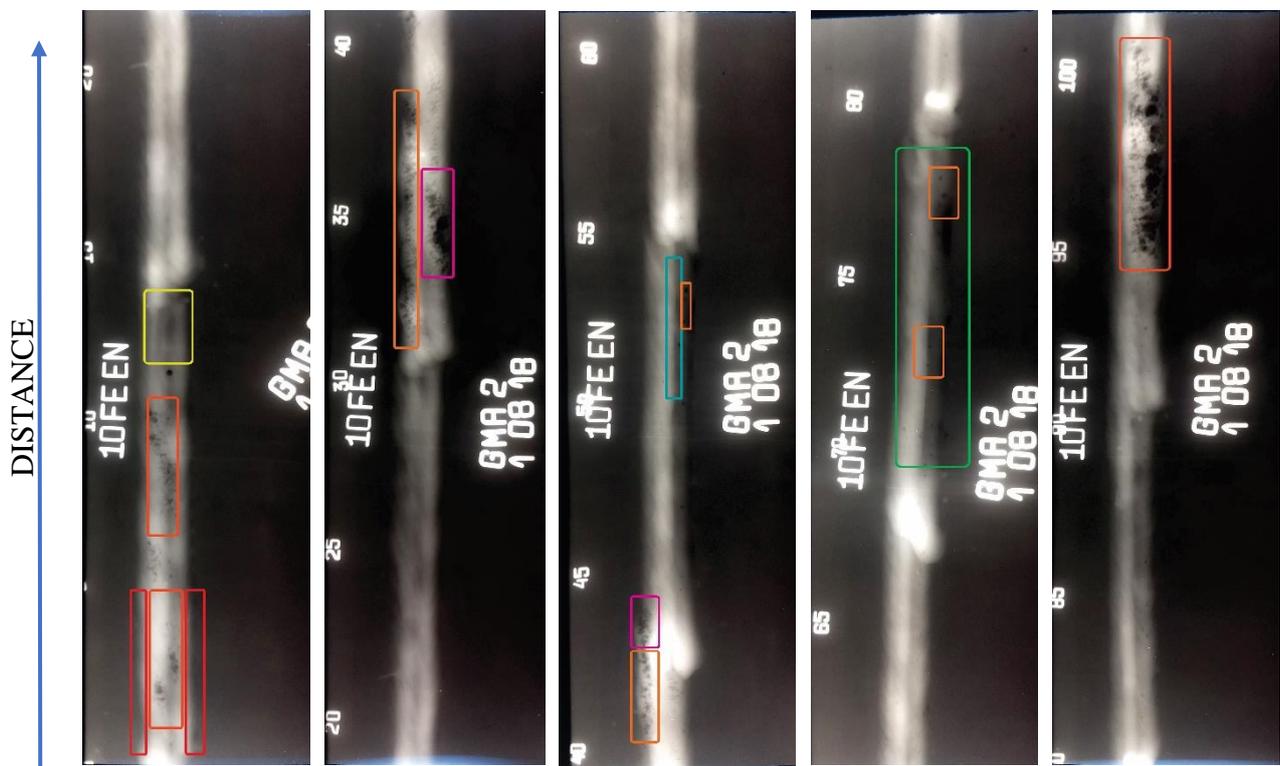
FIGURE A9: MAP OF THE DEFECTS IN GMA2 PIPE SAMPLE

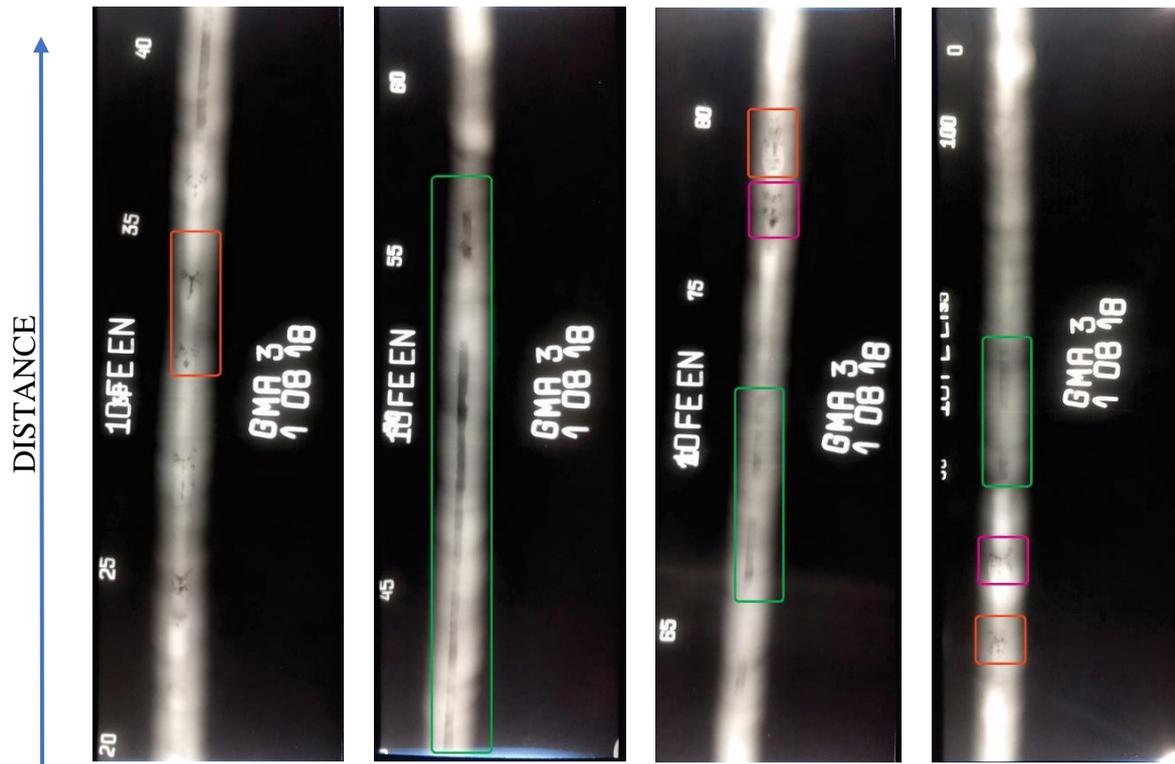
FIGURE A10: MAP OF THE DEFECTS IN GMA3 PIPE SAMPLE

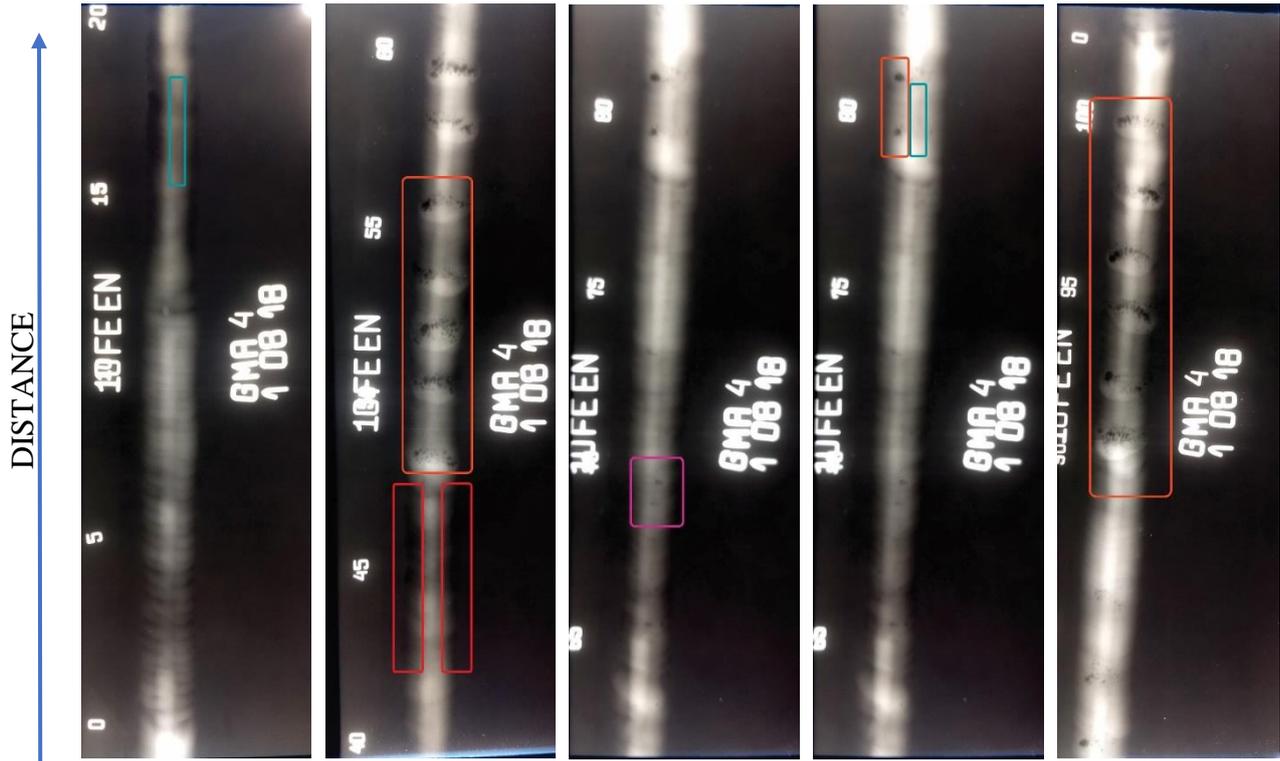
FIGURE A11: MAP OF THE DEFECTS IN GMA4 PIPE SAMPLE

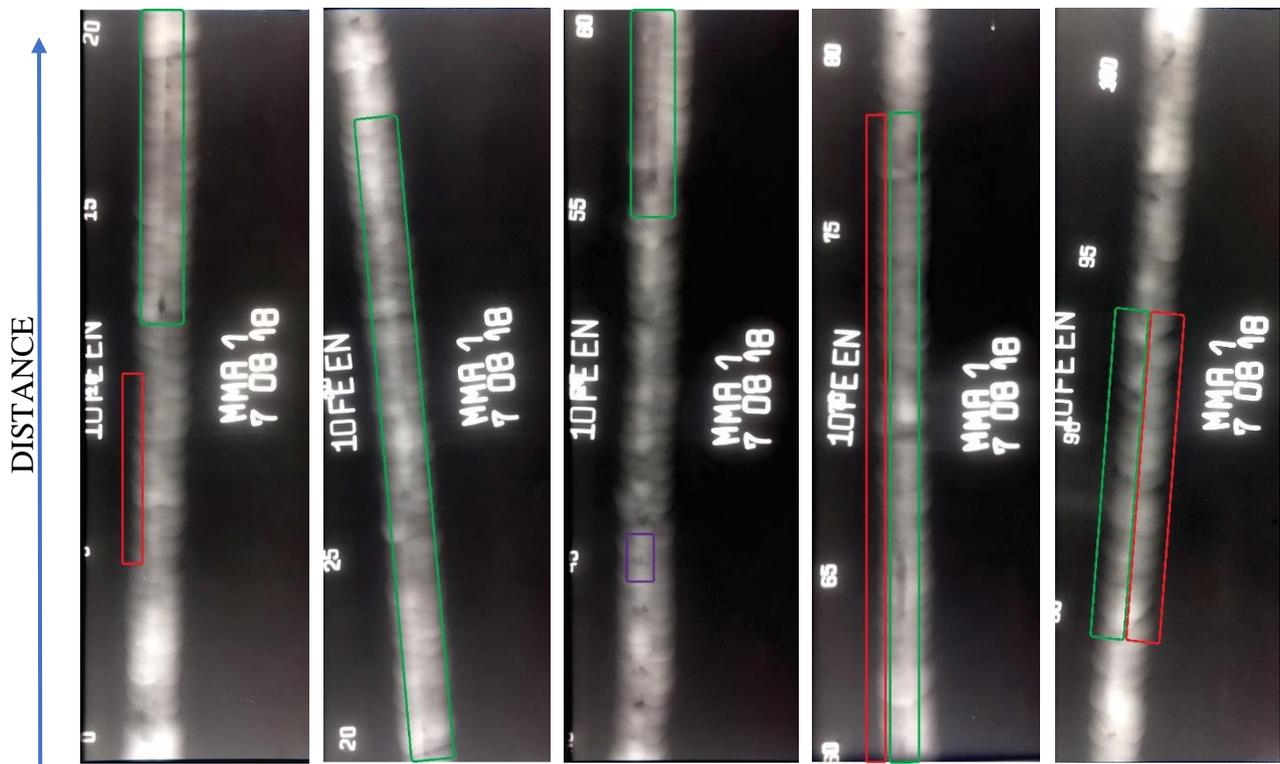
FIGURE A12: MAP OF THE DEFECTS IN MMA1 PIPE SAMPLE

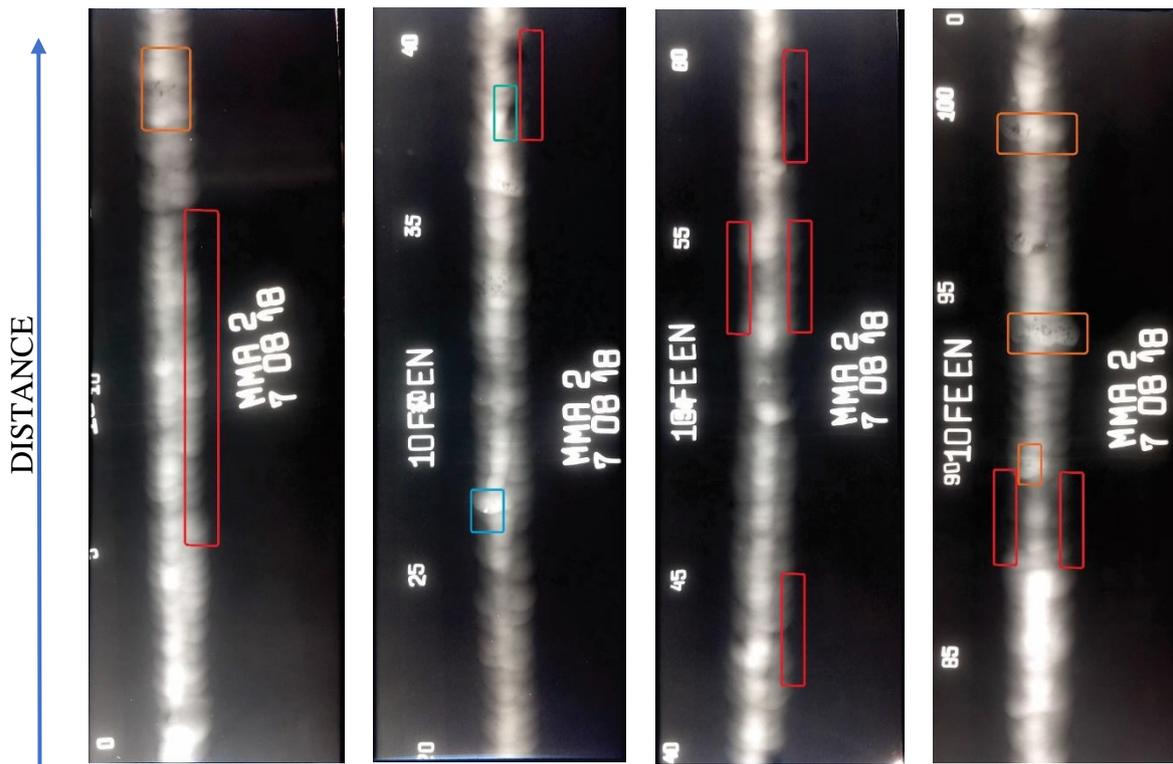
FIGURE A13: MAP OF THE DEFECTS IN MMA2 PIPE SAMPLE

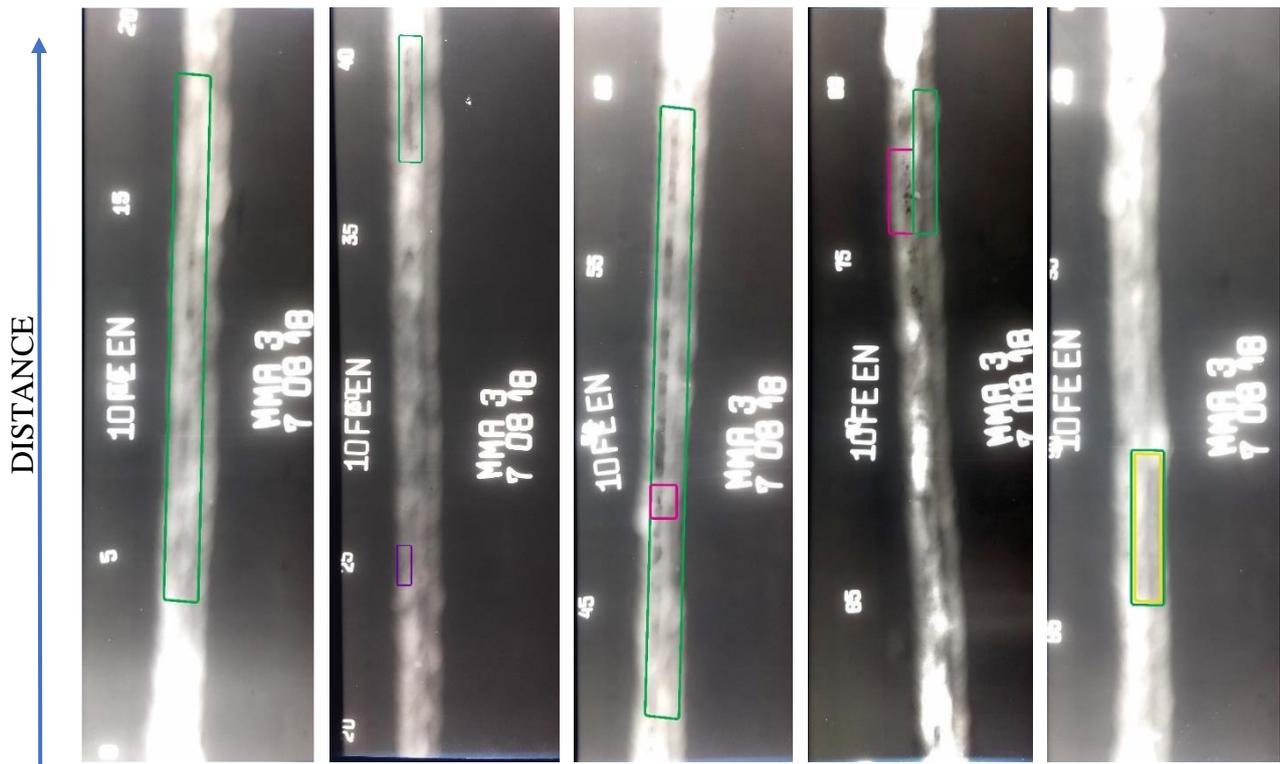
FIGURE A14: MAP OF THE DEFECTS IN MMA3 PIPE SAMPLE

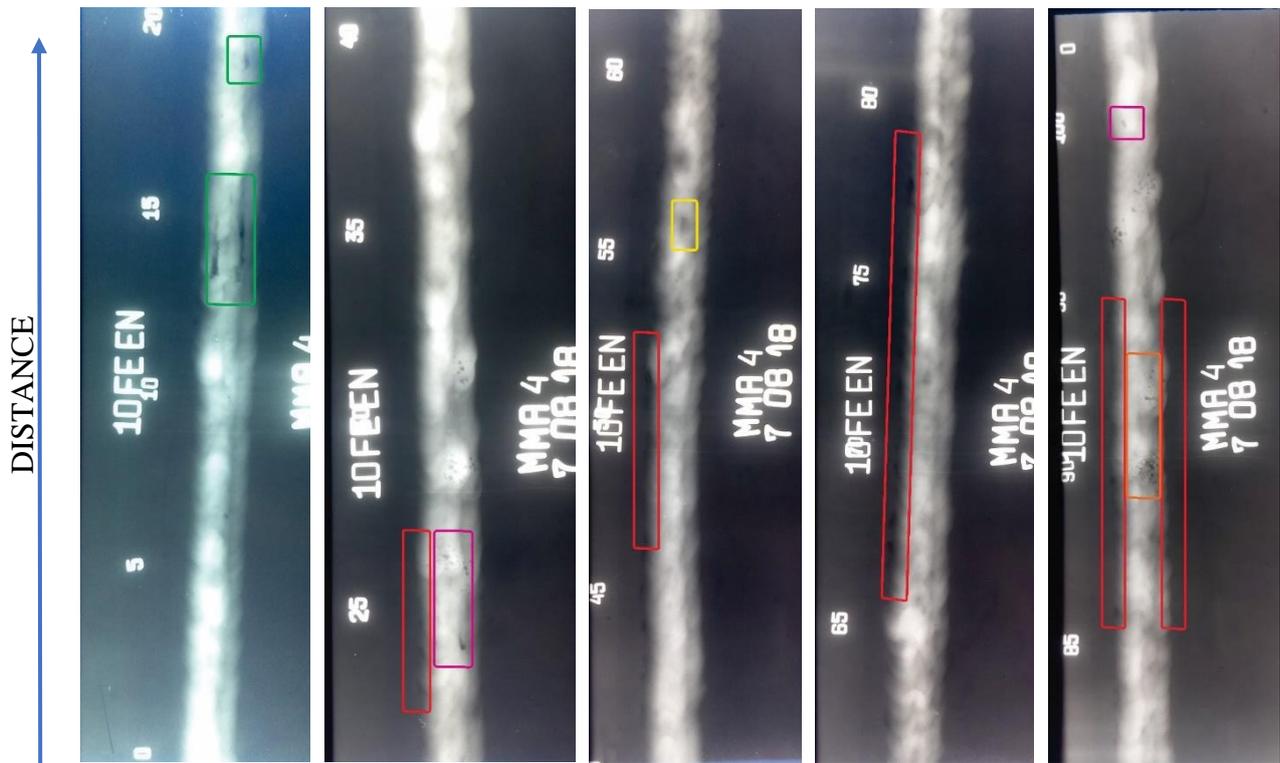
FIGURE A15: MAP OF THE DEFECTS IN MMA4 PIPE SAMPLE

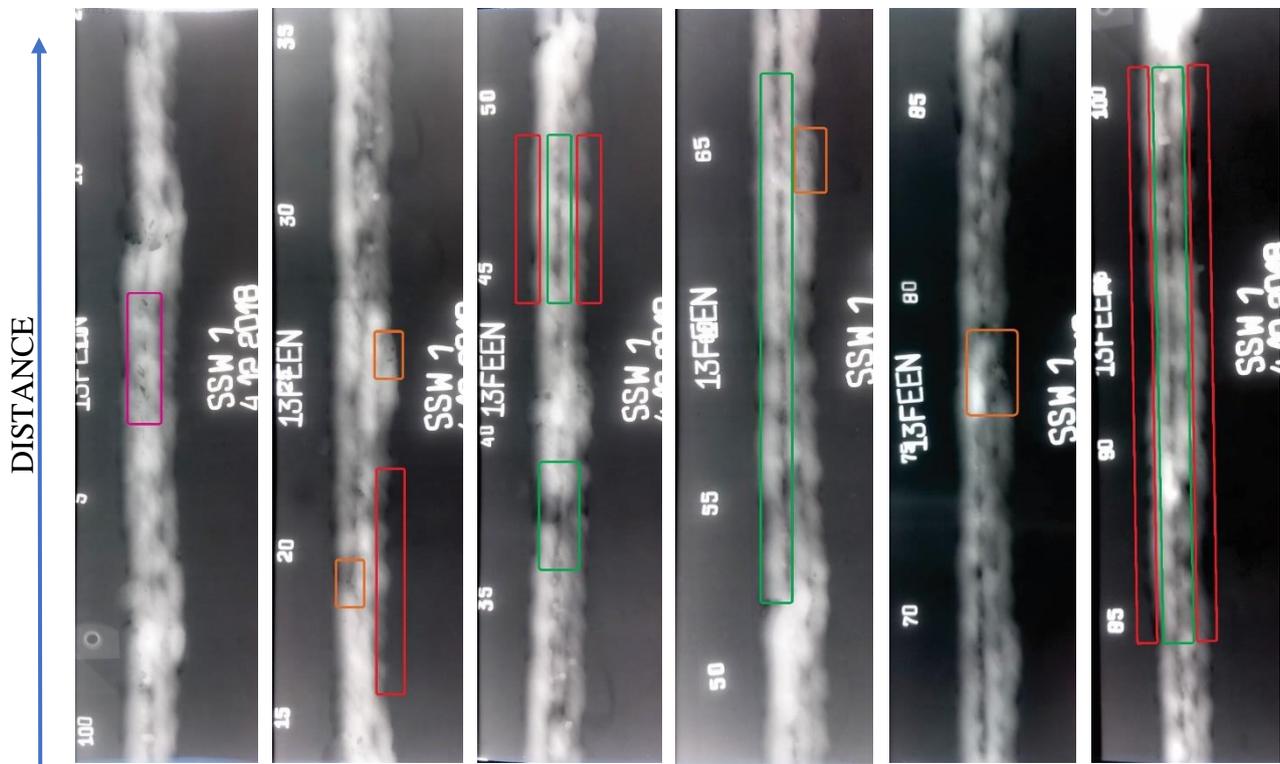
FIGURE A16: MAP OF THE DEFECTS IN SSA1 PIPE SAMPLE

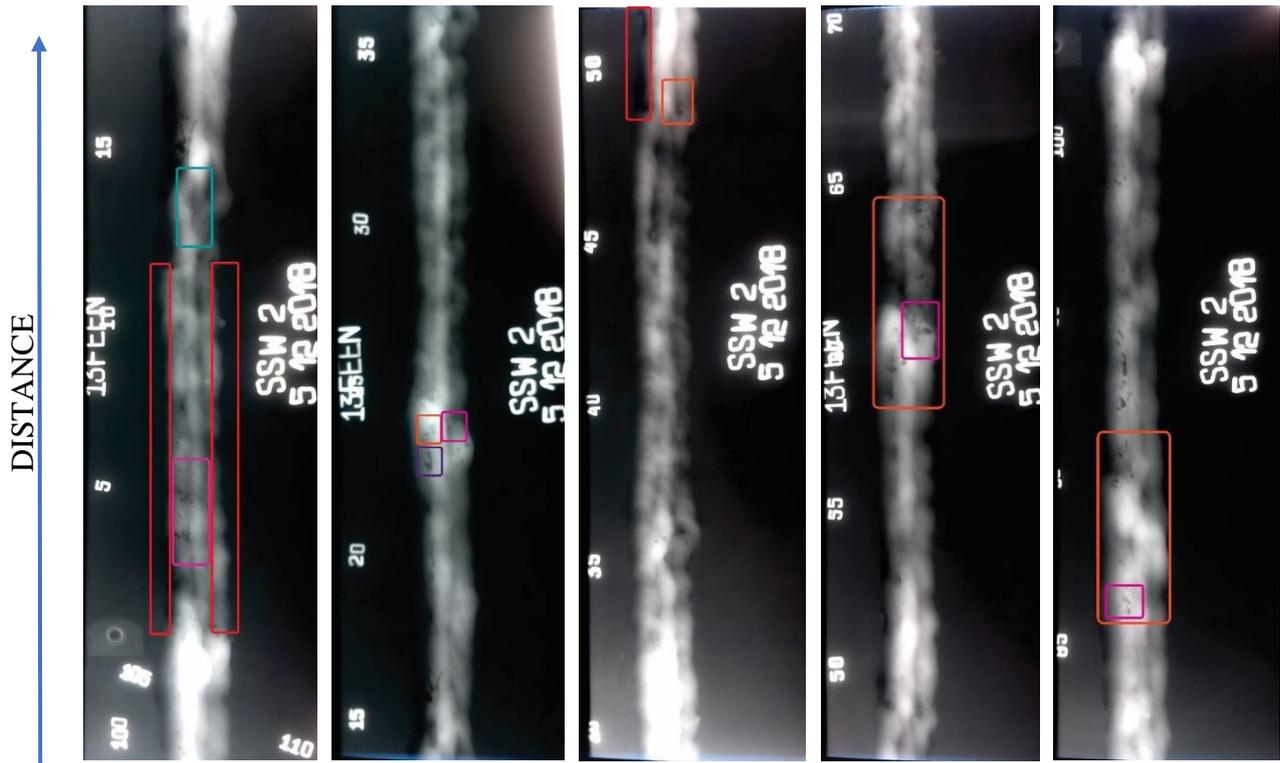
FIGURE A17: MAP OF THE DEFECTS IN SSA2 PIPE SAMPLE

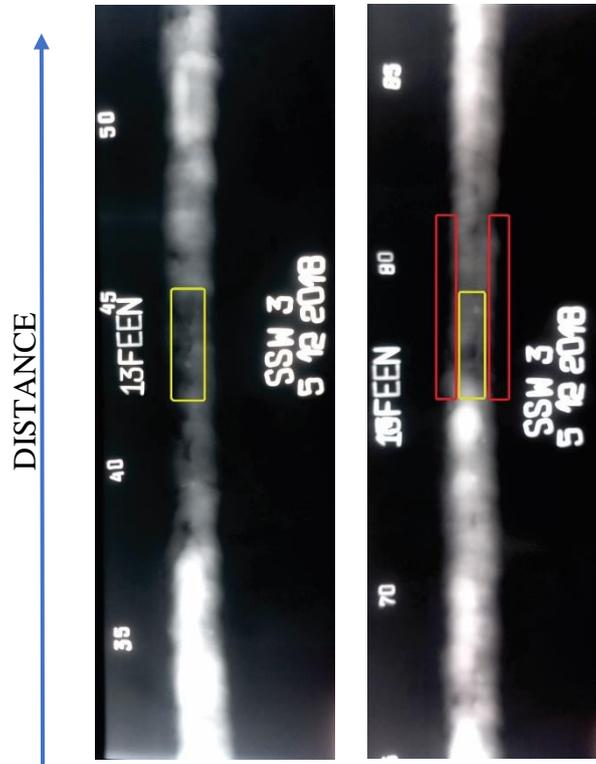
FIGURE A18: MAP OF THE DEFECTS IN SSA3 PIPE SAMPLE

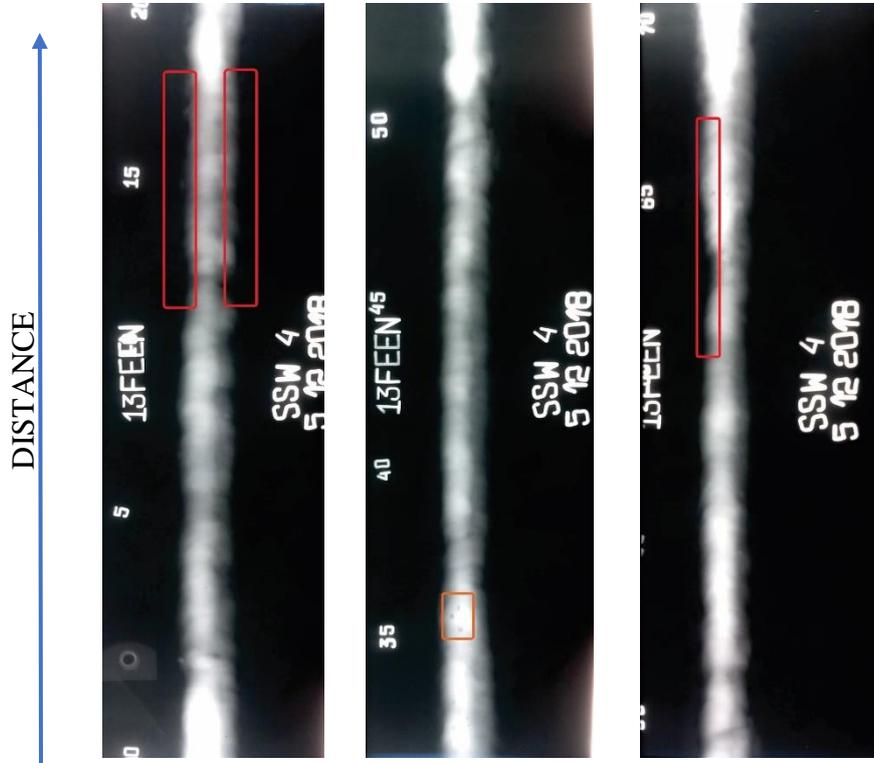
FIGURE A19: MAP OF THE DEFECTS IN SSA4 PIPE SAMPLE
