5. ANALYSIS OF PUBLIC TRANSPORT ACCESSIBILITY – A CASE STUDY OF TYŚĄCLECIA GÓRNE ESTATE IN KATOWICE, POLAND

5.1. Introduction

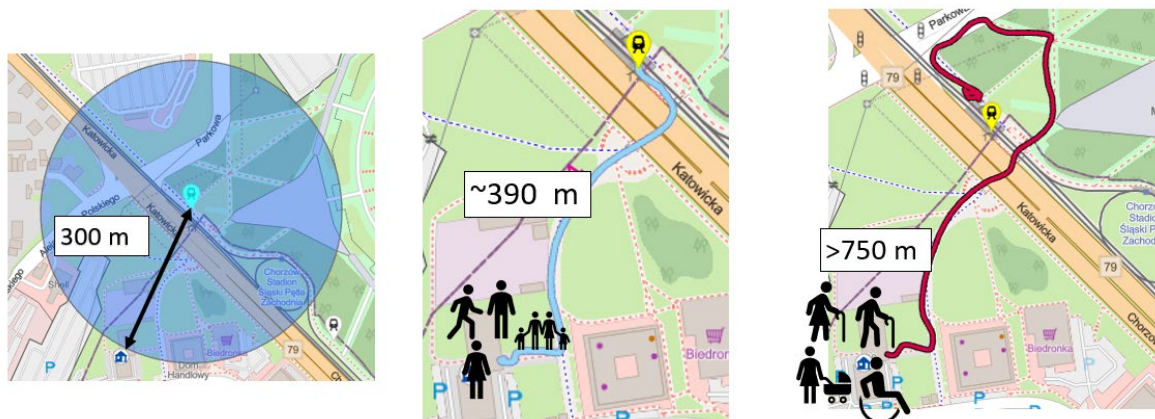
Fig. 5.3. Comparison of the distance to go as a linear and along network that must be passed by people (PNP and PPM) and existing architectural barriers

Moreover, usually, people, with mobility problem (PPM) must travel at least twice as long compared to others (PNP) due to the steep stairs leading to tram stops (“Chorzów Silesia Stadium” and “Chorzów Silesian Park, main entrance”). The drawings show the differences between the distance in a straight line from one of the buildings and the actual distance pedestrians PNP and PPM must travel. The actual distance is greater than the straight line. In the case of people PPM, with architectural barriers this distance may be even doubled (Fig. 5.3).

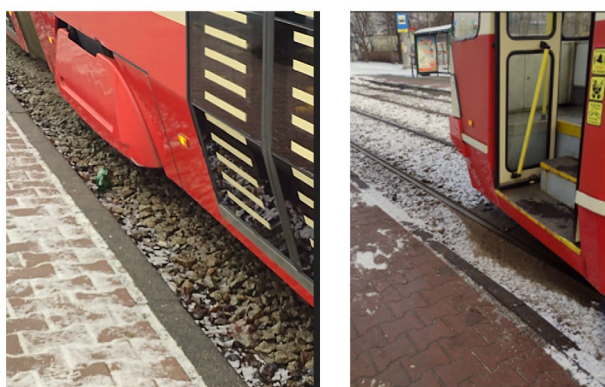
Fig. 5.5. Example of the architecture barrier: a long distance between tram and sidewalk makes this stop not adapted to people with special needs

Another problem for PPM was evident from the survey: when PPM people tried to get into the tram at Chorzów, Silesian Stadium the distance between the sidewalk and the stairs to board the tram is too far (a distance of about several tens of centimeters (Fig. 5.5). It has happened that the wheels of the trolleys get stuck between the car and the stop.

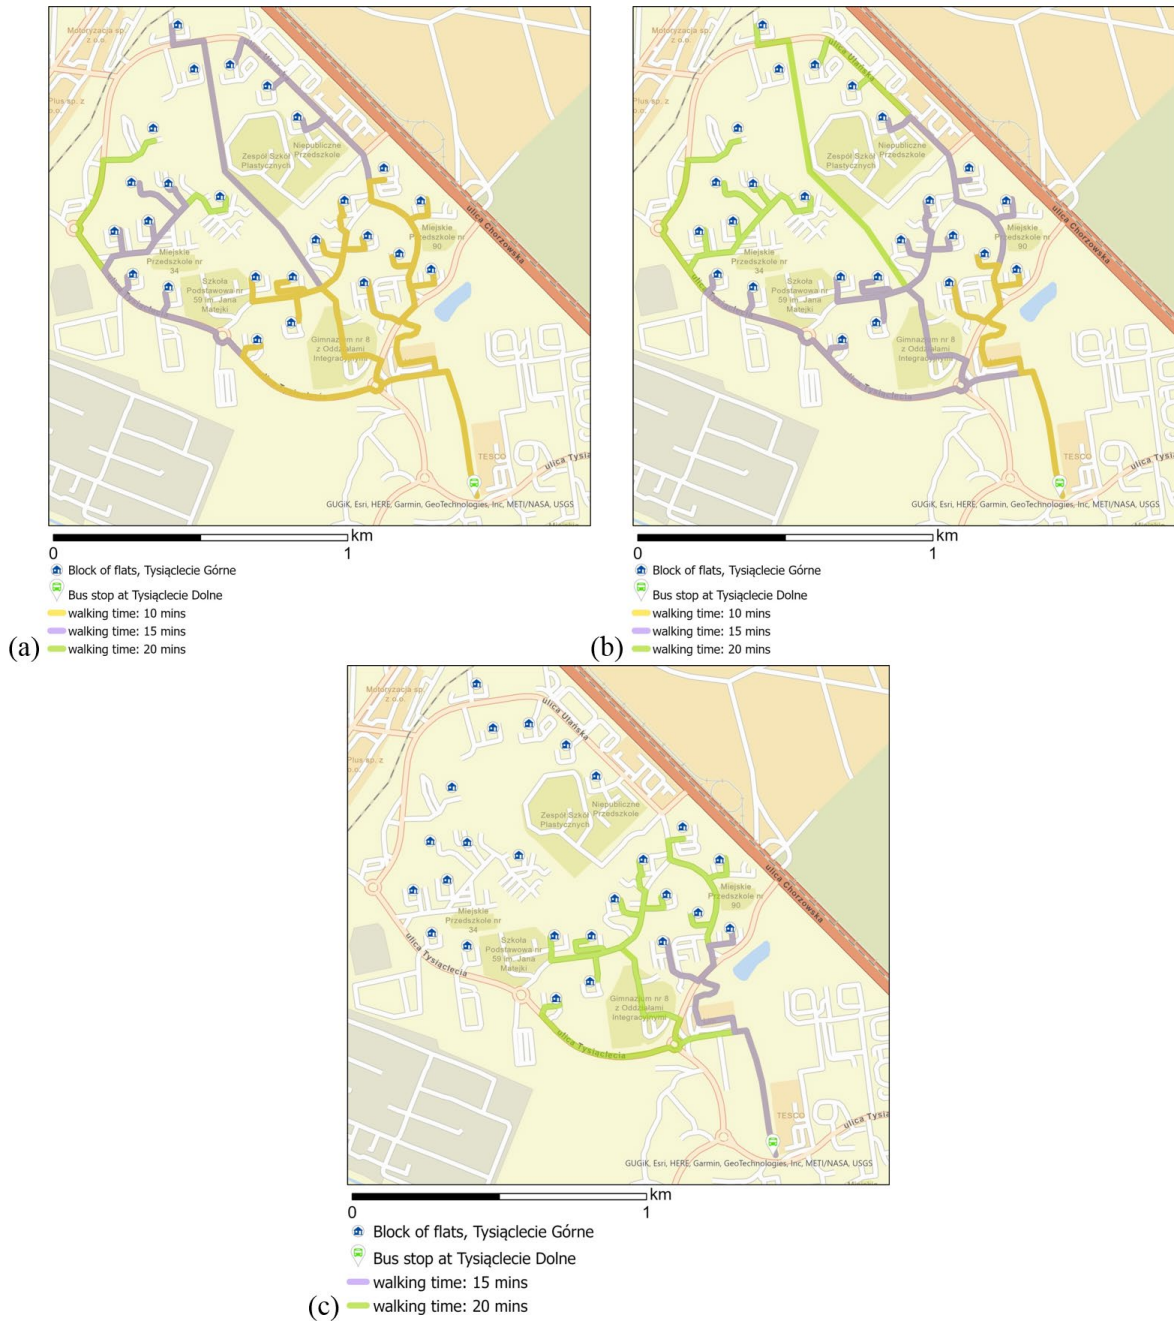
Fig. 5.10. The distance that can be reached by pedestrian depends on the speed (a) 6 km/h; (b) 5 km/h, and (c) 3 km/h, respectively), if they move from Tysiąclecie Dolne to Tysiąclecie Górne estate on foot, due to a lack of connection between two parts of the estate

Tysiąclecie Górne estate (the blocks located near the border with Chorzów, northwest) depend on the speed of motion. If someone moves with a speed of 6 km/h walking time can be about 15–20 minutes. If someone moves slower, the time increases to 25 minutes or more (Fig. 5.10).

Further, more detailed distance-time analysis presented the distance that could be reached by people if they moved with a different speed. This concerned situations where someone is travelling (B, KT and B, TK) in the evening or during the weekend and decides to walk on foot from Tysiąclecie Dolne to Tysiąclecie Górne. In this case, the following variables were taken into account: (1) human movement speed between 3 km/h and 6 km/h (2) location of the bus stops and houses (3) architectural barriers and network connections accessible for PPM people (4) slope and topography, and (5) time of the motion: between 10 and 20 mins.
