Technology of laser repair welding of nickel superalloy inner flaps of jet engine

Purpose: of this paper: work out laser welding repair technology of cracked MIG 29 jet engine inner flaps made of cast nickel superalloy ŽS-3DK (ЖС-3ДК, Russian designation).

Practical implications: The technology can be applied for repair cracked MIG 29 jet engine inner flaps.

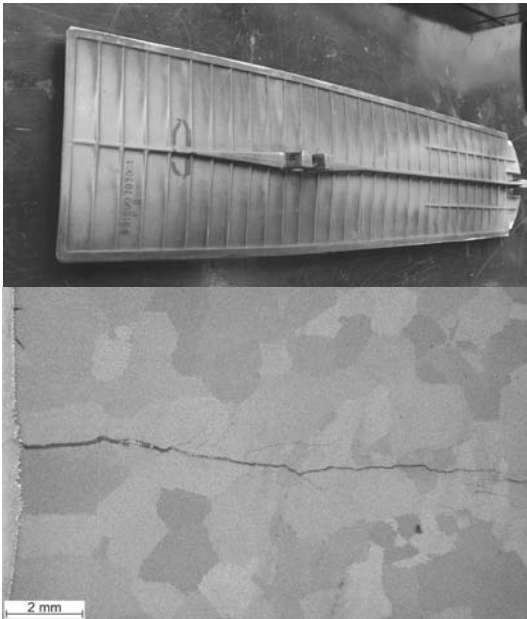
Fig. 1. View and macrostructure of a crack of jet engine inner flap made of nickel superalloy ZS-3DK (ЖС-3ДК)

The main objective of present study is to work inner flaps made of cast nickel superalloy ŽS-3DK (ЖС-3ДК, Russian designation), the chemical composition corresponding to approximately RENE 95 (61% Ni, 8% Co, 14% Cr, 3.5% Mo, 3.5% W, 3.5% Nb, 2.5% Ti, 3.5% Al), Table 1. Inner flaps work in very complex operating conditions, with variable thermal and mechanical loads, erosion, corrosion, cavitation particularly under the influence of heated high temperature steam of gases at the engine exhaust. Superalloy RENE95 belongs to a group of precipitation-hardened nickel base alloys but due to their high content of alloying elements, especially the total content of titanium and aluminium (2.5% Ti + 3.5% Al), their weldability is very poor [5-7]. The most common defects of the inner flaps are cracks which starts at the edge of flap and develop through the thickness to the middle area of the inner flap, Fig. 1.

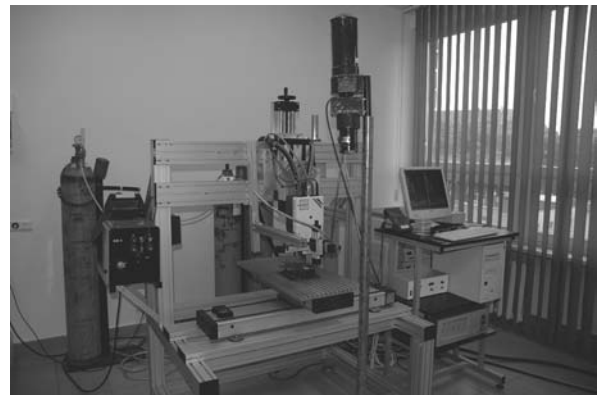
Fig. 2. Laser HPDL surfacing experimental CNC stand

Preliminary study of automatic welding technologies GTA, PTA and laser HPDL has shown that just laser welding can provide high quality repair welds. Following studies are concentrated on selection welding technique and welding parameters to provide highest quality repair welds. Because cast structure of inner flap contains natural internal defects like porosity, nonmetallic inclusions, microcracks, it was decided to use high quality and very good weldability nickel alloy INCONEL 625 as the consumable material, Table 1. Second approach was directed to provide minimum welding stresses by application of low heat input parameters. Finally laser HPDL powder INCONEL 625 repair welding process has been developed providing very high quality process of repairing of inner flap cracks, Fig.2.

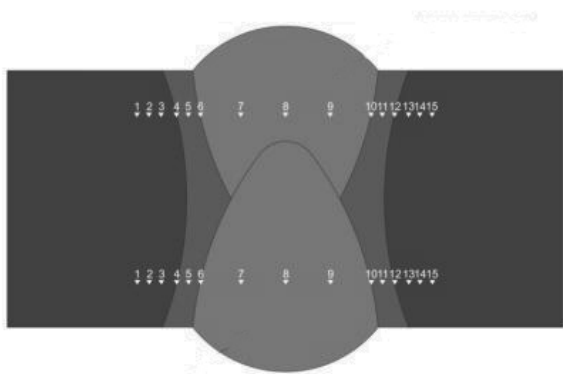
Fig. 7. Layout of micro hardness measurements on the cross section

mechanical properties and erosive wear resistance, Tables 3, 5 and 6, Figs. 7, 9. The results of measurements of HRC hardness face HPDL repair joints showed significantly lower hardness (48-49HRC) than base material - 55.6HRC. This is due to the fact used as additional material with nickel superalloy INCONEL 625, characterized by lower mechanical properties, but very good weldability. Microhardness measurements on cross-section have shown that all repair welds are characterized by hardness $\mu\text{HV}0,5$ at a similar level of $370-450 \mu\text{HV}0,5$, Table 3, Fig. 7.

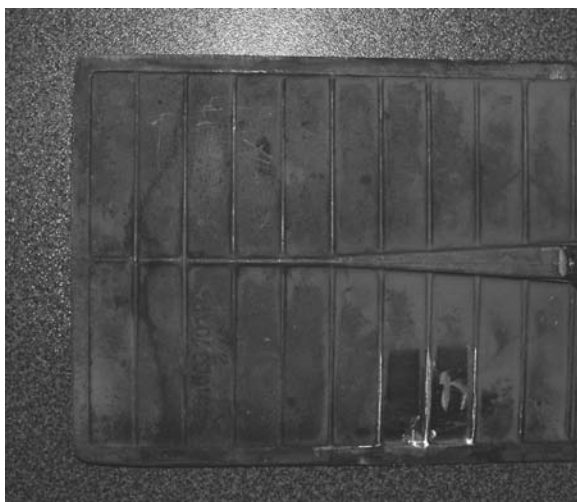
Fig. 8. View of a repaired crack from the inner flap of nickel superalloy ZS-3DK (ЖС-3ДК), using HPDL laser welding, Table 4

Visual, penetrant and metallographic examinations of model repair cracks in welded joints of the inner flap, showed a high-quality welds without internal and external defects, despite poor weldability of nickel superalloy ZS-3DK (ЖС-3ДК), Table 2, Figs. 4 and 5. In the last stage of the study, developed using the technological process of laser welding repair cracks inner flap, Table 4, carried out the repair of damaged jet flap, Fig. 8.

Summarizing the results of the study can be concluded that it is possible to repair the defects of inner flaps by HPDL laser welding with use in powder form INCONEL 625 nickel alloy as an additional material, Fig. 8.

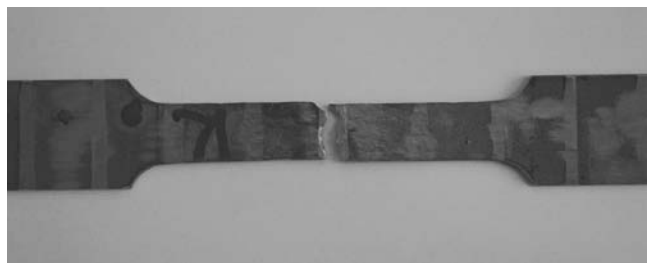
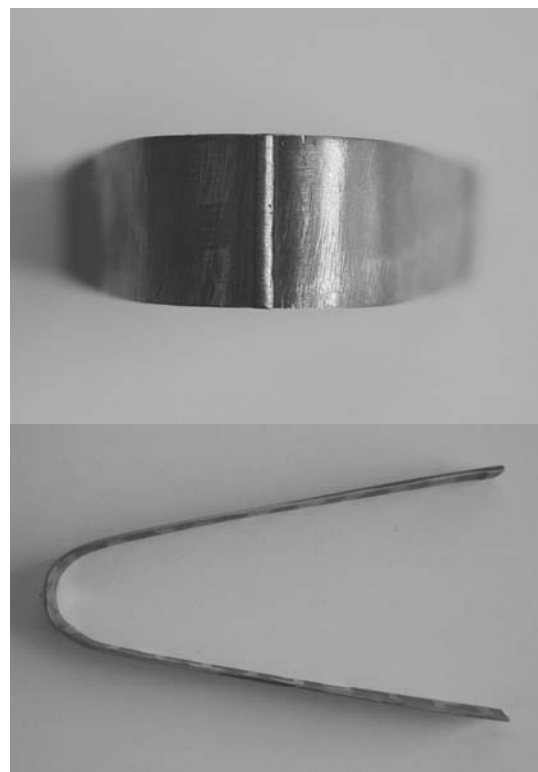
Break in the parent material

Break in the HAZ

Bending from the root of bead

Fig. 9. A view repaired butt joints of the inner flap the nickel superalloy RENE 95, HPDL welded after static tensile test and static bending test from the face and from the root

Testing the mechanical properties of test joint plates taken from the inner flap, and HPDL laser welded with INCONEL 625 powder of the optimum welding parameters showed high mechanical properties of test joint. The high plastic properties of welded test joints by laser HPDL confirmed the static bending test from both the face and root side, in each case was 180° bending angle, Table 5, Fig. 9.
