Characterisation of APS TBC system during isothermal oxidation at 1100°C

L. Swadźba ^a, G. Moskal ^{a,*}, B. Mendala ^a, T. Gancarczyk ^b

^a Silesian University of Technology, ul. Krasińskiego 8, 40-019 Katowice, Poland

^b WSK "PZL Rzeszów", ul. Hetmańska 120, 35-078 Rzeszów, Poland

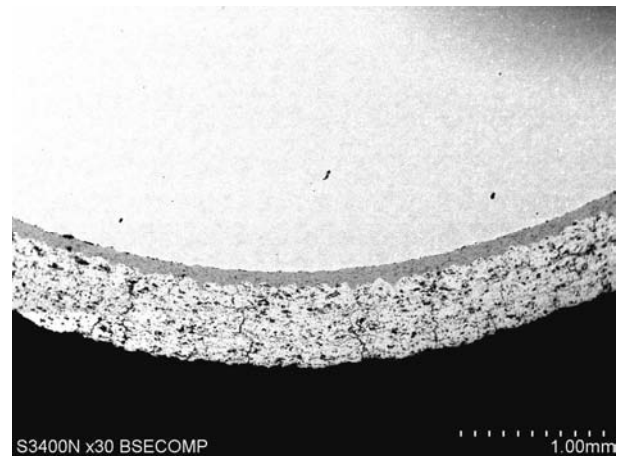
The TBC system in as-spray condition are shown in (Fig. 6 and 7). Figure 6 presents an air plasma sprayed coating with layered structure of ceramic top coat and inner bond coat. The thickness of ceramic layer was ca. 550 μm and was very similar on the all surface of the specimen. The thickness of bond coat was ca. 130 μm. The typical microstructure of the plasma sprayed YSZ could be seen with pores, lamellae boundaries and micro-cracks. The metallography of the as-sprayed NiCoCrAlY bond revealed a dense, non-homogeneous coating structure containing visible splat boundaries and very small interlamellar porosity, isolated spherical internal porosity, and non-uniform dispersion of Y₂O₃ and Al₂O₃ (Fig.7). Total porosity of the ceramic top layer and bond coat were evaluated by image analysis from the polished cross section.

Fig. 6. General view of the TBC system in before the oxidation

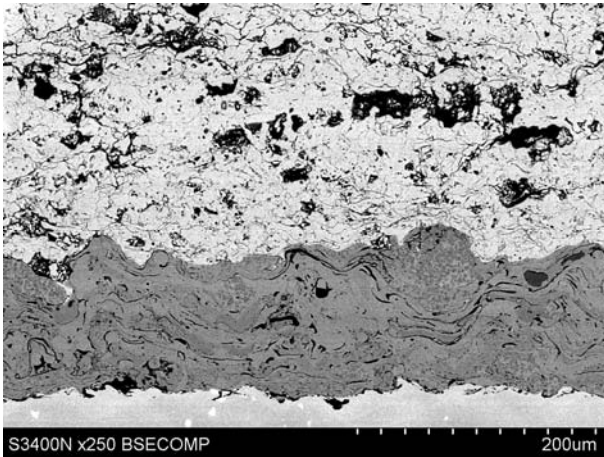
Fig. 7. Optical microstructure of the investigated TBCs
