INFLUENCE OF THE IMPACTOR GEOMETRY ON THE DAMAGE CHARACTER IN COMPOSITE STRUCTURES

Andrzej Katunin^{1a}, Michał Zuba^{1b}

¹Institute of Fundamentals of Machinery Design, Silesian University of Technology

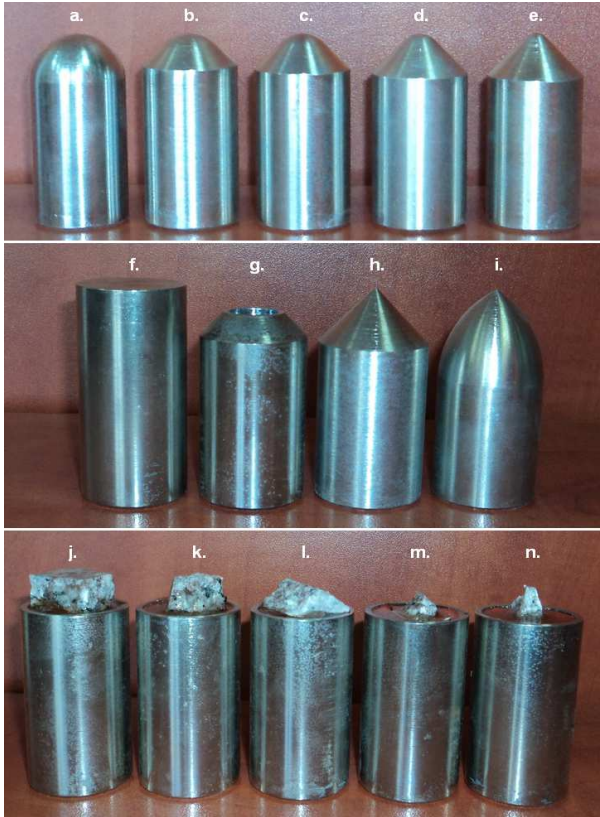
A procedure of performing the damage simulation was as follows. During the tests several types of impactors were considered. Two general types of impactors were used (see Fig.2): with metallic indenter part and with a stone indenter part (for the simulation of stone impacts). The impactors presented in Fig.2a-e contain the rounded end of R17, R14, R11, R8 and R5, respectively; Fig.2f presents a flat-ended impactor of R17; Fig.2g presents a ring-ended impactor of R9.5; Figs.2h-I present the conical and bullet-like indenters; and Figs.2j-n present impactors with immersed stones: with flat impact surface, with rough impact surface, edge-ended, vertex-ended and angle-oriented vertex-ended, respectively. The damaging was performed with various energies of impact starting from 10 J to 40 J with a step of 10 J. An exemplary planar view of a damaged plate was presented in Fig.3. For convenience hereinafter we use the following notation of the damaged cases: in

M20 the letter denotes a type of impactor according to those presented in Fig.2 and the number denotes the energy of impact.

Fig. 2. Impactors used for the tests

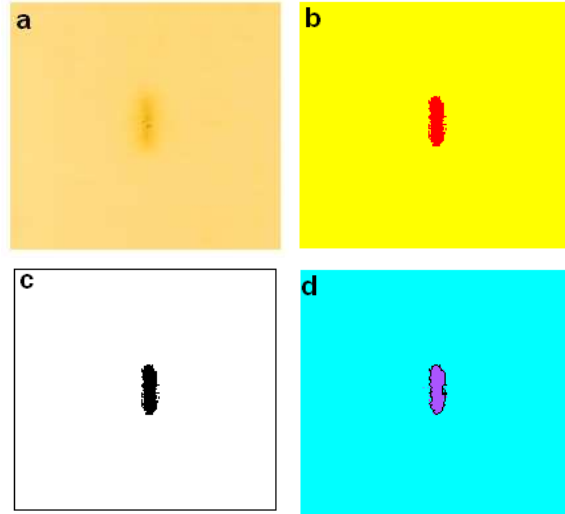
In order to evaluate damage areas the images obtained during TLI were processed using segmentation algorithm. The images were loaded into the Matlab® environment and processed with use of the Image Processing Toolbox™. The processing consisted of the following steps. The RGB channels were firstly normalized to the unitary range and the thresholding operation was applied (with empirically determined threshold value of 0.8) in order to extract the damaged region from the image. Then, the resulted image was binarized. Finally, the boundary tracing algorithm was applied in order to select the damage region and evaluate its area in pixels. These steps were presented in Fig.7. From the proportions of speci-

Fig. 7. Steps of image processing of A20 case: a) original TLI image, b) normalized and thresholded image, c) binarized image, d) image with a traced boundary of damage

mens' dimensions with respect to the damage area the latter was determined in mm. The determined areas of damages were stored in Table 1.
