# PENETRATION RESISTANCE OF COMPOSITE STRUCTURES WITH IMPACT DAMAGES

Andrzej Katunin<sup>1a</sup>, Mateusz Tyczka<sup>1b</sup>

<sup>1</sup>Institute of Fundamentals of Machinery Design, Silesian University of Technology

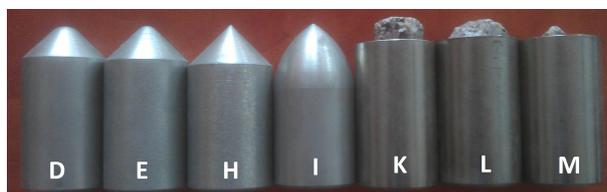
Fig. 1. Impactors used for inducing damages of the plates

Following this, after visual inspection, 19 pre-damaged plates were selected for further analysis. The impactors, were used for the damaging of these plates were presented in Fig.1. Here and further the letters denote the type of impactor. The views of the considered damages can be found in [19]. Some of them were presented in Fig.2.

where  $\rho$  is a density of a liquid,  $g$  is a gravitational constant and  $h$  is a height of the actual fluid column corresponded with the critical penetration resistance. In this study it was assumed that  $\rho = 1000 \text{ kg/m}^3$  and  $g = 9.81 \text{ m/s}^2$ . Obtained results were presented in Table 1, where the symbols of tested plates denote the type of impactor (see Fig.1) and the impact energy value (numeral), for instance see [19].

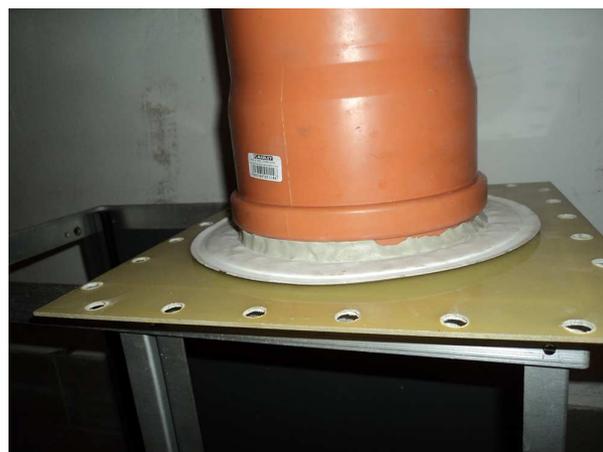
Fig. 4. View of the penetration resistance test rig

The test rig was constructed as follows. Pre-damaged plates were connected with a steel flange, which was connected with a polychlorvinyle pipe of a length of 1 m and diameter of 160 mm. The diameter of a pipe was selected according to the maximal span of cracks in the tested plates. The connections were realized by gluing the mentioned elements using two-component epoxy-based commercial hydraulic mastic. The connected construction was placed on the metallic frame, which allows for observation of a bottom surface of a tested plate. The specimen was oriented in a such way that the

pressure of a water column was applied to the impacted surface of a tested structure, which is in agreement with a physical nature of the investigated events. The scheme and a photograph of a test rig was presented in Figs. 3 and 4, respectively.

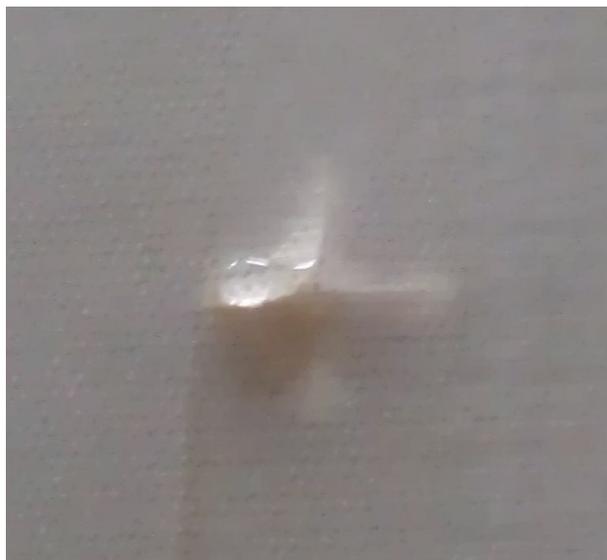
Fig. 5. Drop formation in the cracked region on the bottom surface of a plate

The penetration resistance of composite structures was tested in the following way. The pipe was filled by water with a capacity of 100 ml. The time interval between the consecutive fillings was 1 min. After every filling the bottom surface of a plate was examined for the formation of a drop (see Fig.5).
